Chapter : 5 Trial Operation on a Running Motor Mounted Blower

5.2 The Equipment Details

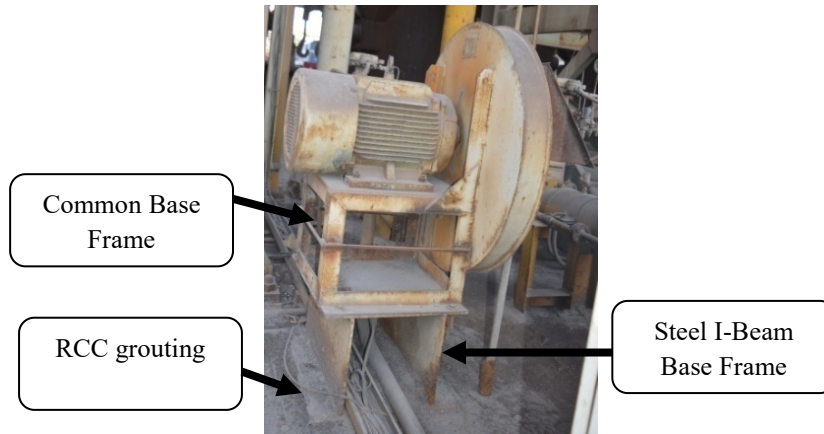
Figure: 5.2 Blower & Motor Common Frame on I- Beam Structure.

The blowers supply the combustion air to the gas burners for the heating and drying of the refractory items of the hot metal ladles after relining or repair. The blowers are all centrifugal type and directly mounted on motor. The motor and the blower block are mounted on a common frame which is bolted on the I-beam base frame which is bolted to the concrete base.(Figure :5.2)

From the above discussion we can conclude that the reason for high vibration of the blower and the motor were due to structural weakness only as checking the tightness of the base bolts indicated there were no specific mechanical looseness. Phase analysis has also indicated the same. However there is a possibility of blower rotor unbalance but that will be dominant after rectifying the structural weakness of the centrifugal blower. As in the experimental set-up it has been verified that channel structural base is the best option for the steel base frame for a motor mounted blower it was decided to replace the I- beam of the present base with same size steel channel but keeping all other parts like the common base plate of motor and blower same.

During a suitable shut down the 300mm I beams was removed and replaced with 300 mm channel frame. The base frame drawing is enclosed (Appendix-E). Only

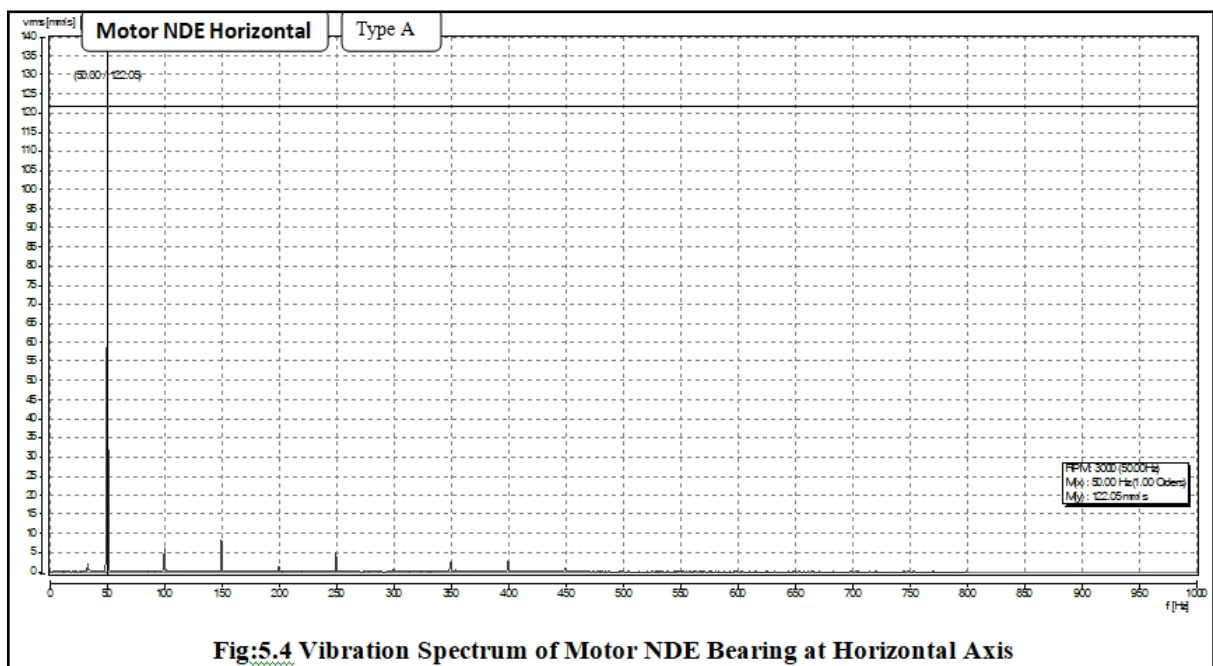
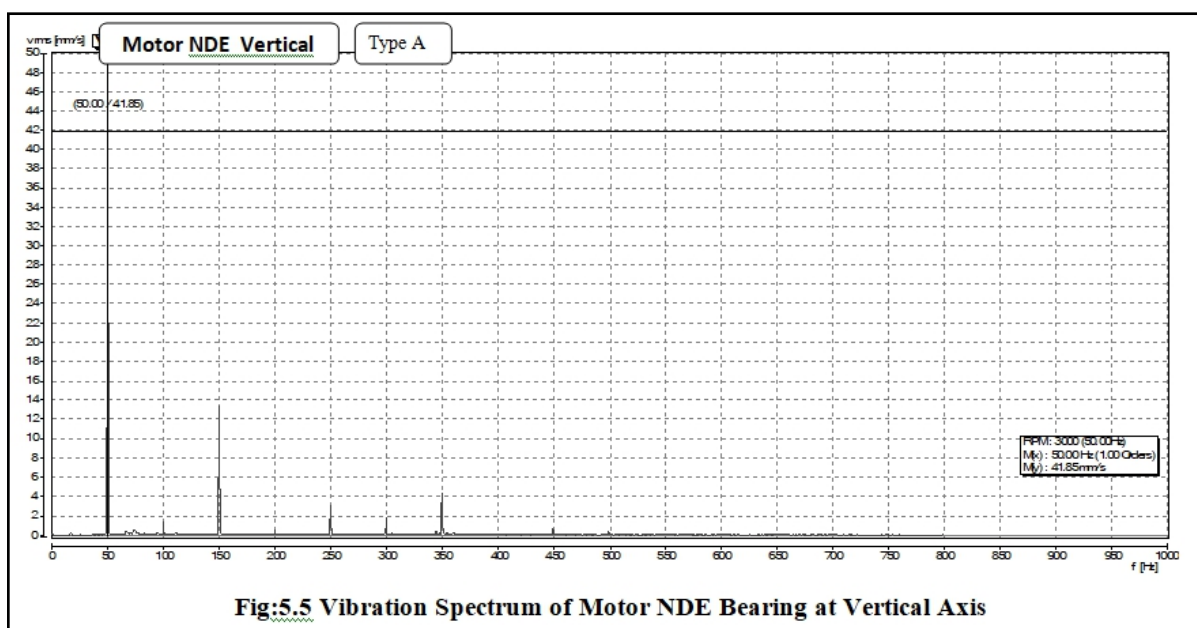
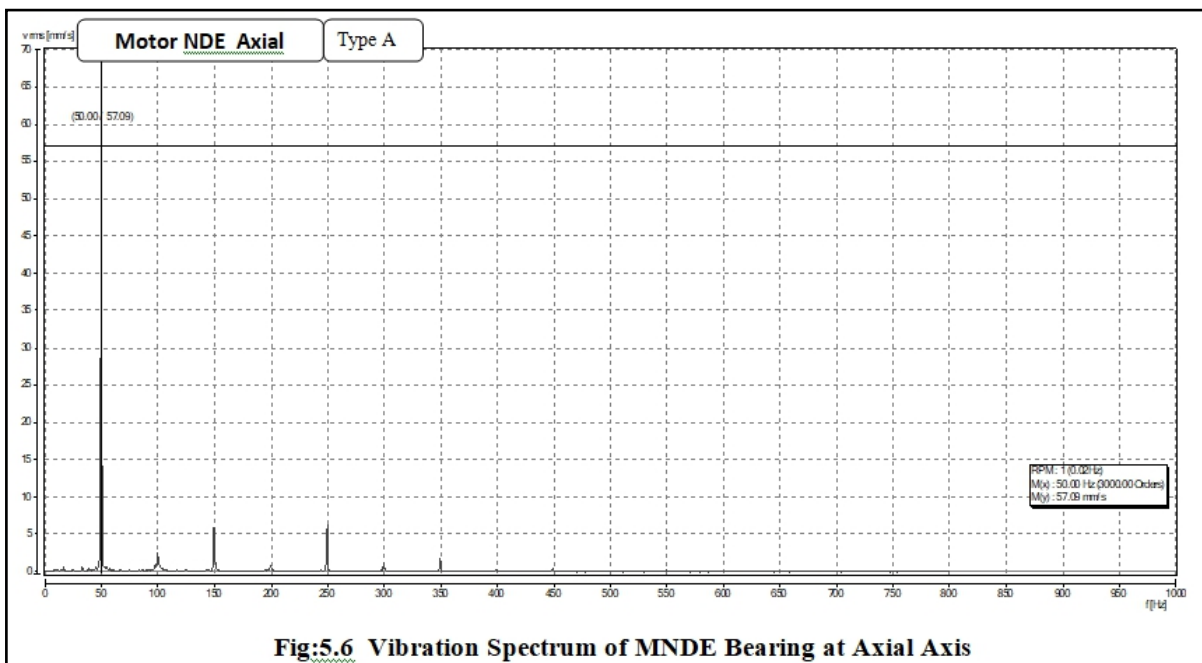
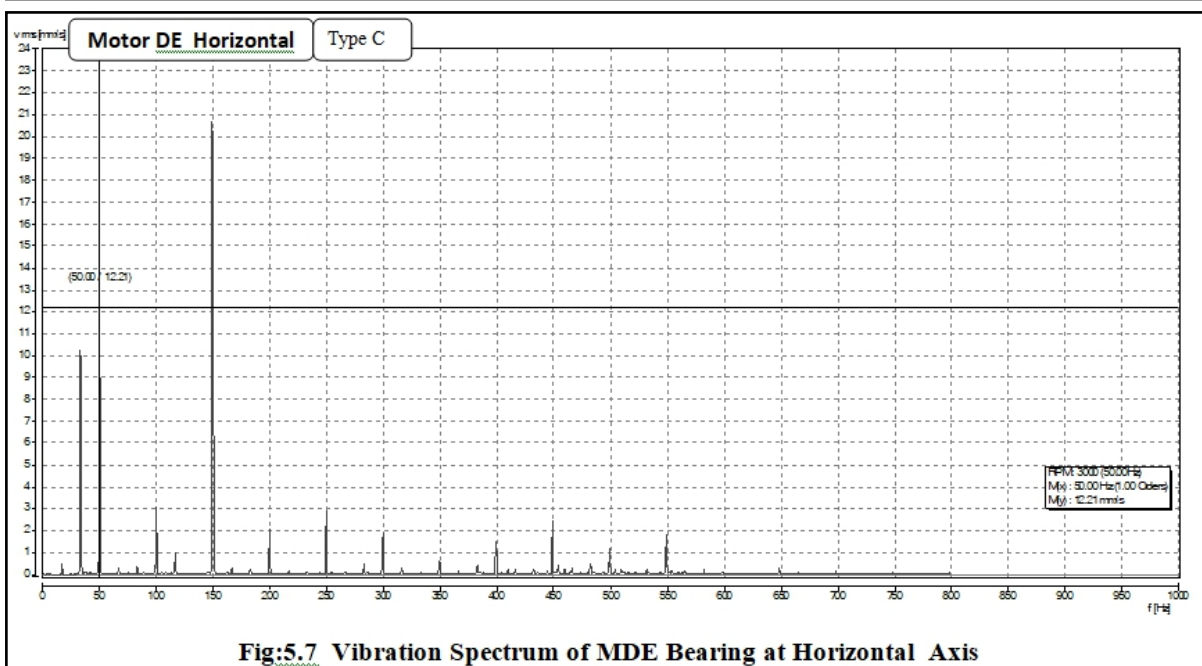
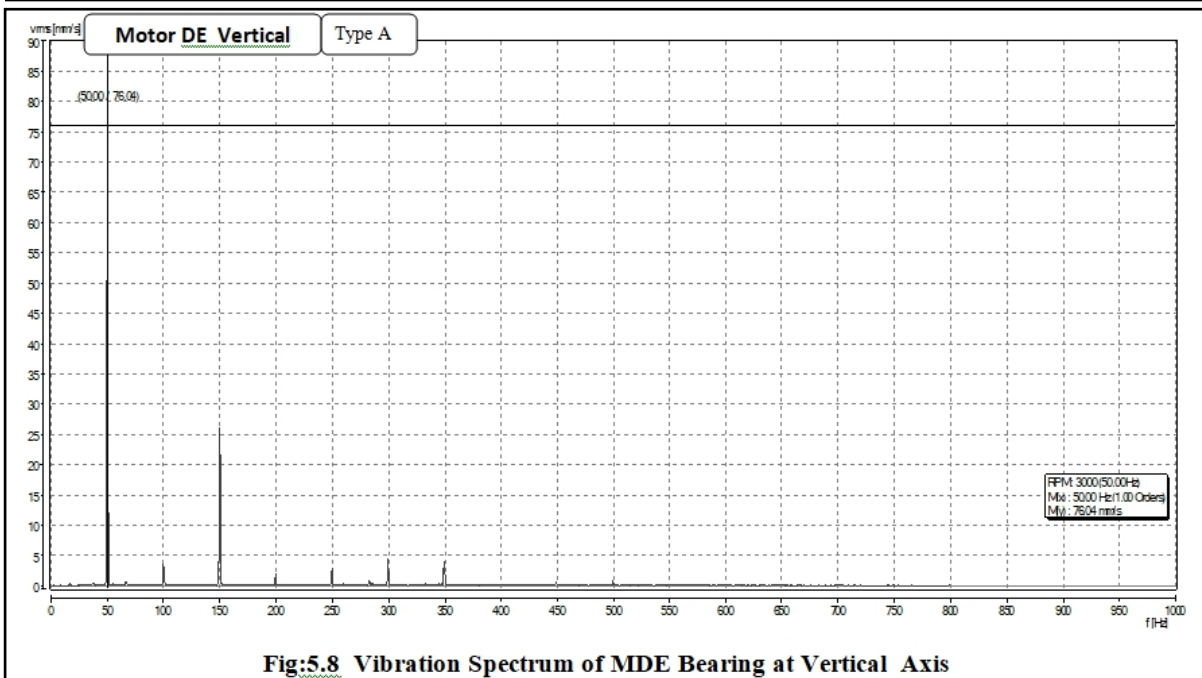
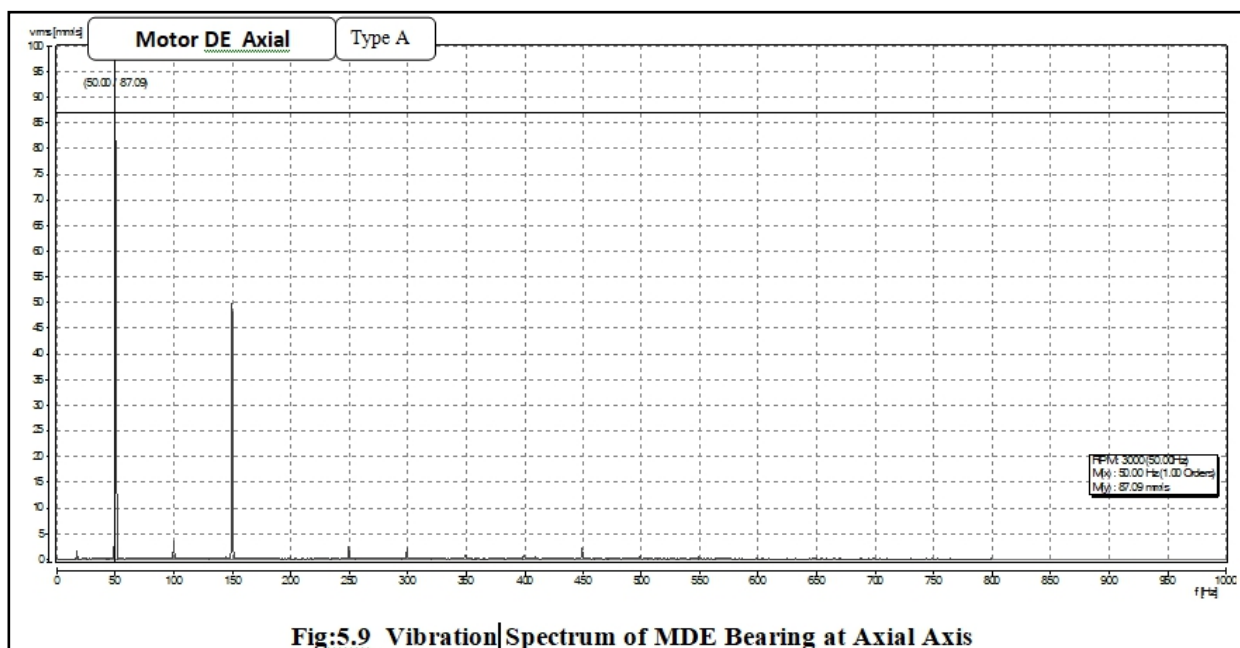
Vibration spectrum of each value of Table: 5.3 are shown from Figure 5:4-5.9

In reference to Table:6.0 of the Illustrated Vibration Diagnostic Chart [Appendix B] the above spectrums are quite similar to those obtained for *Mechanical Looseness*. In the referred chart there are three types of spectrums for horizontal vibrations marked as **Type A**, **Type B** & **Type C**. According to the chart **Type A** is caused by structural looseness/weakness of machine feet ,base plate or foundation ,also by deteriorated grouting, loose hold down bolts, at the base and distortion of the frame or base.

this case . So phase analysis was done which showed that there is an approximately 180° phase difference between vertical measurements on machine foot base plate and machine base itself. This clearly indicated there is structural looseness and even if there is any mass unbalance it is not dominant at present. From the study of the above spectrums (Figure :5.4 to Figure:5.9) it is observed that all the spectrums are of **Type: A** except for Figure:5.7 of motor drive end bearing vibration of horizontal axis and the reason can be of rotor unbalance of which there is an indication but not dominant because of the vibration due to base weakness. From the above discussion we can now draw a conclusion for the machine defect which is generating the abnormal vibrations.

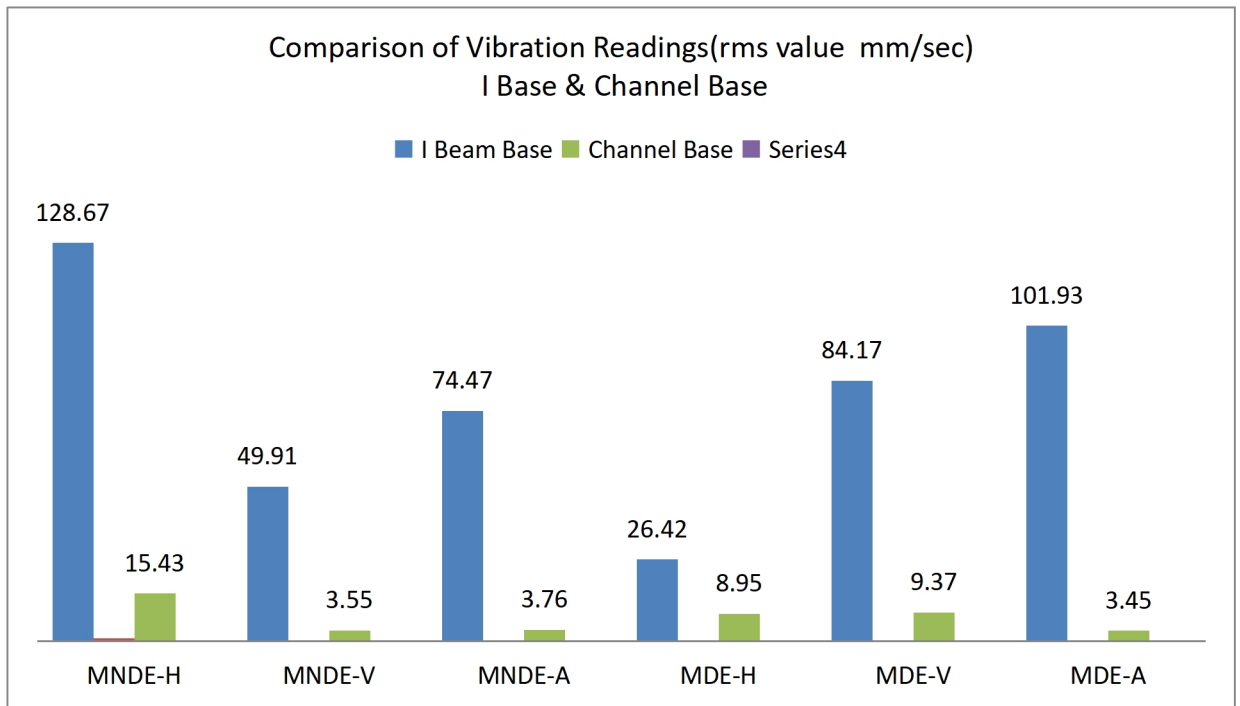
Figure 5.11 Comparison of the vibration readings of I Base & Channel Base shown graphically.

It was observed that there was a drastic drop in the vibration amplitude at both the measuring points and in all the three axes as shown in the comparison chart (Table:5.5) & graphically (Figure:5.11)

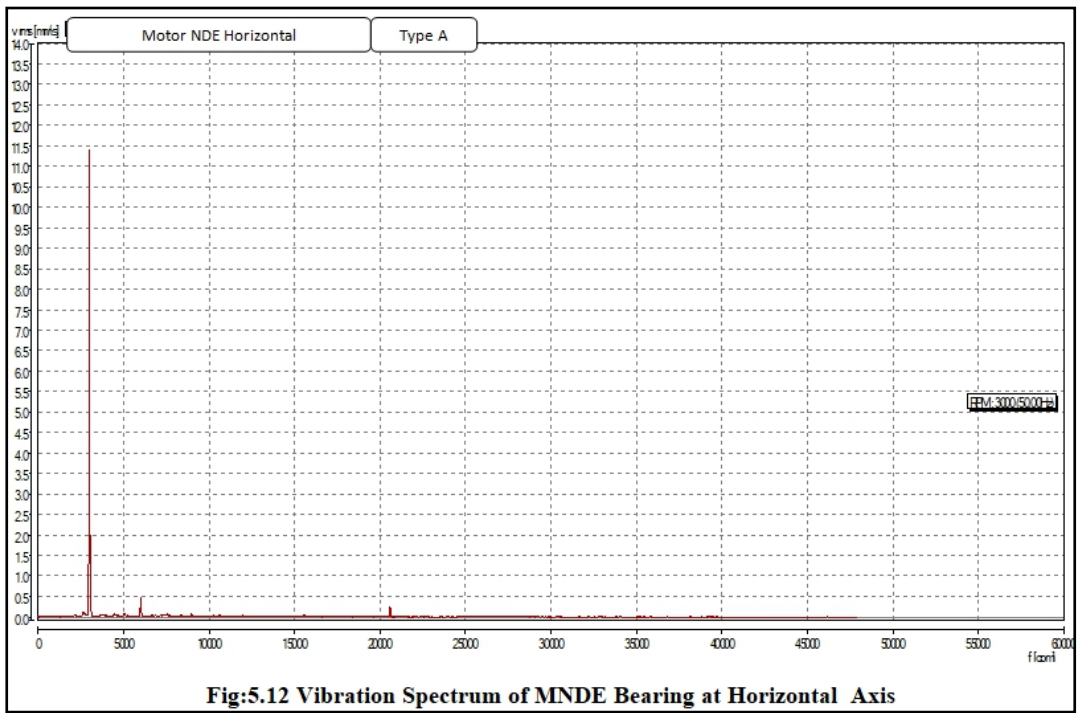
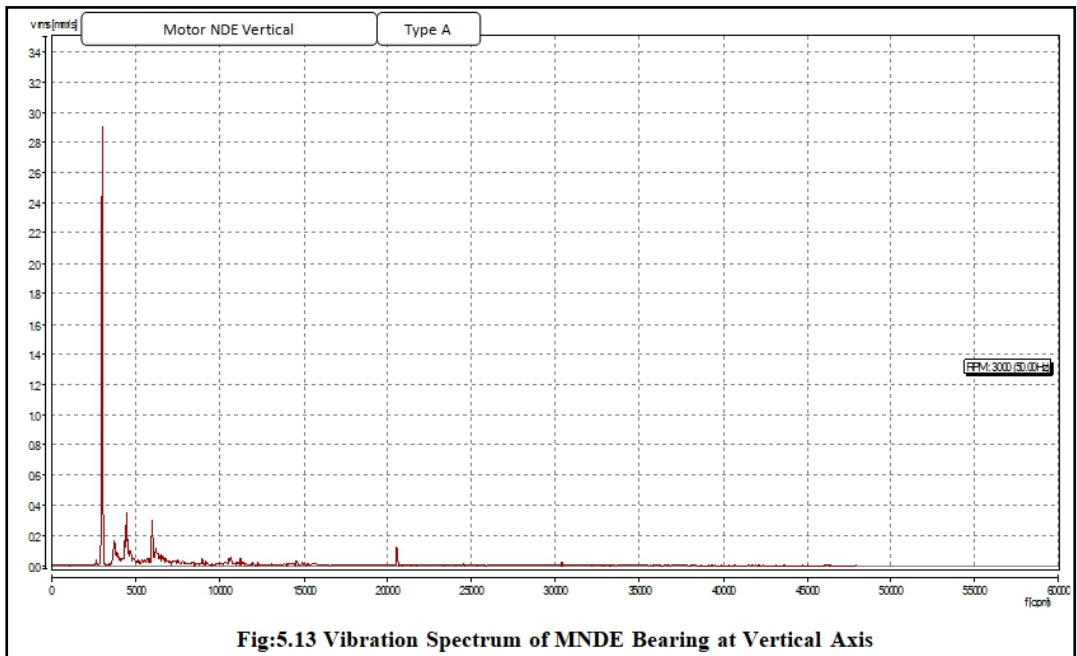
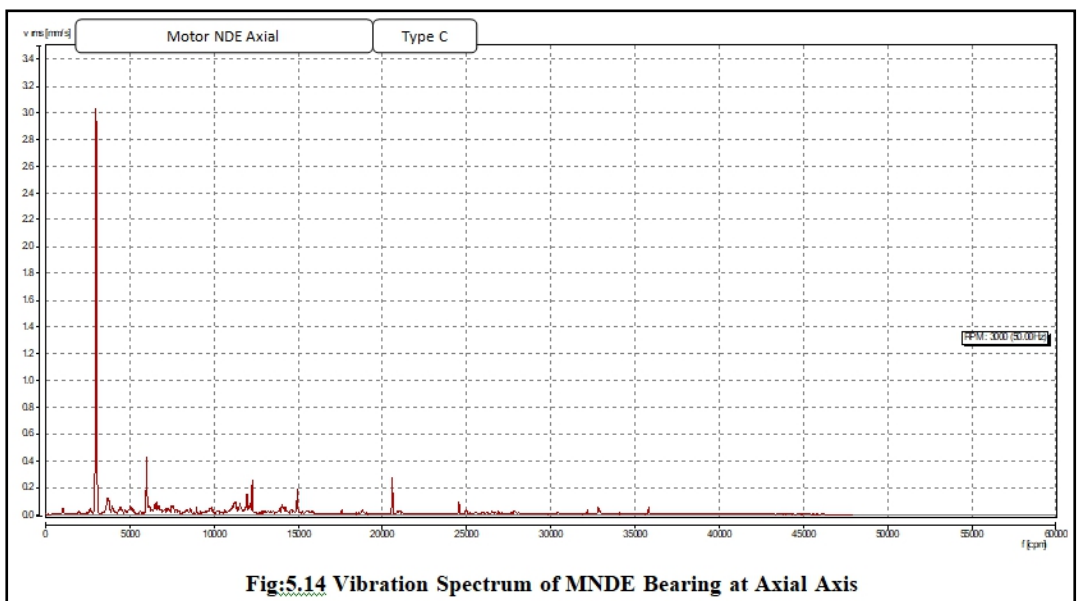
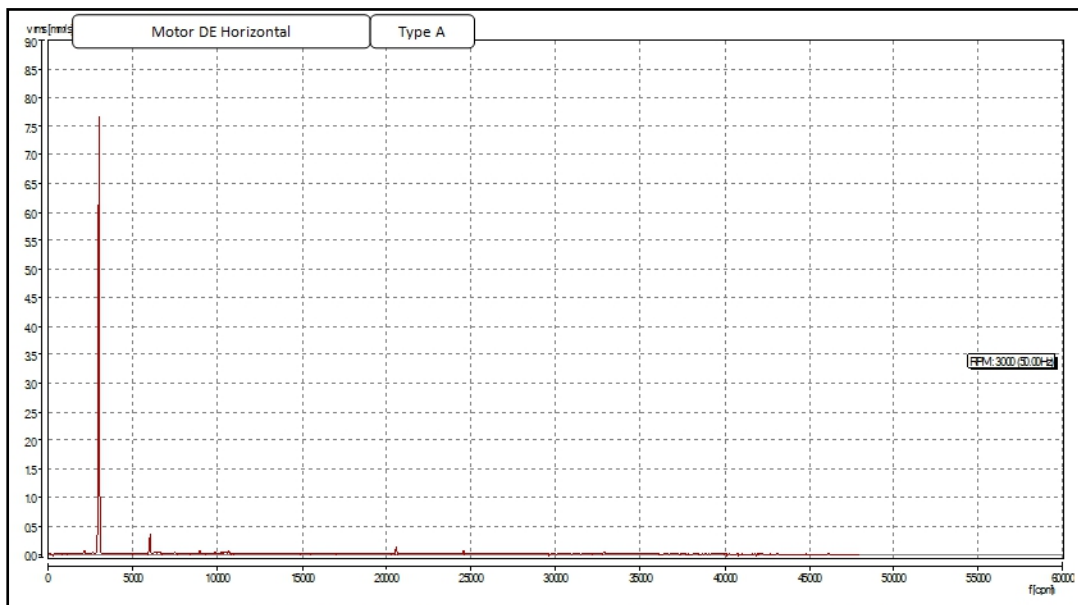
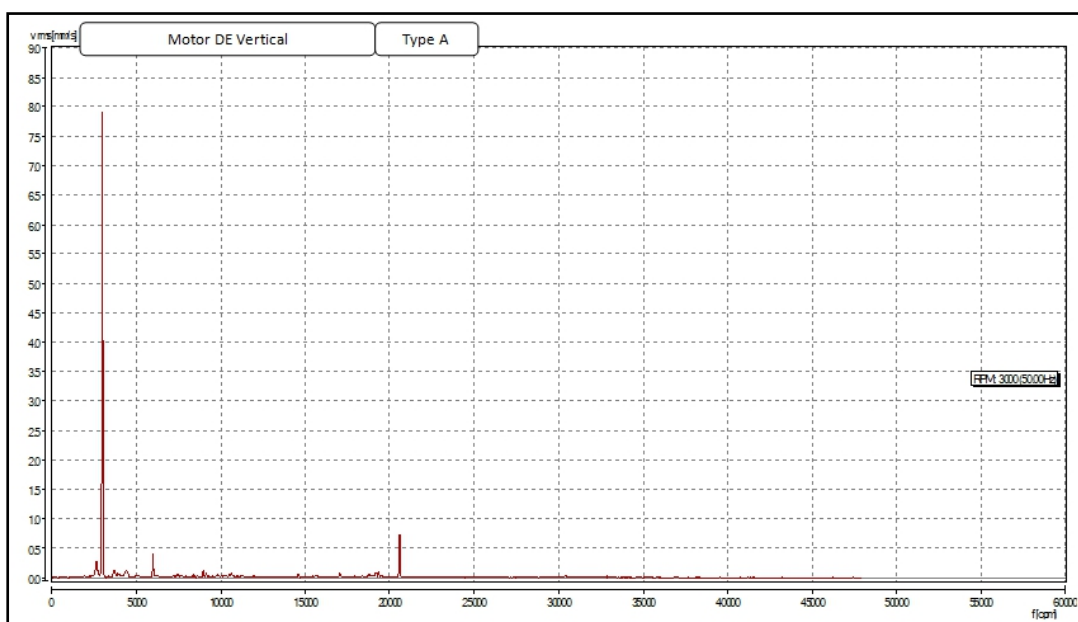
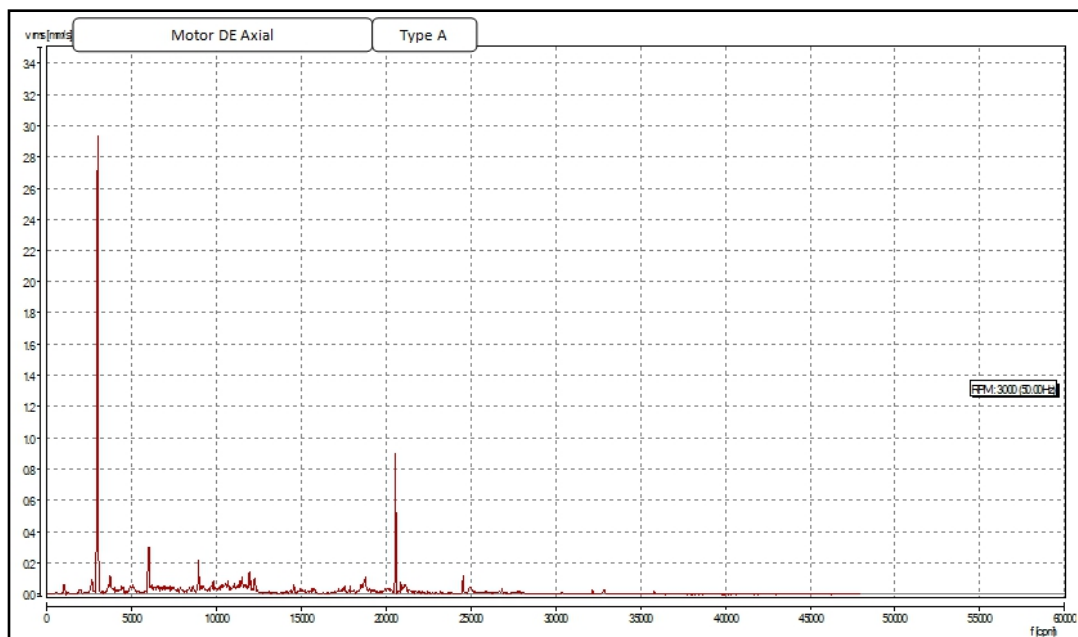
The spectrum of each vibration value of Table: 5.4 are shown from Figure 5:12-5.17

After the modification of the base from I-beam to channel ,vibration level in all the axes for both the motor's drive end and non-drive end bearing had dropped significantly but there is still a residual vibration of 15.43 mm/sec (root mean square) value and 8.95 mm/sec (root mean square) value in the motor's non-drive end and drive end bearing

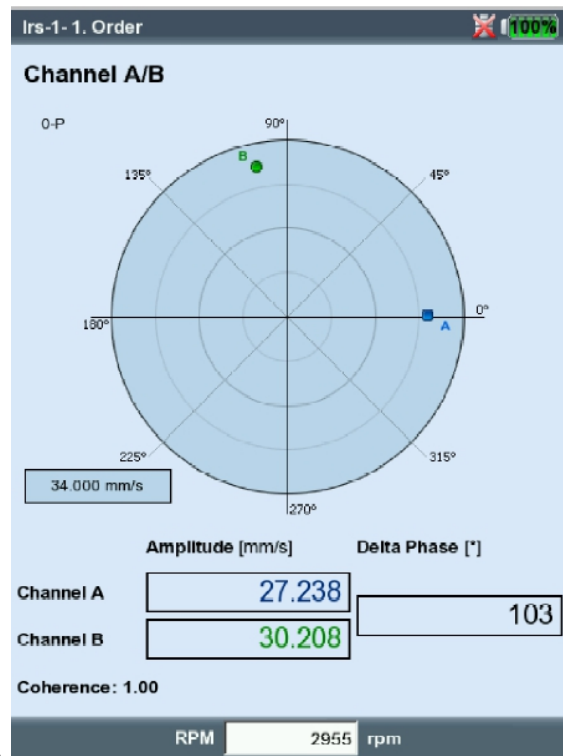
In the above case we had placed one sensor on the blower’s non-drive end bearing housing radial position and another sensor in the same housing in the vertical position. The phase analysis showed that there is a phase difference of 103° (Figure: 5.19) which indicates as per the observation of Toney DeMateo[17] there is an unbalance in the impeller. The printout generated by the analyser is shown in Fig:5.19

Figure:5.19 Phase Analysis Shows Phase Difference of 103° which Indicates Unbalance Based on phase analysis report steps were taken to dynamic balance the impeller in-situ.
