Chapter:3 Problems & Analysis of Motor Mounted Centrifugal Blowers.

3.2 Case Study -1: Combustion Air Blower of a Furnace (DBL-10)

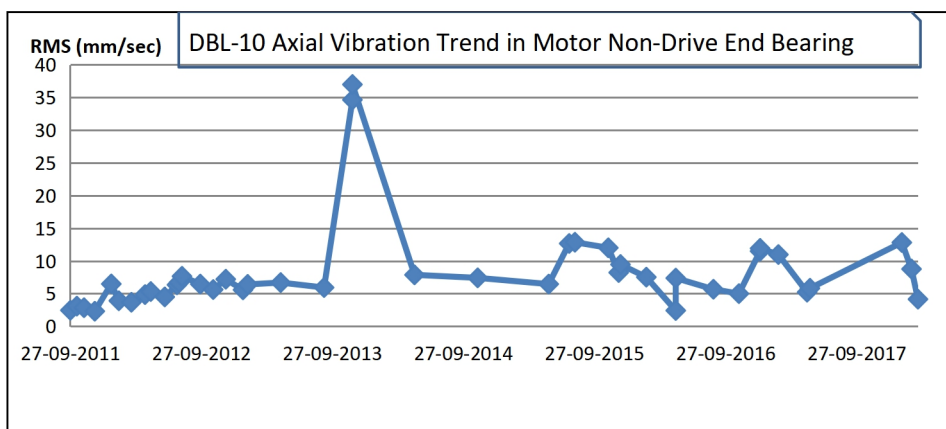
and the phase analysis confirms it. The machine ultimately failed on 25.11.2013 due to crack propagation at the base.

The base was repaired by welding but since then the vibrations in all the axes would periodically increase due to the loosening of the holding bolts because of constant high vibration and same is contained by frequently stopping the blower to retighten the base bolts.

The study of the trend graphs and the spectrum analysis indicated that the box type base provided by the manufacturer was not suitable for the high rpm motor mounted blower and this led to the failure of the base which even after repair could not be made rigid to absorb the vibration and this has made the operation of the blower very unreliable. Corrective action is to change the base with a proper designed one fabricated with proper structural.

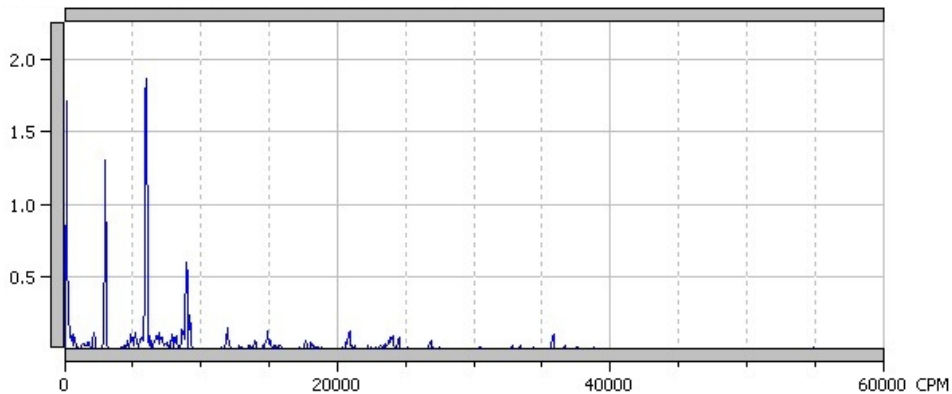
Fig: 3.21 Spectrum analyses indicate structural looseness of the base frame.

phase analysis indicated that the vibration increase was due to structural looseness of the base.(Fig:3.21 & Fig:3.22)

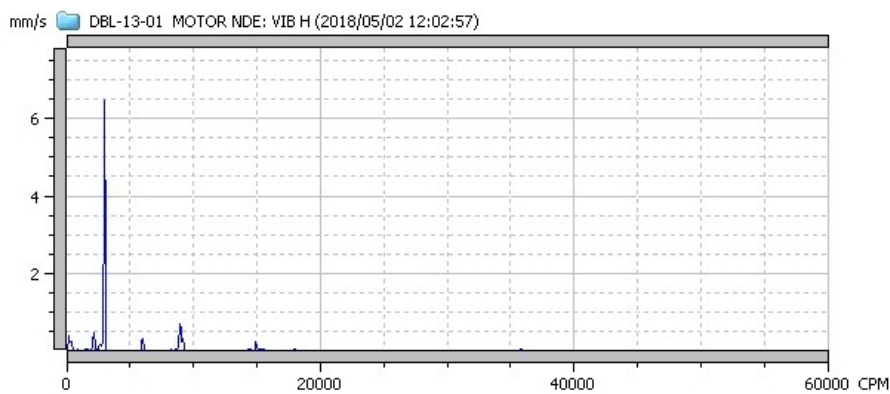
Fig: 3.22 Spectrum Analysis after welding stiffener on the base frame.

In this Case Study -2 the blower base frame was made of box structure by welding two channels face to face. Unlike Case Study -1(DBL-10) this blower vibration was observed from the initial monitoring period which ultimately led to the failure of the base. After repair and modification of the base and adding further stiffeners the vibration amplitude had come down and remained constant over the period. The solution to the problem was making the base more rigid by welding stiffeners and this corrective action was taken more on shop floor intuition than based on any mathematical calculation.

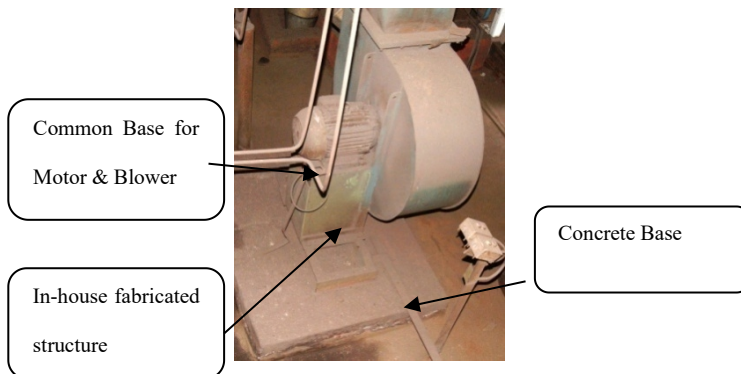
Fig: 3.24 the Motor Mounted Blower (DBL-15)

Unlike the previous two case studies (Case Study-1 & Case Study-2) this vibration problem could not be solved by welding stiffeners to make the base frame more rigid. The box structure was unable to absorb the vibration generated by the high speed blower and as a result due to continuous high vibration the base bolts get loosened and needs frequent tightening.

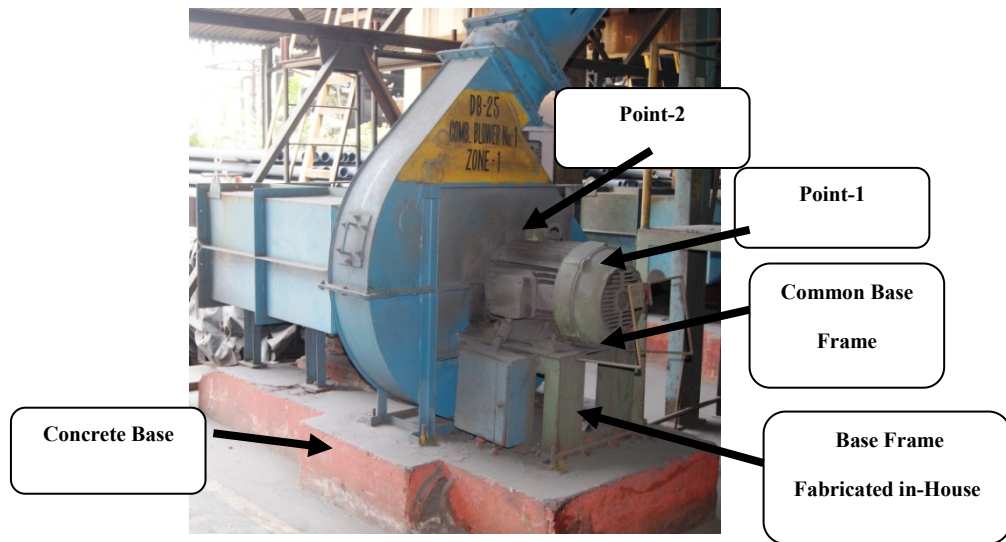
Fig: 3.33 Picture of the Blower Mounted on the Motor.

Like the previous two case studies (Case Study-1 & Case Study-2) this vibration problem of structural looseness was observed and as the structure could not be changed the structure had to be made more rigid with welding of stiffeners. Like the other case studies the base frame was fabricated from available material at site and in

this case it was unequal angles. The root cause of the failure was weak structure and due to increase of vibration amplitude the base had failed twice in the seven year period and after rectification of the crack in the base stiffeners had to be welded to make the base rigid.

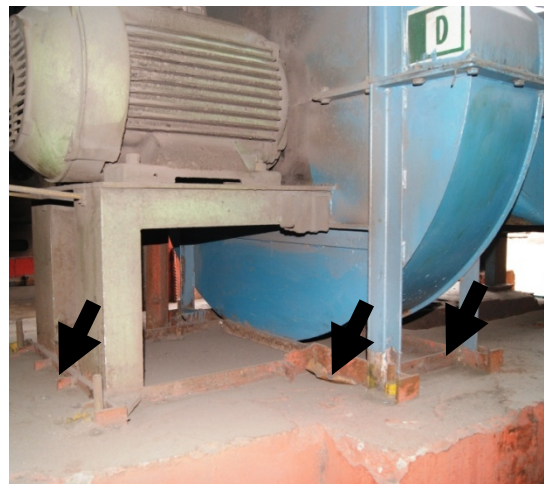
Fig: 3.42 Additional Stiffeners Welded on Base Frame

stability in the vibration trend but after an year of operation there was another failure of the base frame which had to be further repaired and to bring back rigidity additional stiffeners were further welded (Fig: 3.42)

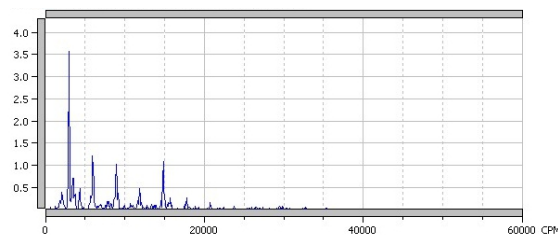
Fig: 3.51 Spectrum analysis shows structural looseness.

In reference to the vibration trend of motor's non-drive end and drive end bearings in all the axes we observe that vibration amplitude was never constant. The spectrum analysis also confirms that vibration was due to the looseness of the structure (Fig: 3.51)

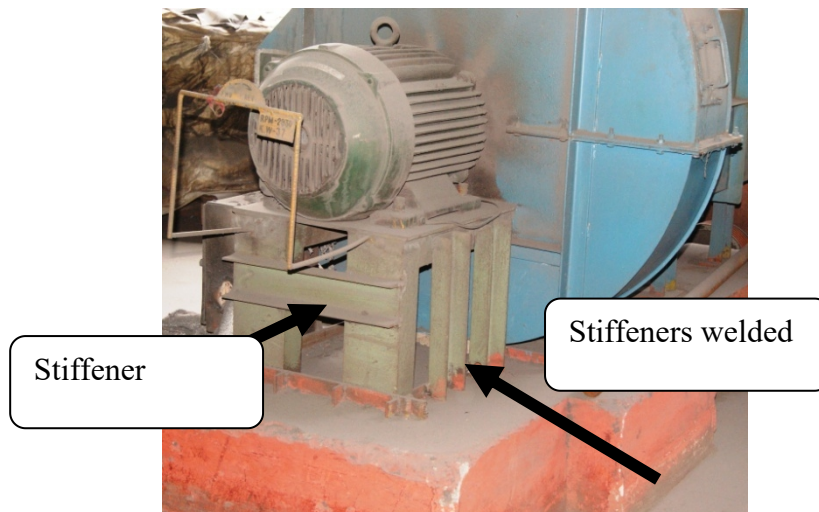
Fig: 3.52: Stiffeners welded on the base frame during the course of time

After welding the stiffeners the blower vibration would reduce for few weeks and the same would increase again as holding bolts would get loose and needed retightening. The blower is still running in this condition as it needs a longer shut down to change the present base to a rigid one.

To make the structure more rigid stiffeners were welded as shown in the Fig: 3.52
