4 RESULTS AND DISCUSSION

4.1 Results for copper clad aluminium

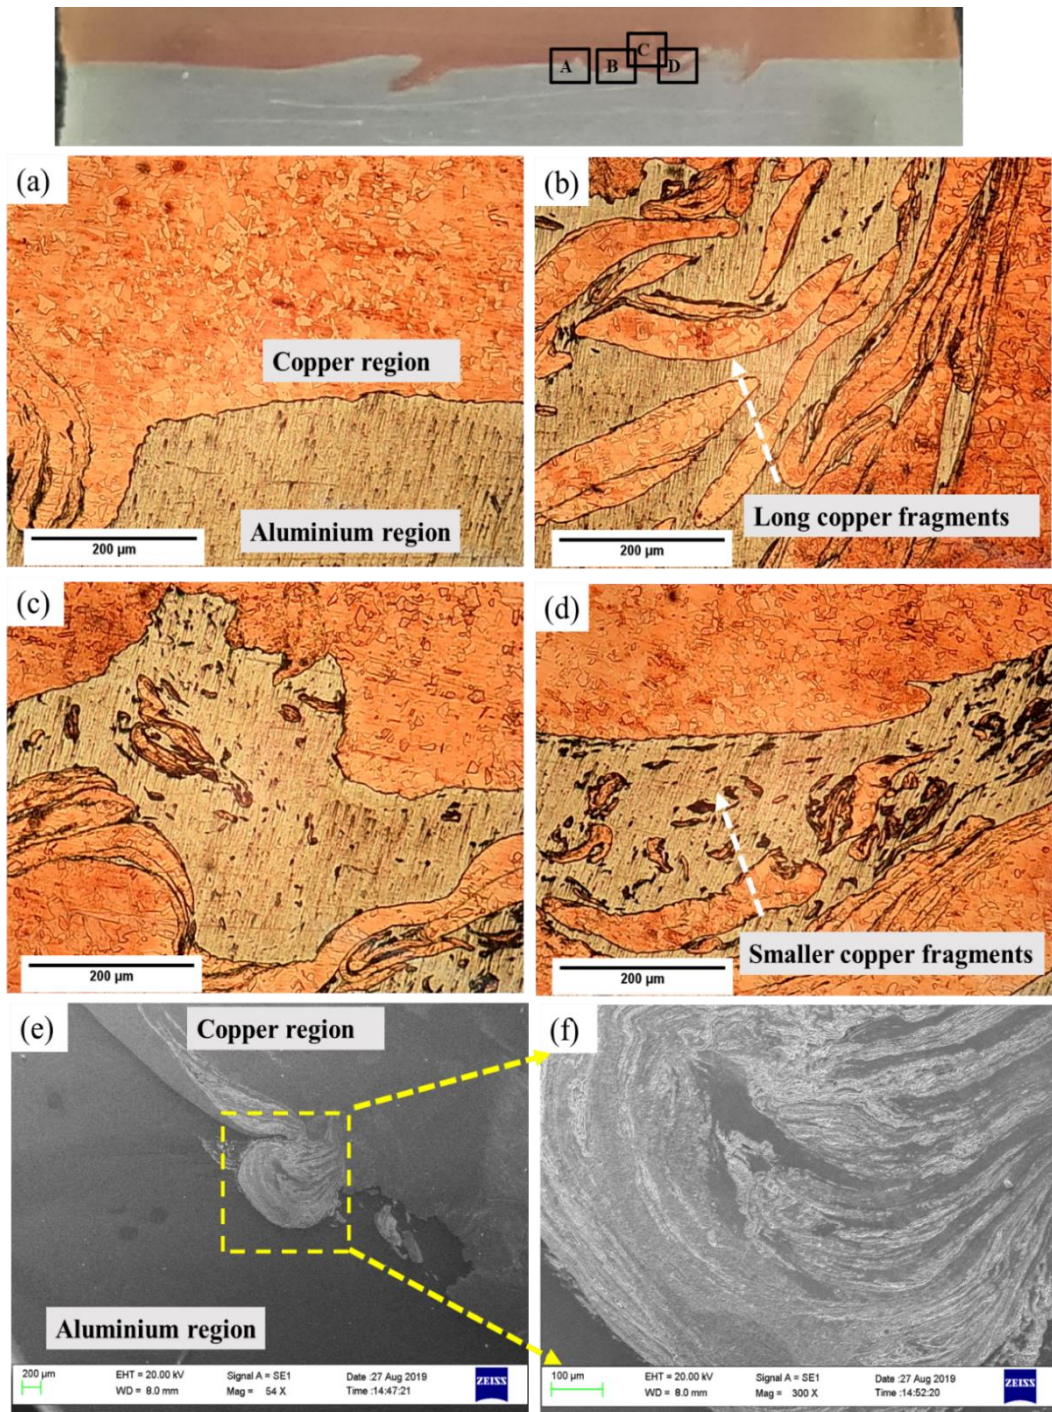
Figure 4-1 Optical microstructure of copper clad aluminium (a) showing interface (b) depicting long copper fragments near interface (c) & (d) indicating small copper chunks distribution (e) SEM image of interface (f) magnified image of same

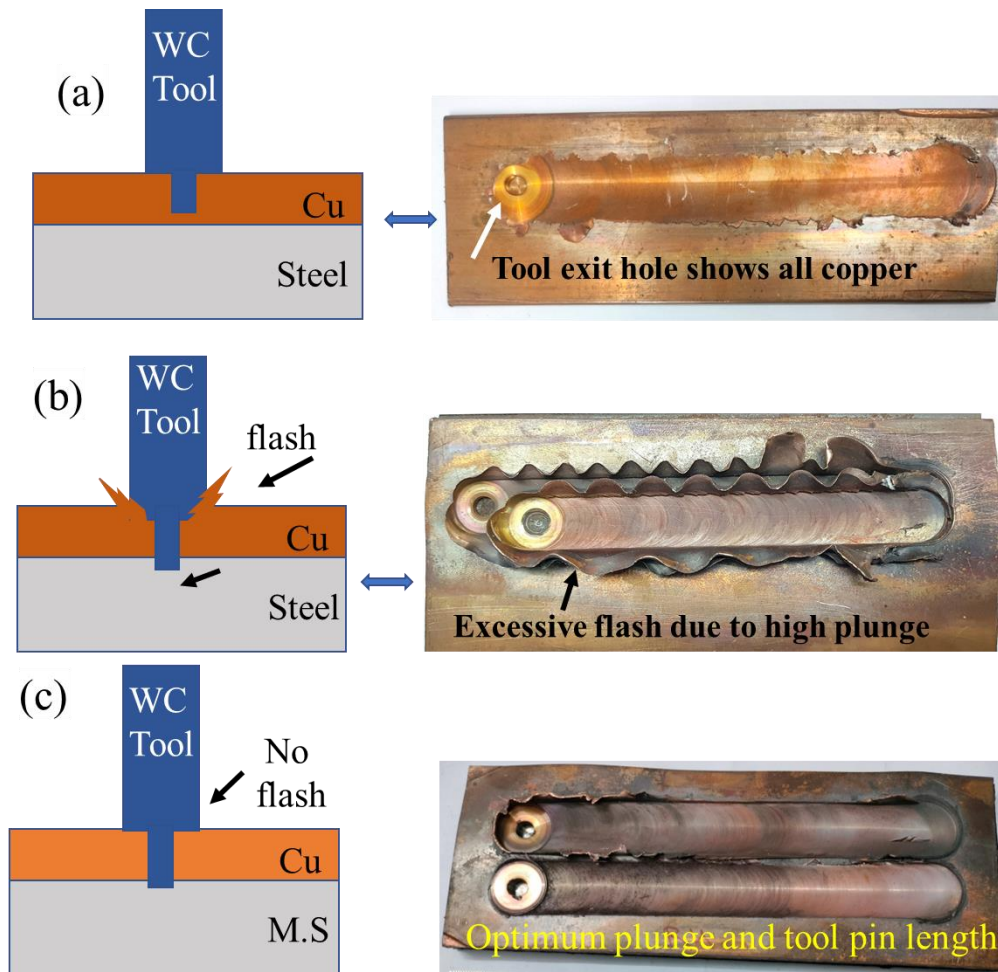
Figure 4-2 Illustration (a) for shorter pin length (b) for larger tool plunge generating excessive flash (c) optimum tool plunge and pin length

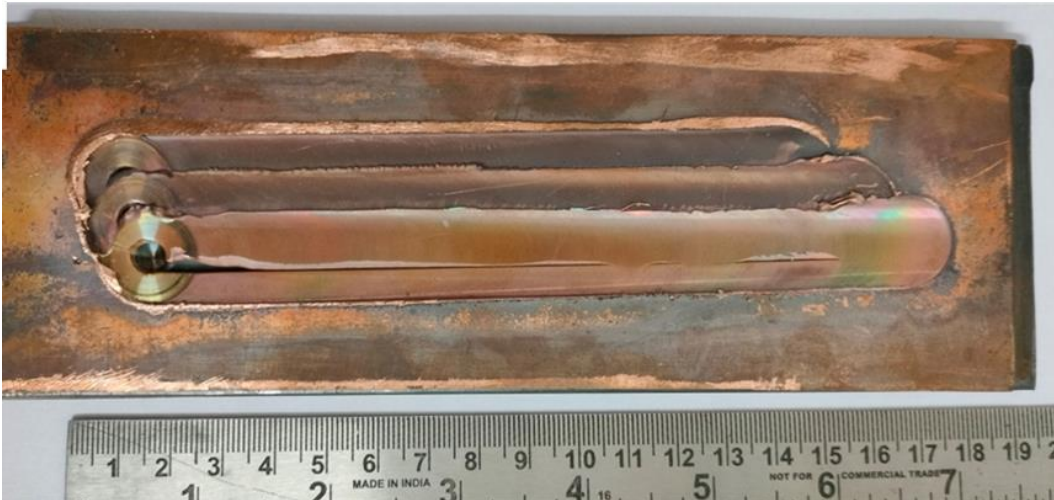
Figure 4-3 Cavity formation due to improper material distribution during multi pass cladding

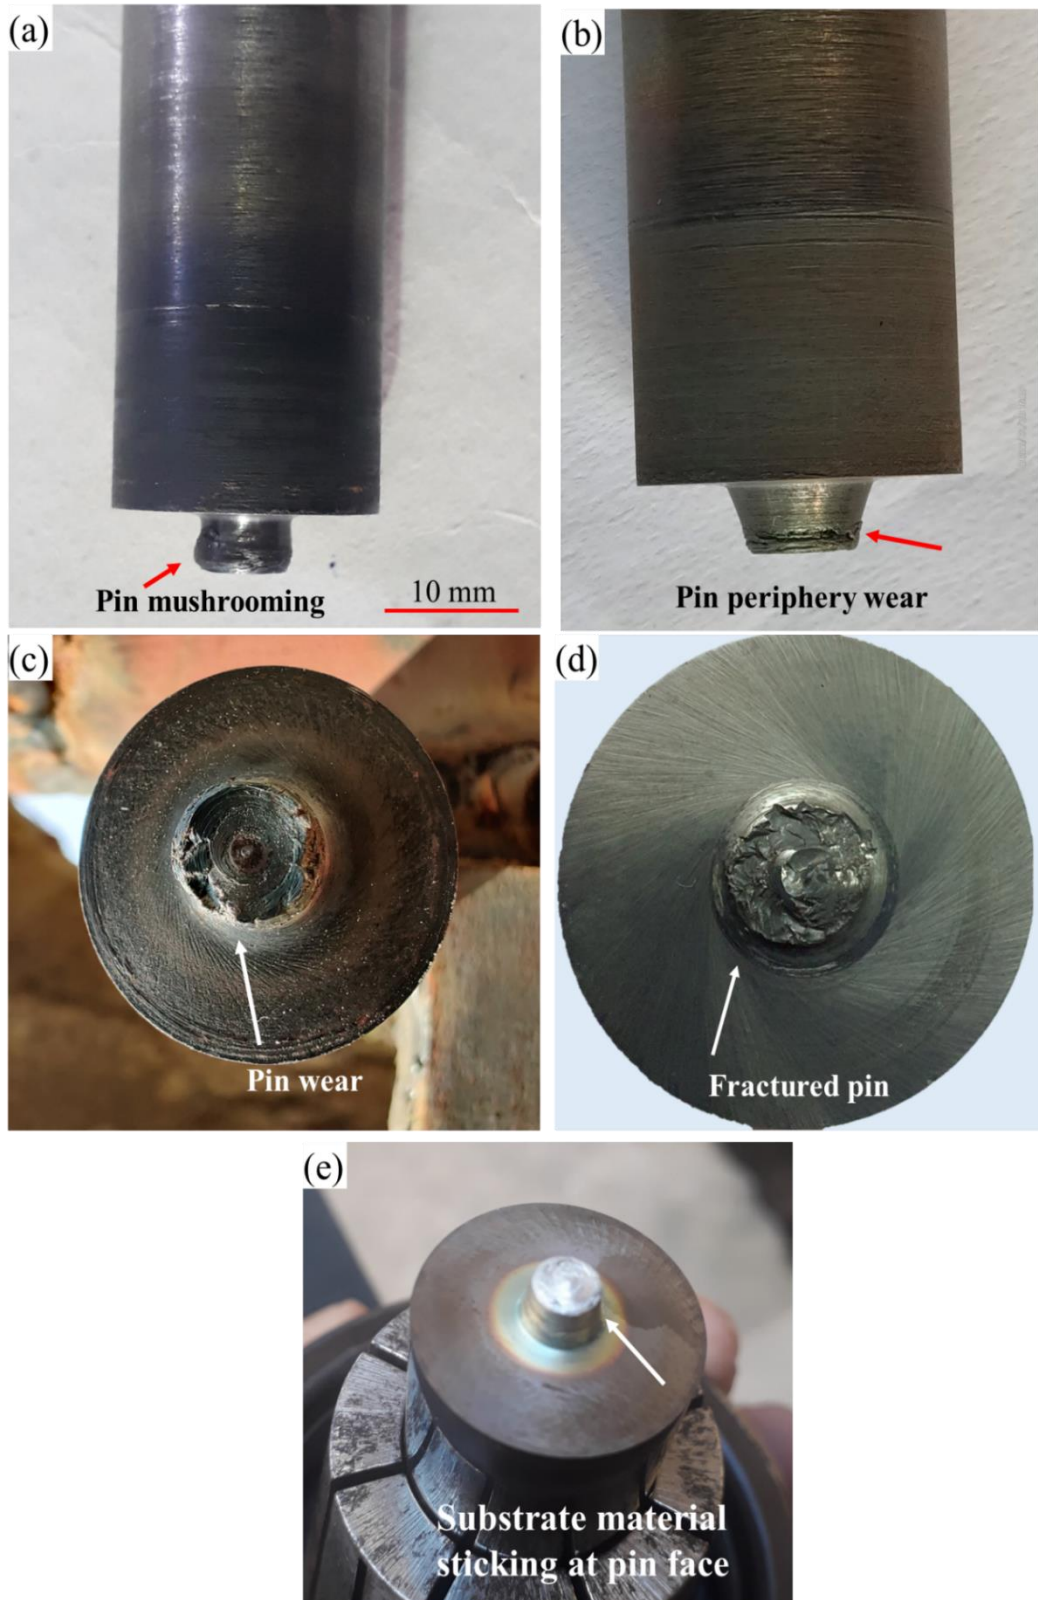
Figure 4-5 Tool defects during cladding copper on steel (a) pin mushrooming (b) pin periphery wear (c) pin face wear (d) tool B after pin breakage (e) aluminium substrate sticking on pin face for copper clad aluminium

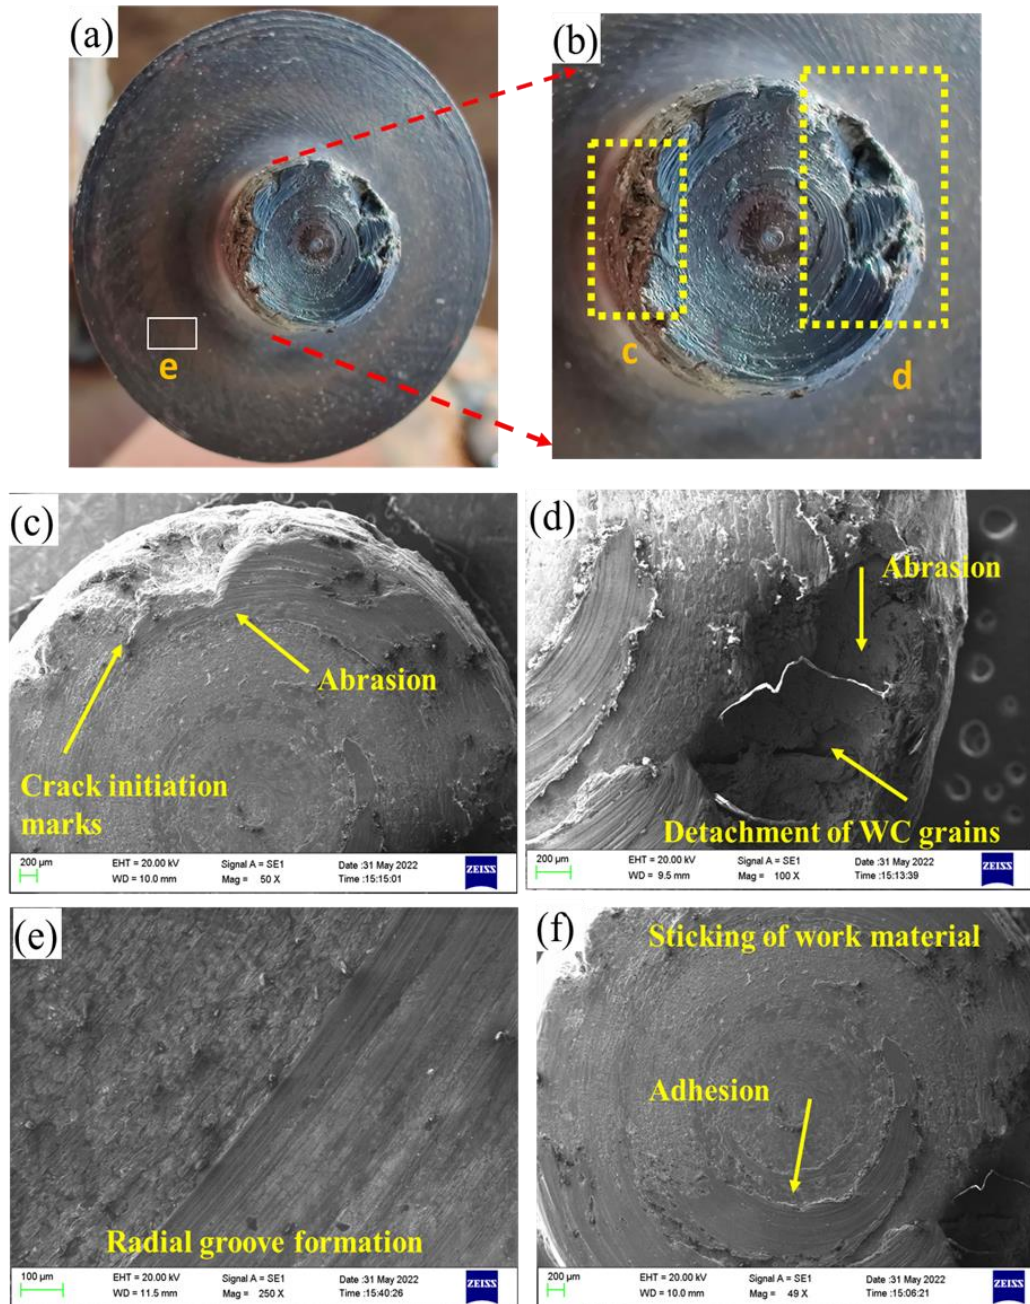
Figure 4-6 SEM image of face wear of 'tool A' pin depicting (a) entire tool face with shoulder (b) enlarged pin face (c) pin periphery demonstrating crack initiation and abrasion (d) material uprooting and cavity formation (e) radial groove formation in shoulder (f) sticking of work material in pin due to adhesion

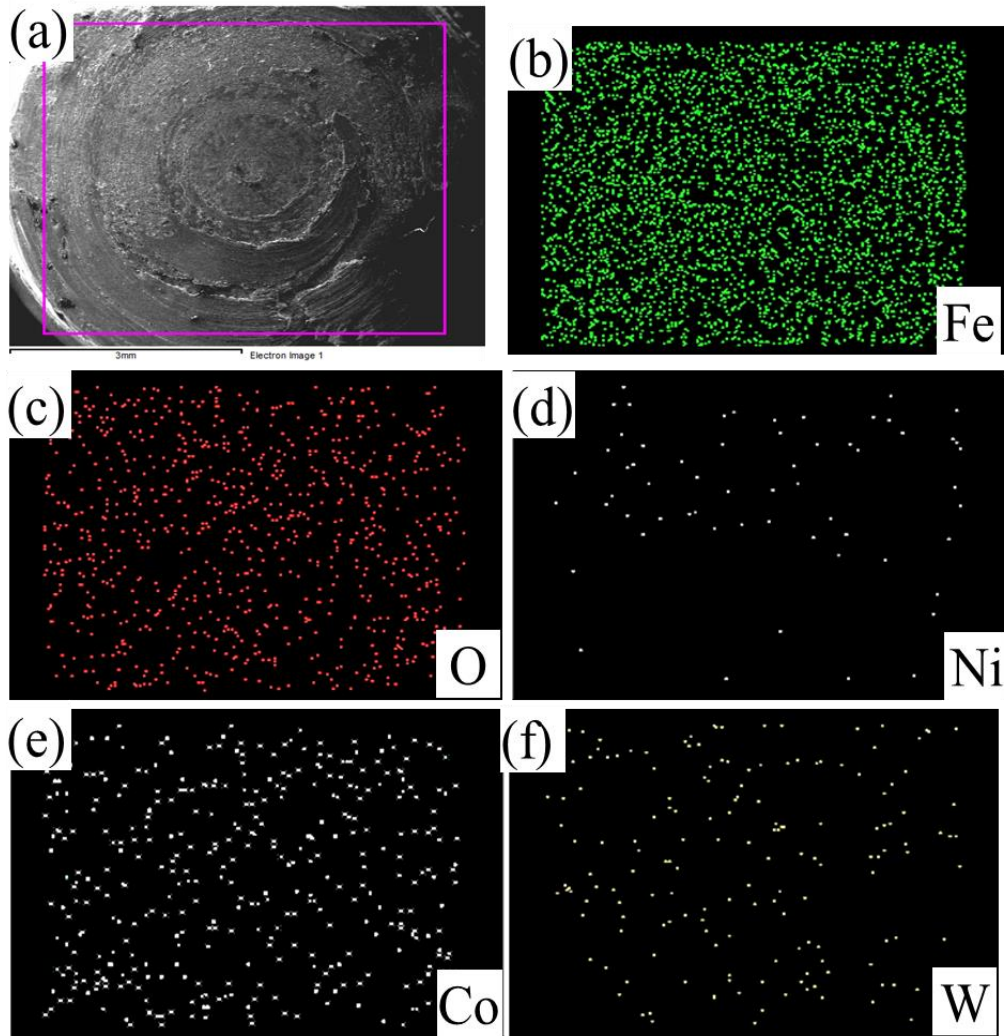
Figure 4-7 EDS mapping of 'tool A' pin surface

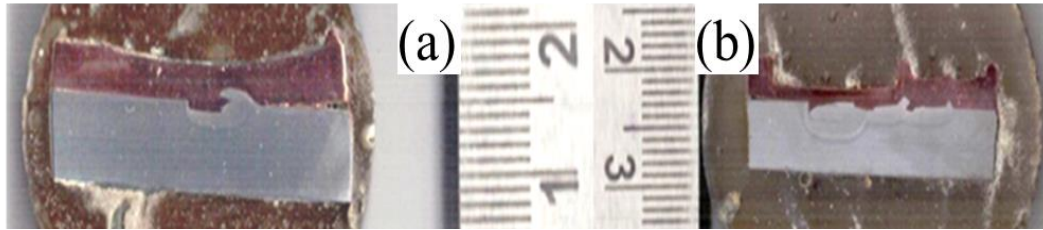
Figure 4-10 Transverse cross section of cladded sample for (a) single pass (b) multipass

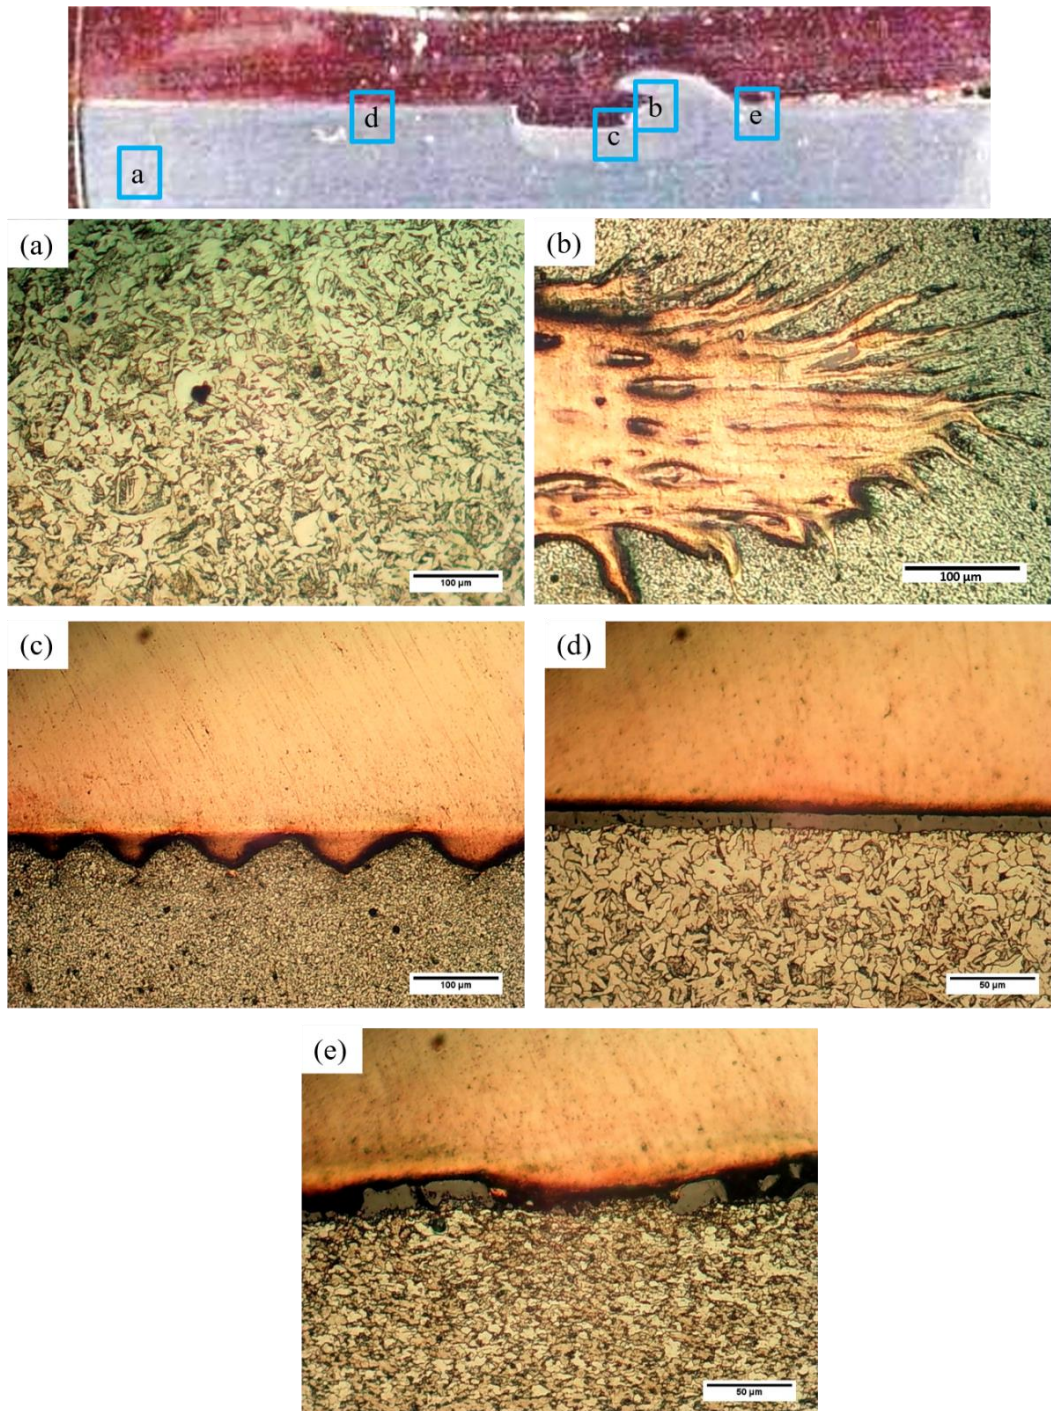
Figure 4-13 *Optical microstructure of transverse cross-section of single pass copper clad steel at various indicated locations*

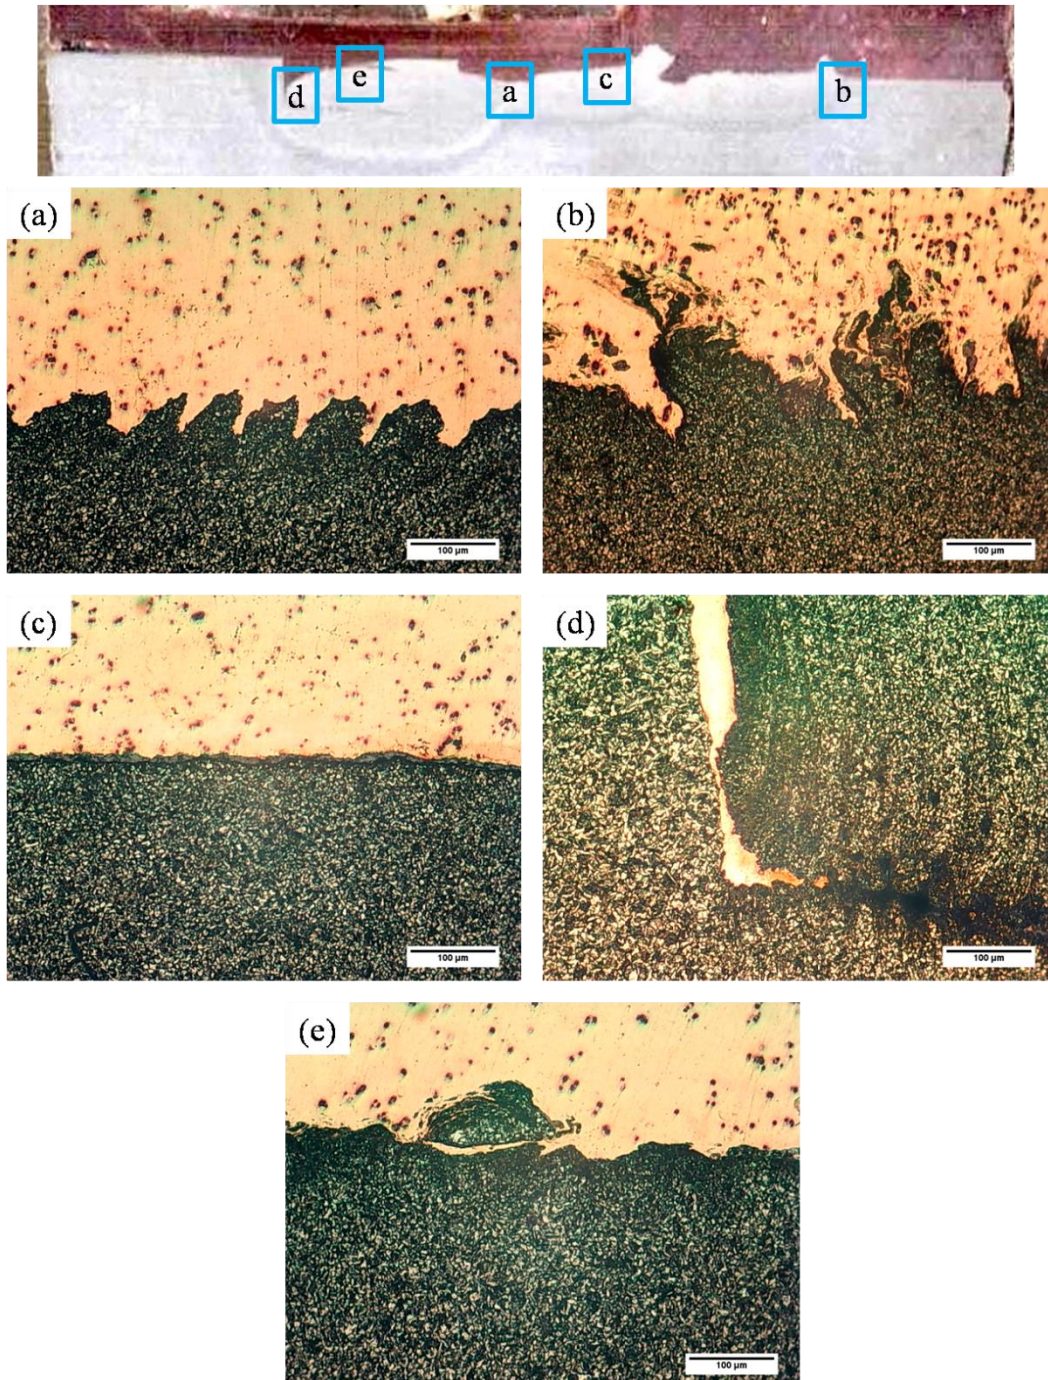
Figure 4-14 Optical microstructure of transverse cross-section of multi pass copper clad steel at various indicated locations

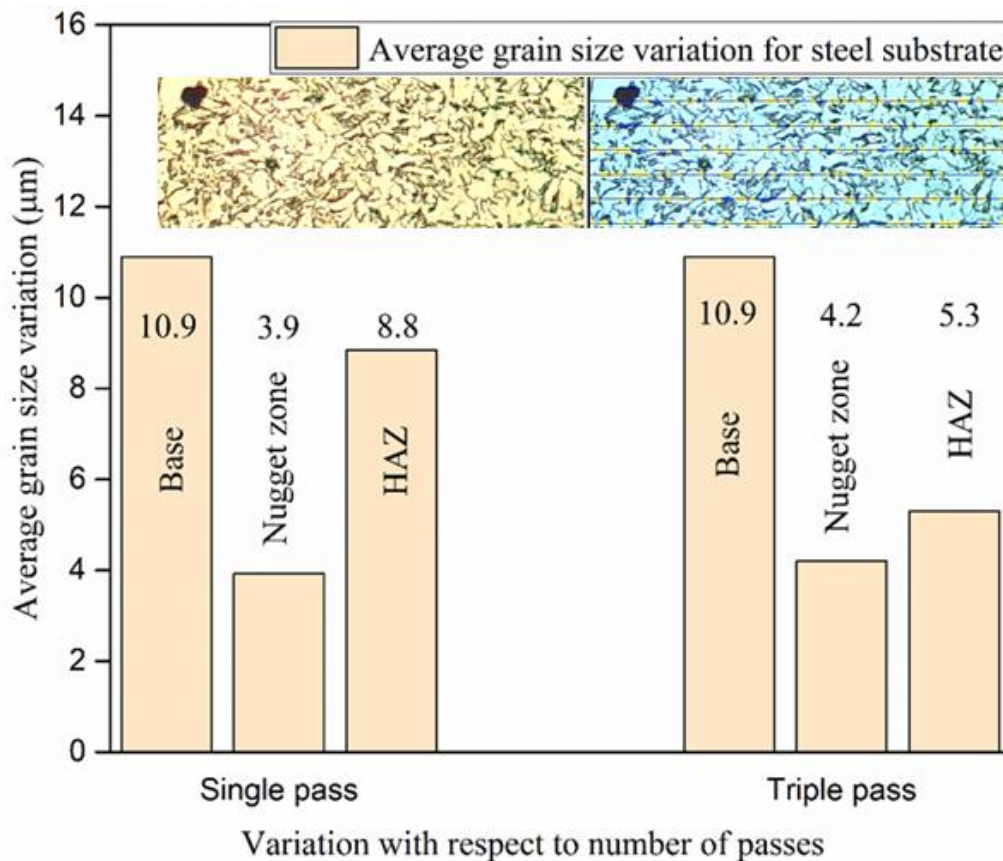
Figure 4-15 Grain size variation across different locations of steel substrate for single pass and multipass cladding

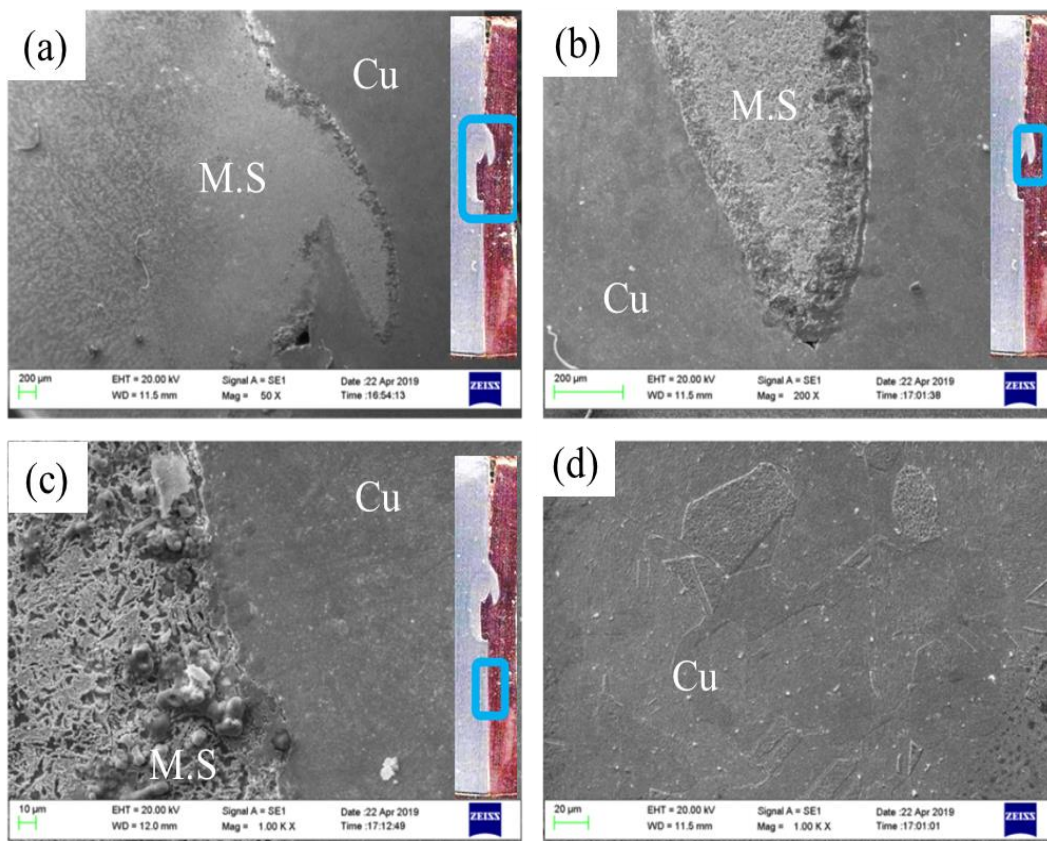
Figure 4-16 SEM micrograph of copper clad steel after single pass (a), (b), (c) are at different locations of transverse section (d) top face of clad layer

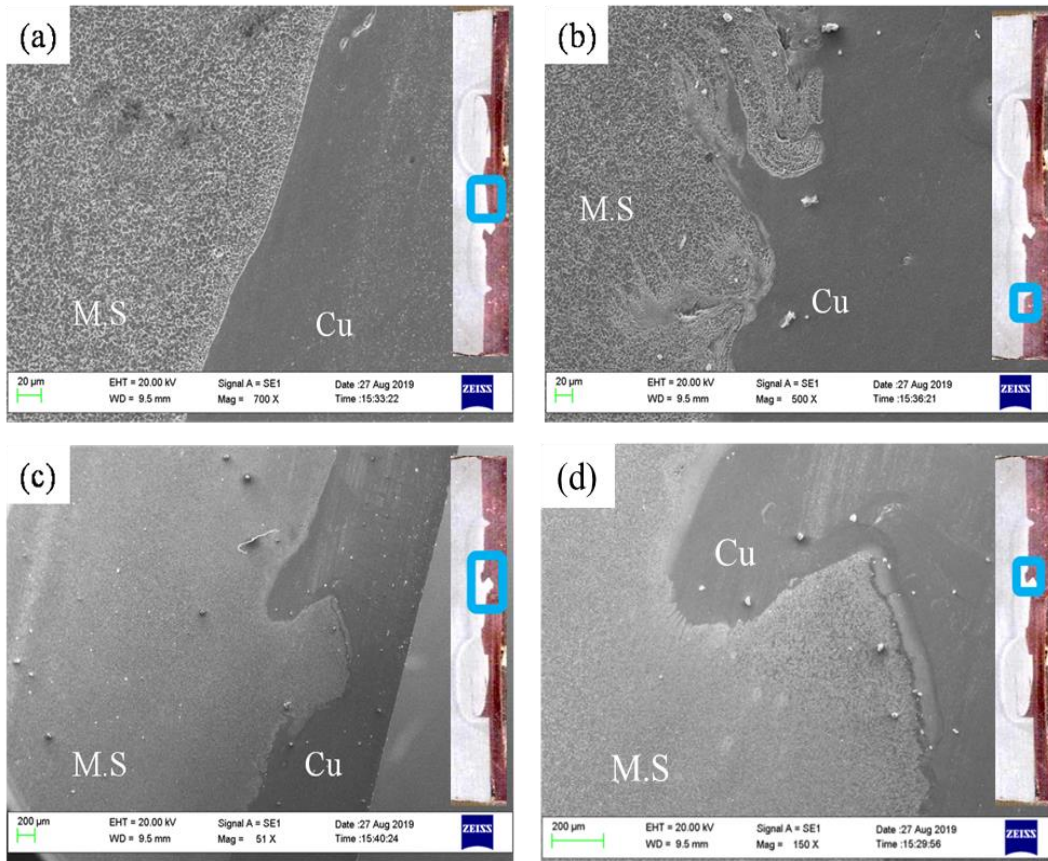
Figure 4-17 SEM micrograph of copper clad steel for three passes at various indicated locations

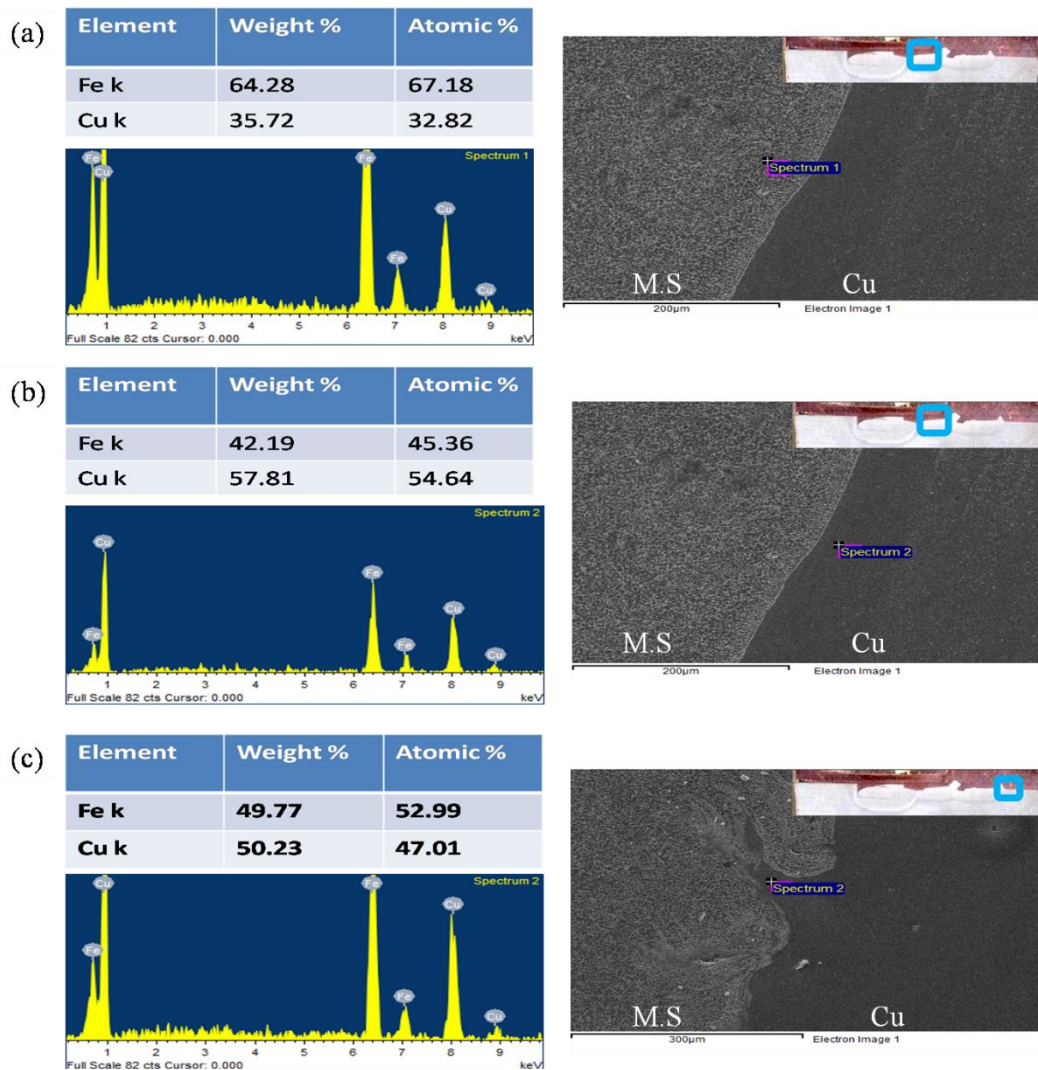
Figure 4-18 EDS quantification of different locations of three pass copper clad steel

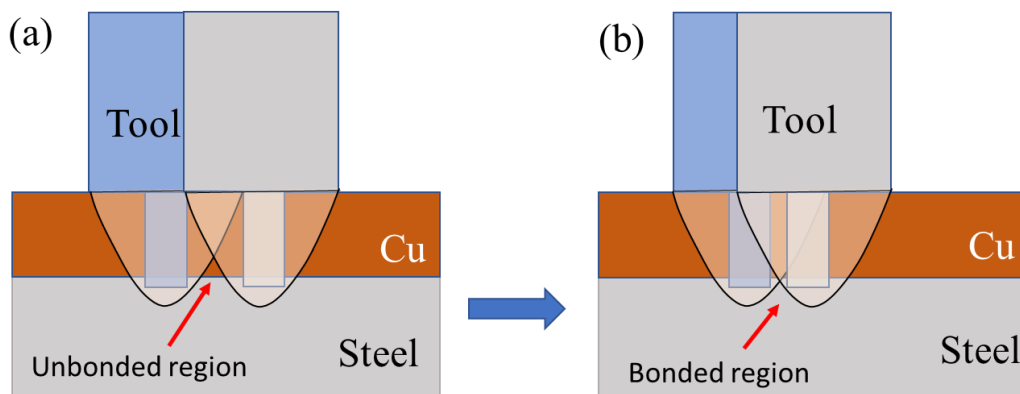
Figure 4-20 Schematic diagram demonstrating the extent of overlap (a) due to larger pin offset distance at the clad-substrate interface (b) optimum offset distance during any two successive FSW passes

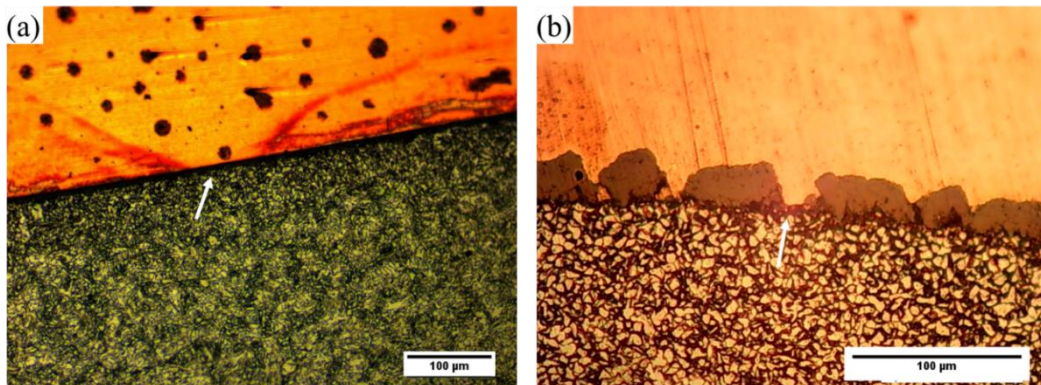
Figure 4-21 Microstructure with (a) high offset of 12 mm revealing superficial bonding along with continuous interface (b) 8 mm offset revealing broken oxide layer interface at 200X

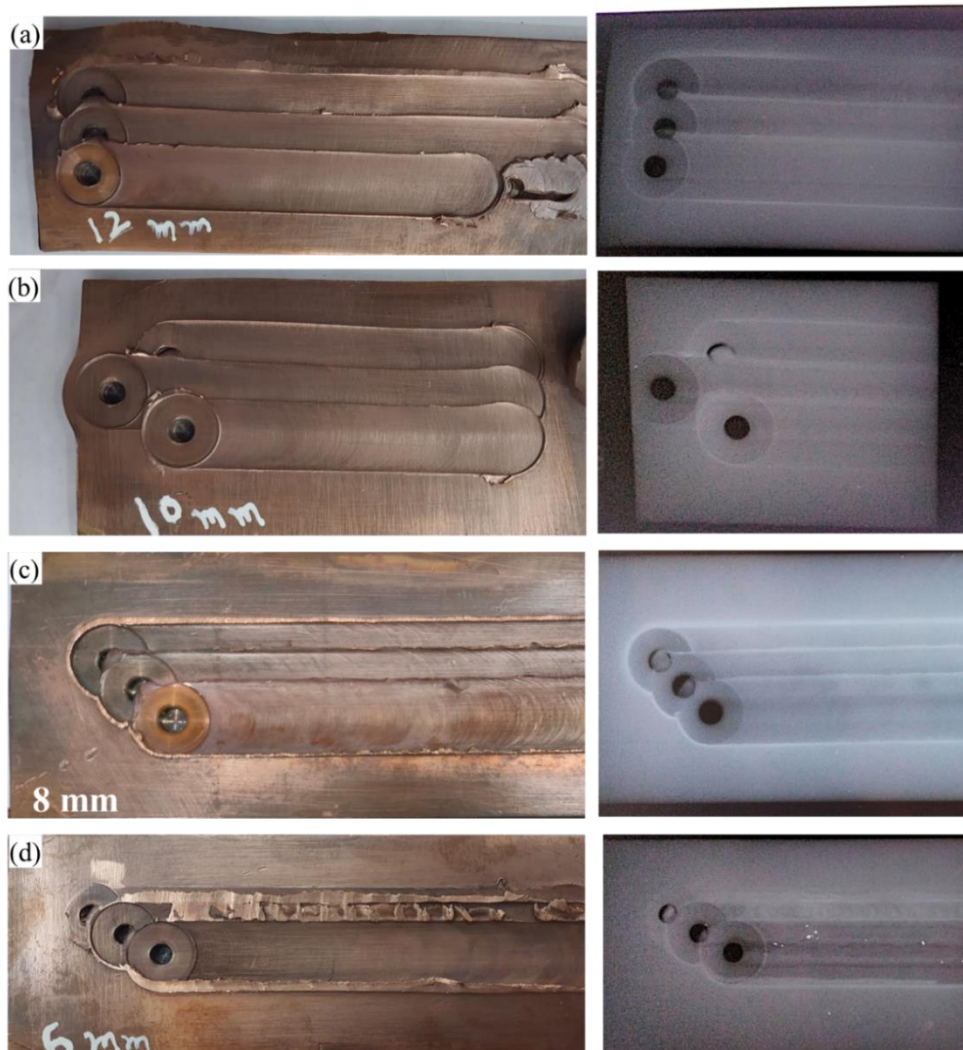
Figure 4-22 X Ray radiography along with different offset condition samples (a) 12 mm offset distance (b) 10 mm offset distance (c) 8 mm offset distance (d) 6 mm offset distance

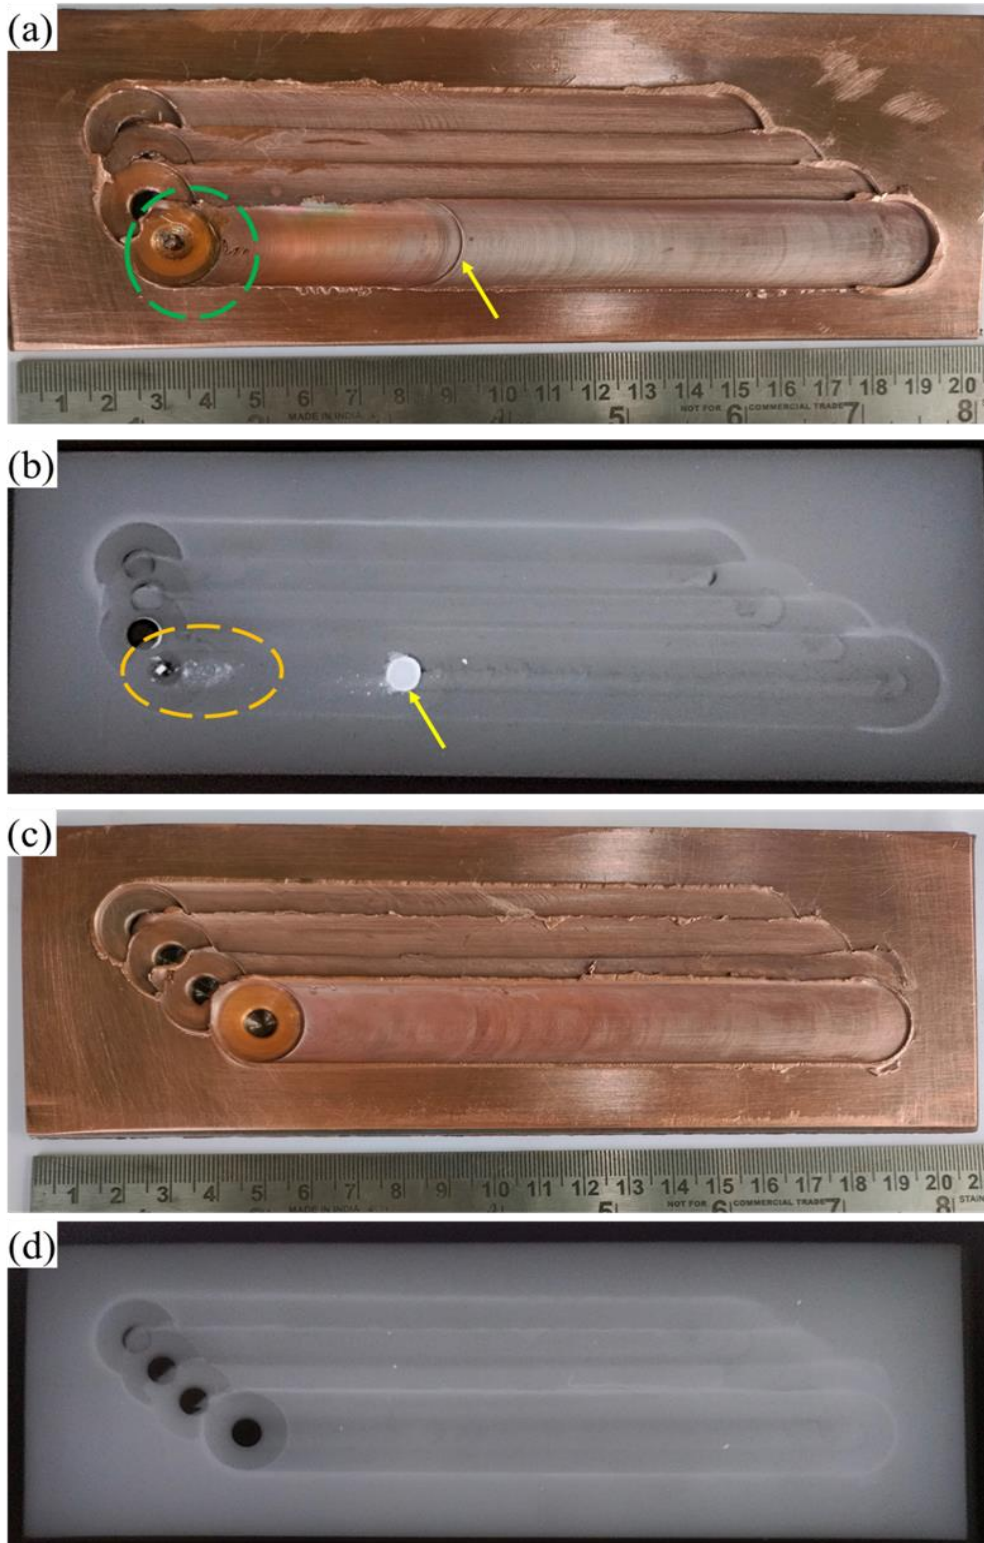
Figure 4-23 Prepared samples demonstrating (a) flaw in cladded plate (b) radiography of same sample shown in fig. a showing entrapped tungsten carbide inside (c) sample without any flaws, (d) radiography of sample shown in fig. c without any flaws

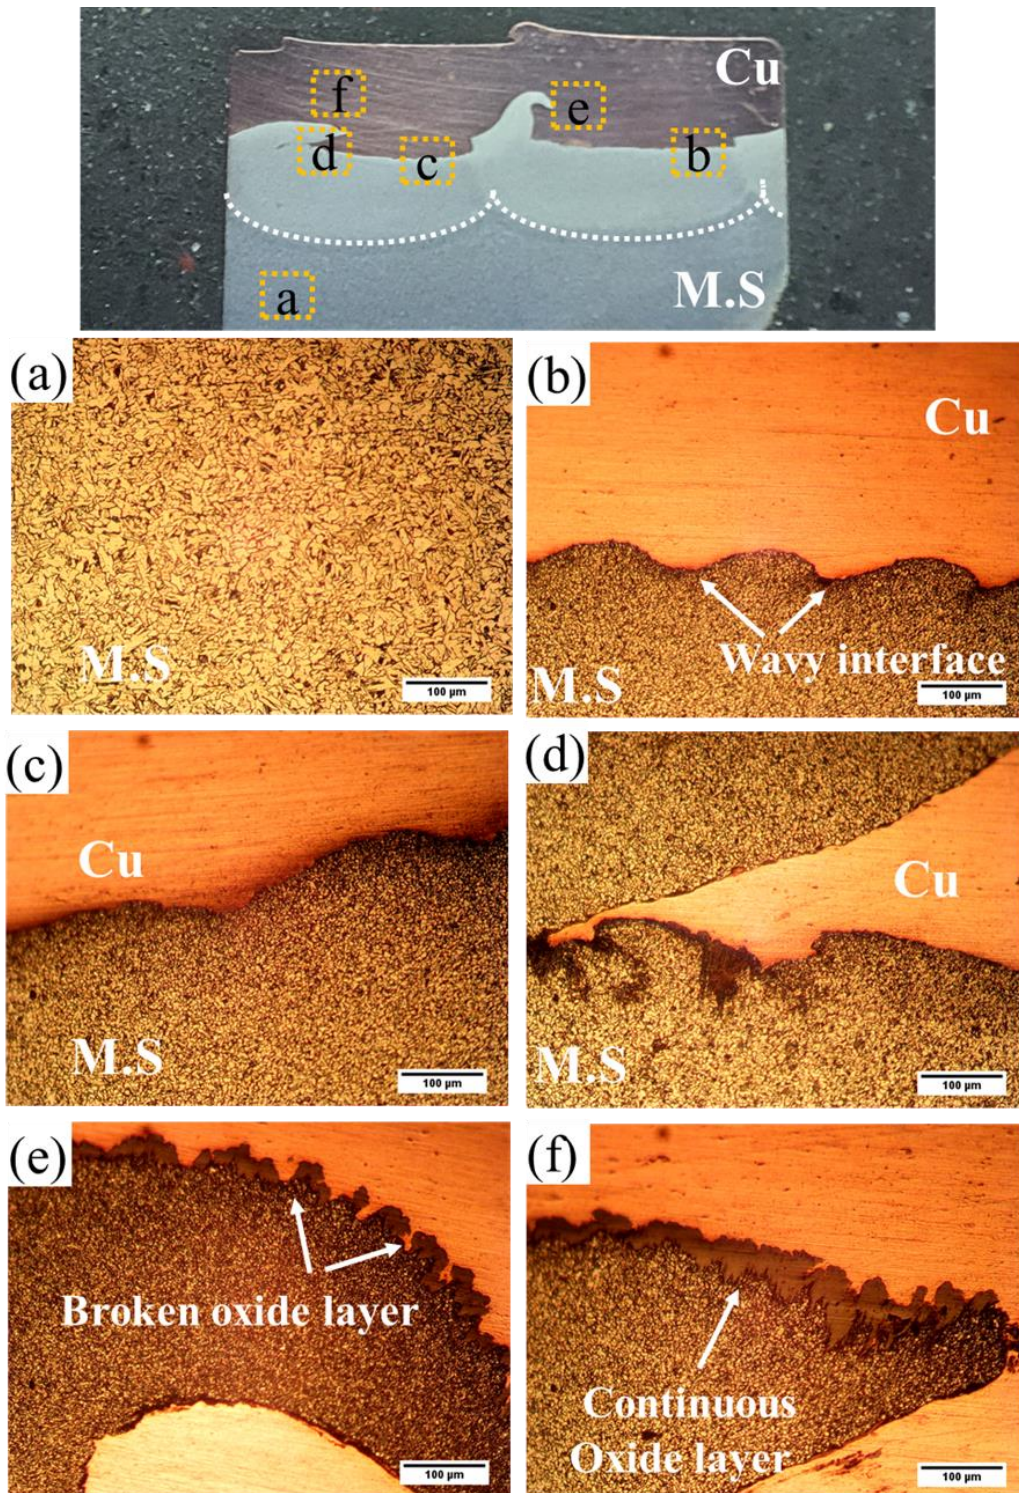
Figure 4-24 Optical microstructure of cross section (a) base steel (b) image showcasing wavy profile near the copper steel interface (c) interface below tool pin surface without any oxide layer (d) copper tail penetrating steel substrate (e) bounded steel region with broken oxide layer (f) steel region penetrating copper area

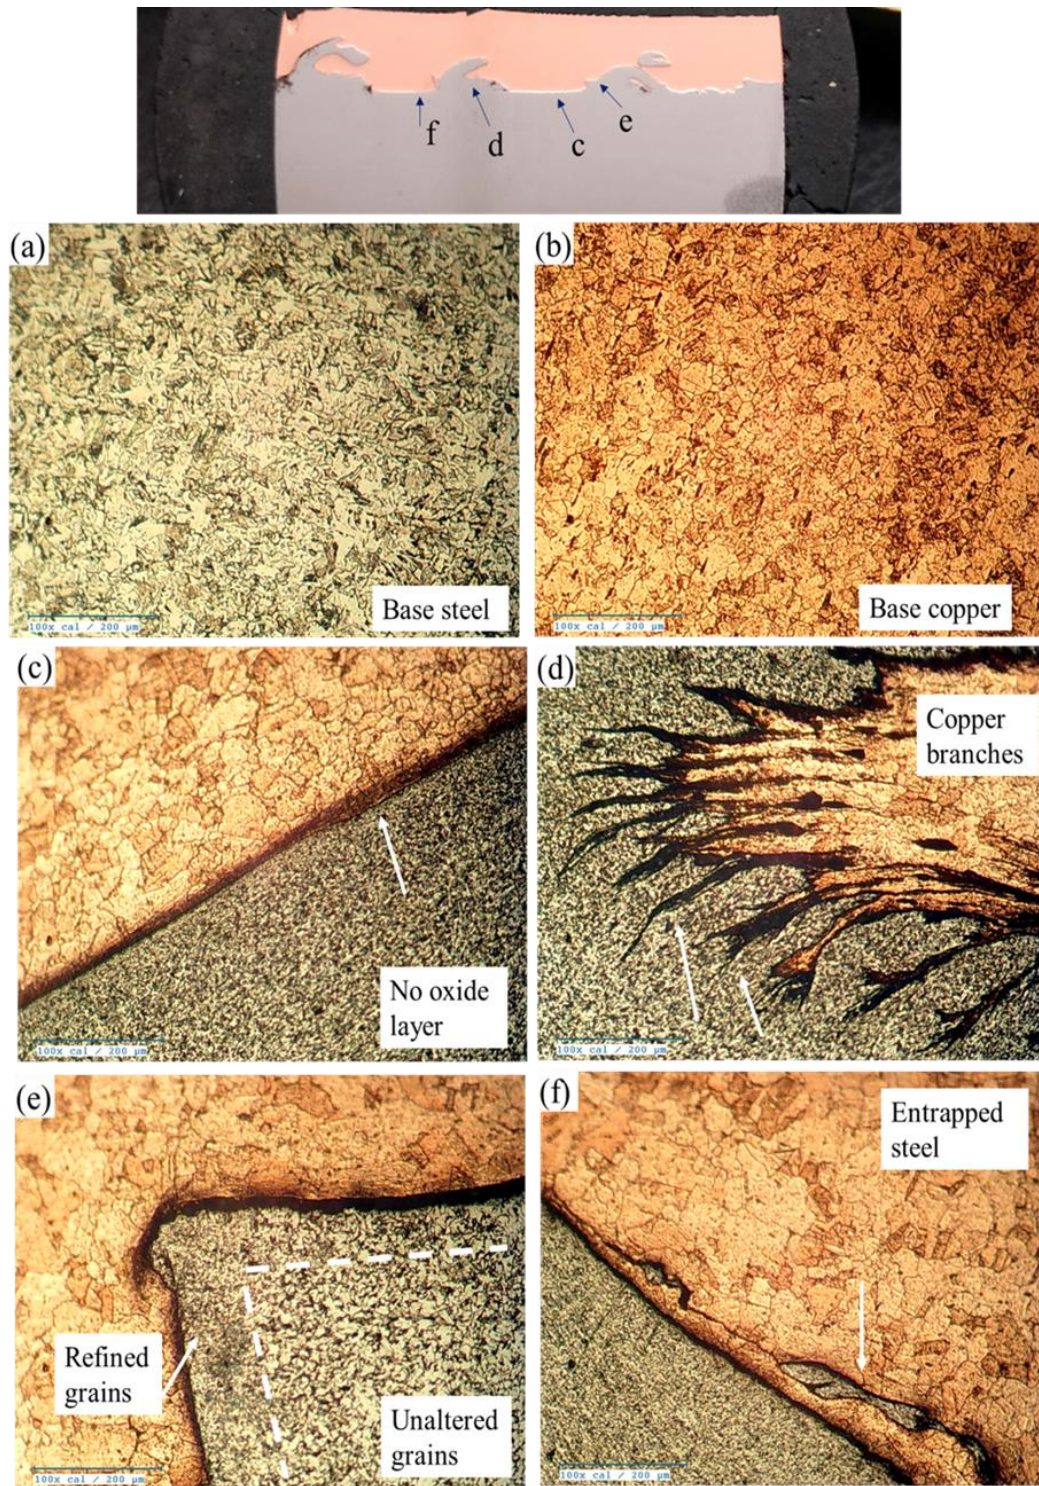
Figure 4-25 Optical microstructure of transverse cross section (a) base steel (b) base copper (c) interface region near stir zone demonstrating grain refinement in steel substrate without oxide layer (d) copper branches penetrating steel surface (e) region showcasing unaltered and refined grain zones of steel (f) location with engulfed steel portion

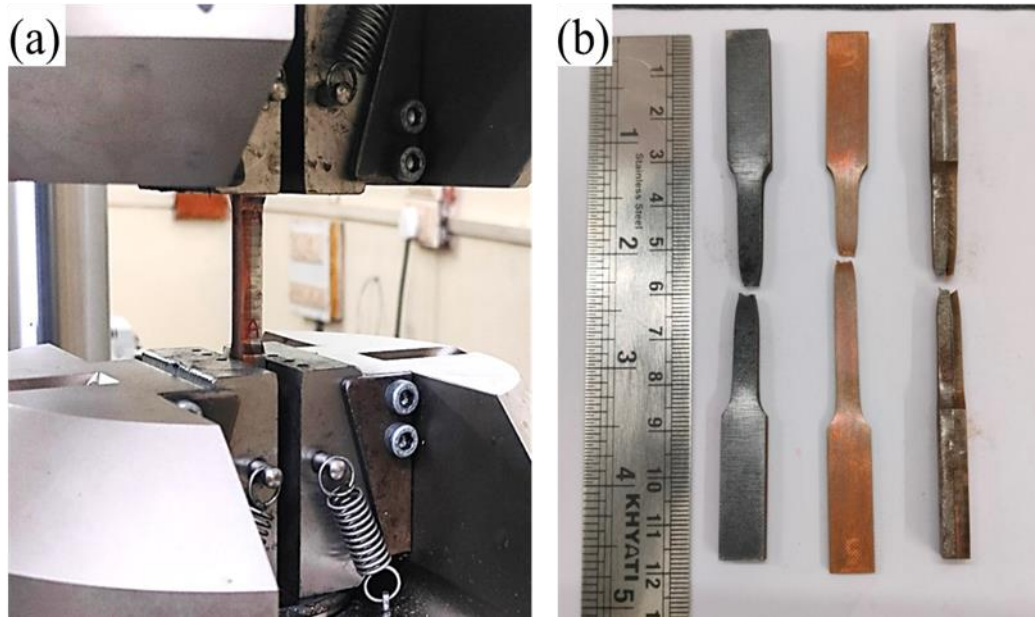
Figure 4-29 Demonstration of (a) necking phenomena in clad sample (b) fractured tensile samples

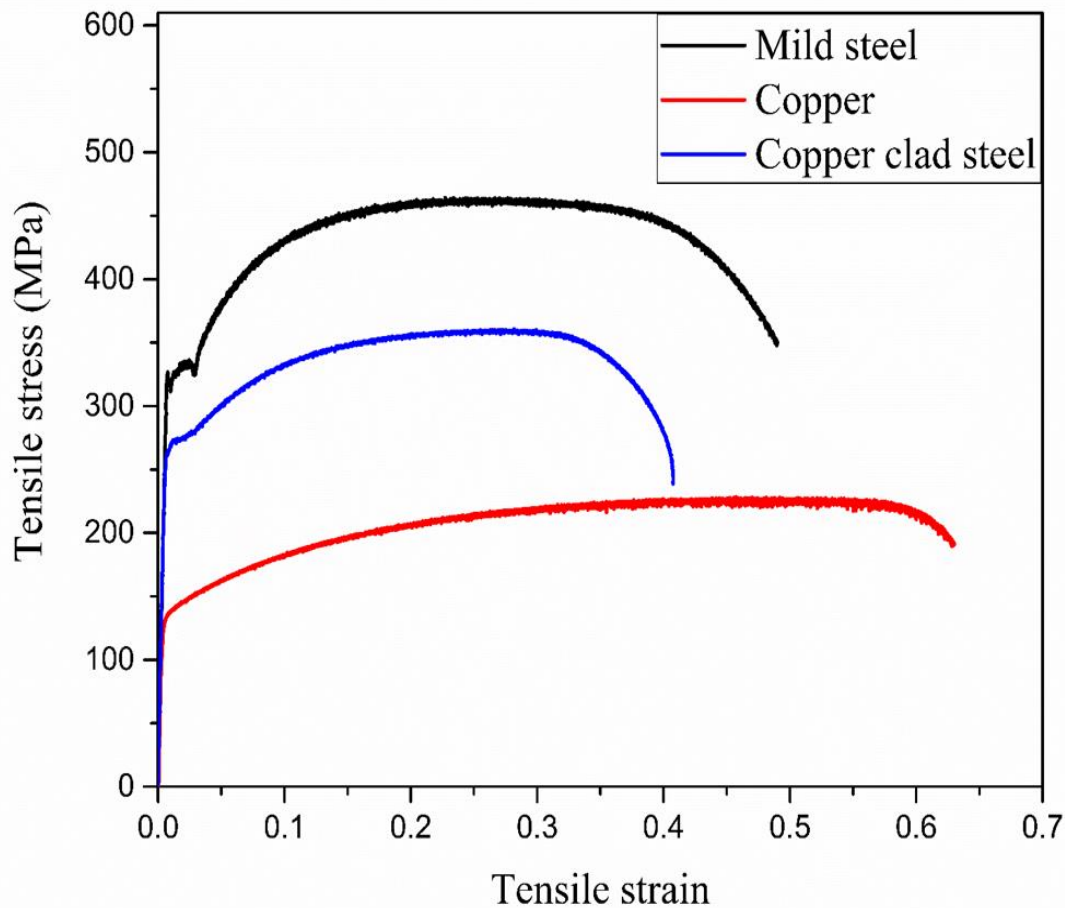
Figure 4-30 Stress strain graph comparing the tensile properties of copper, steel, and clad bimetal joint
