4 RESULTS AND DISCUSSION

4.1 Results for copper clad aluminium

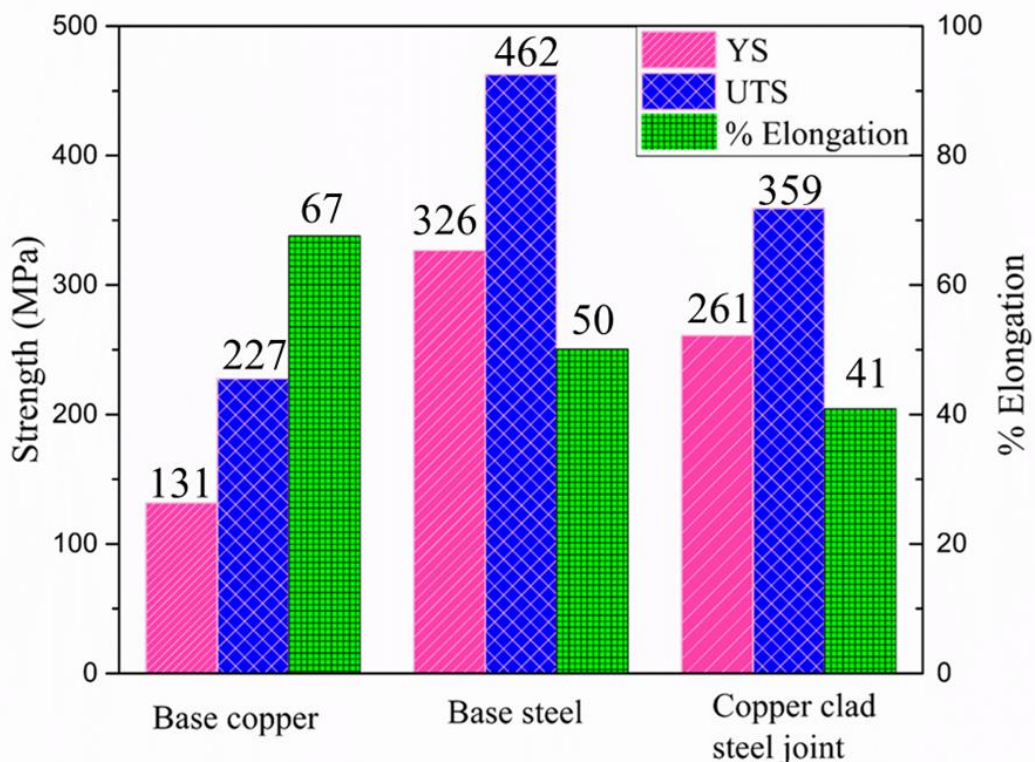
Figure 4-31 Comparison of tensile properties (YS, UTS, and % elongation) for base copper, mild steel, and copper clad steel

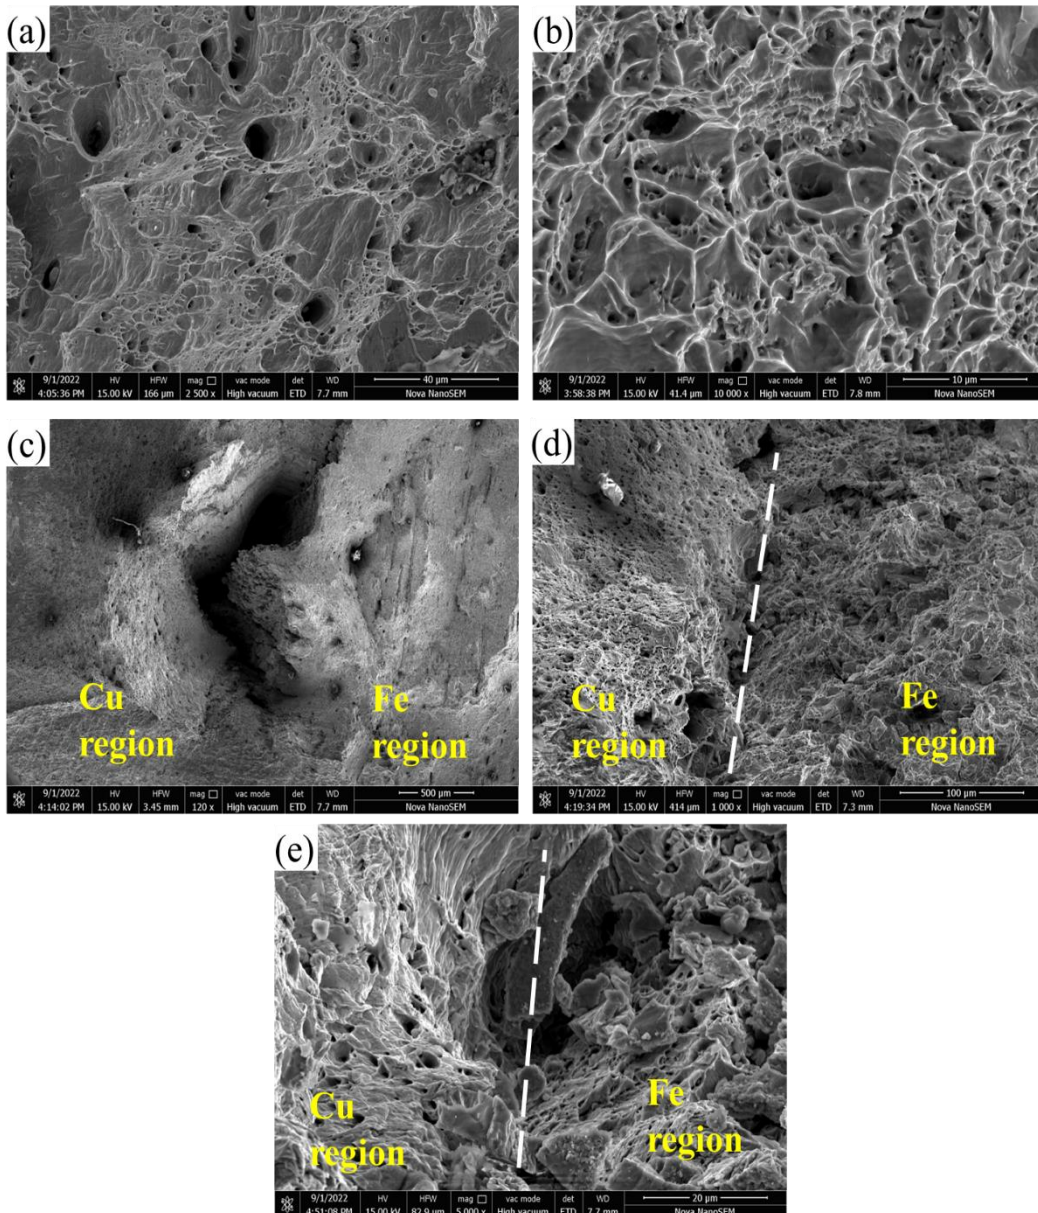
Figure 4-32 Fractography images for (a) received copper (b) received mild steel (c) copper clad steel fractured face portion (d) interface fractured surface (e) enlarged copper steel interface showing dimples in copper

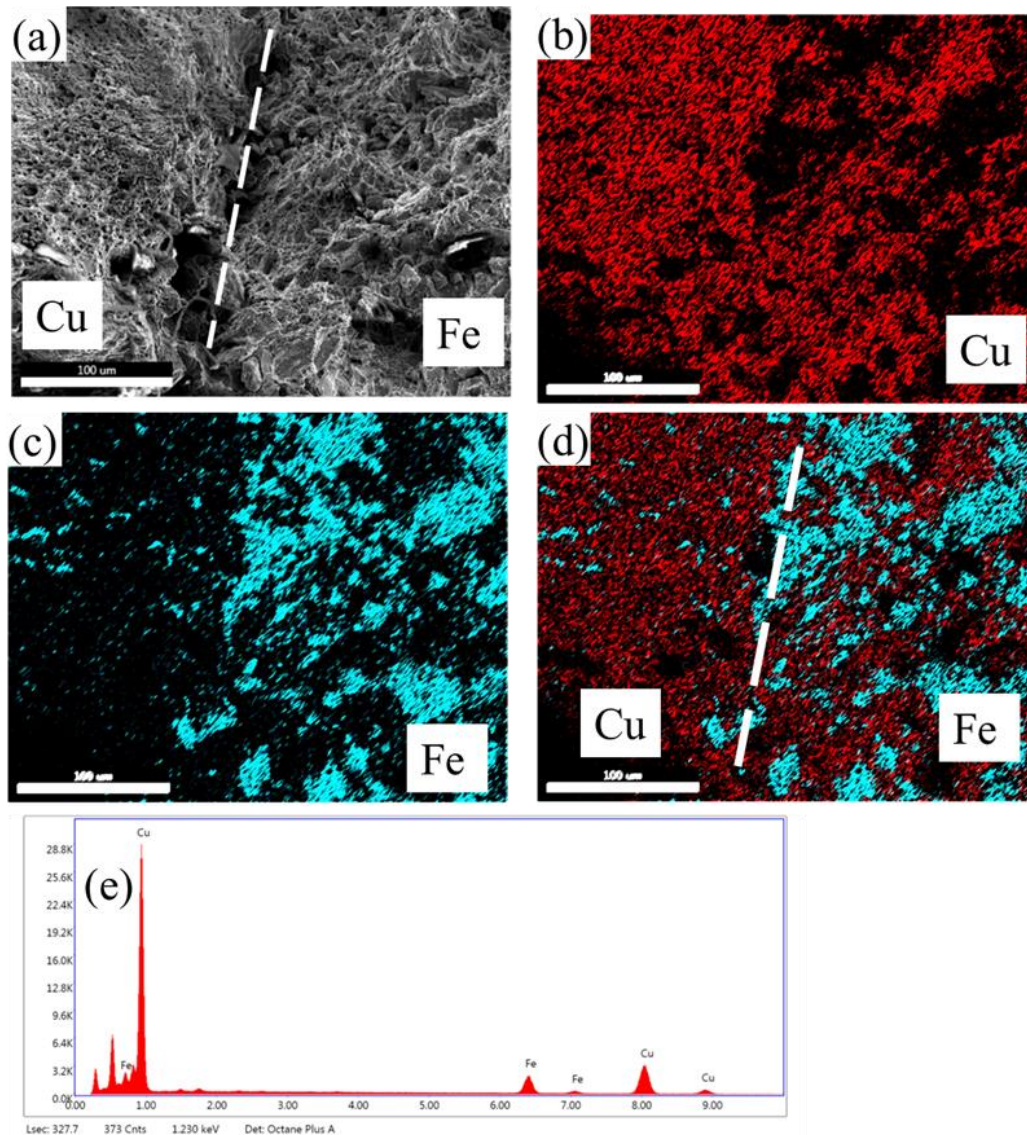
Figure 4-33 (a) SEM image of fractured interface region (b) EDS map of copper distribution (c) EDS map of steel distribution (d) EDS map of both constituent materials overlaps (e) EDS spectra of copper and steel interface

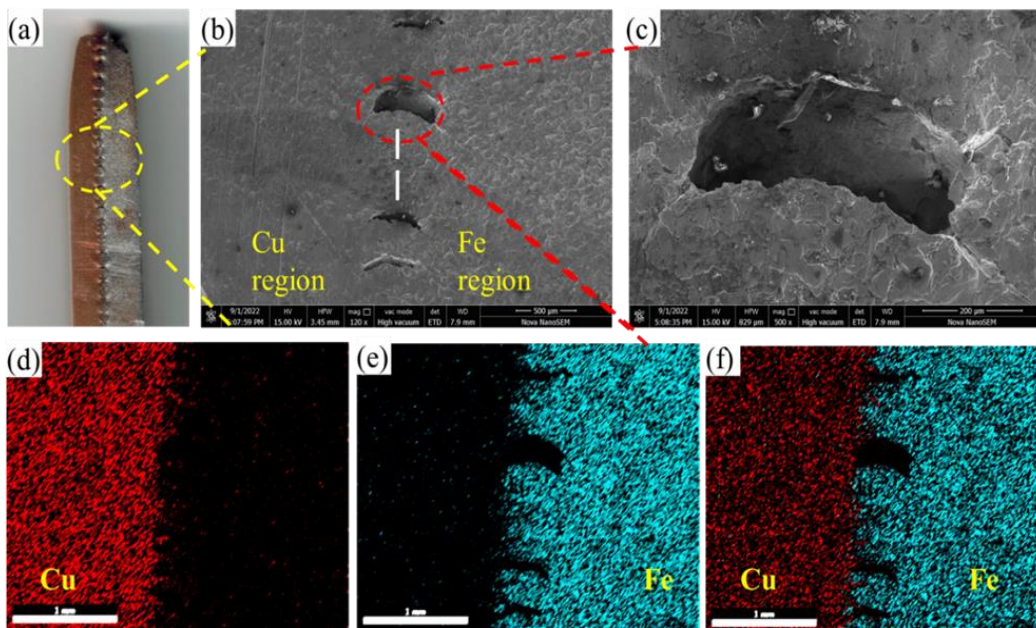
Figure 4-34 (a) Fractured tensile gauge length with stretching marks (b) SEM image of the interface region (c) SEM image of stretched cavity in enlarged view with crack propagation marks (d) EDS map of copper distribution (e) EDS map of steel distribution (f) EDS map showing both constituent materials overlaps

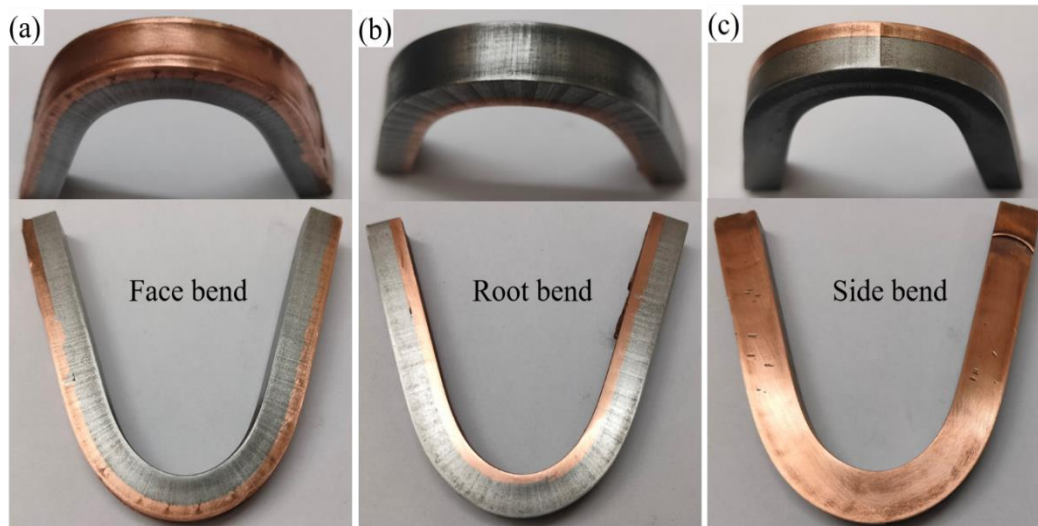
Figure 4-35 Guided bend test results (a) face bend (b) root bend and (c) side bend

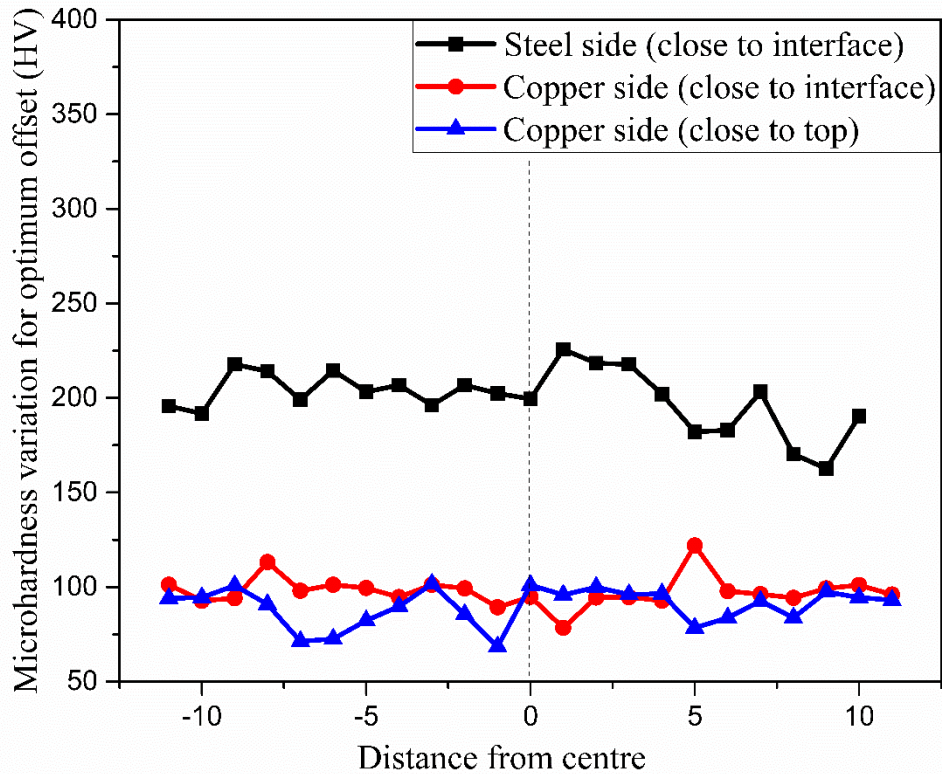
Figure 4-37 Microhardness variation with 7 mm tool offset for copper clad steel at different locations

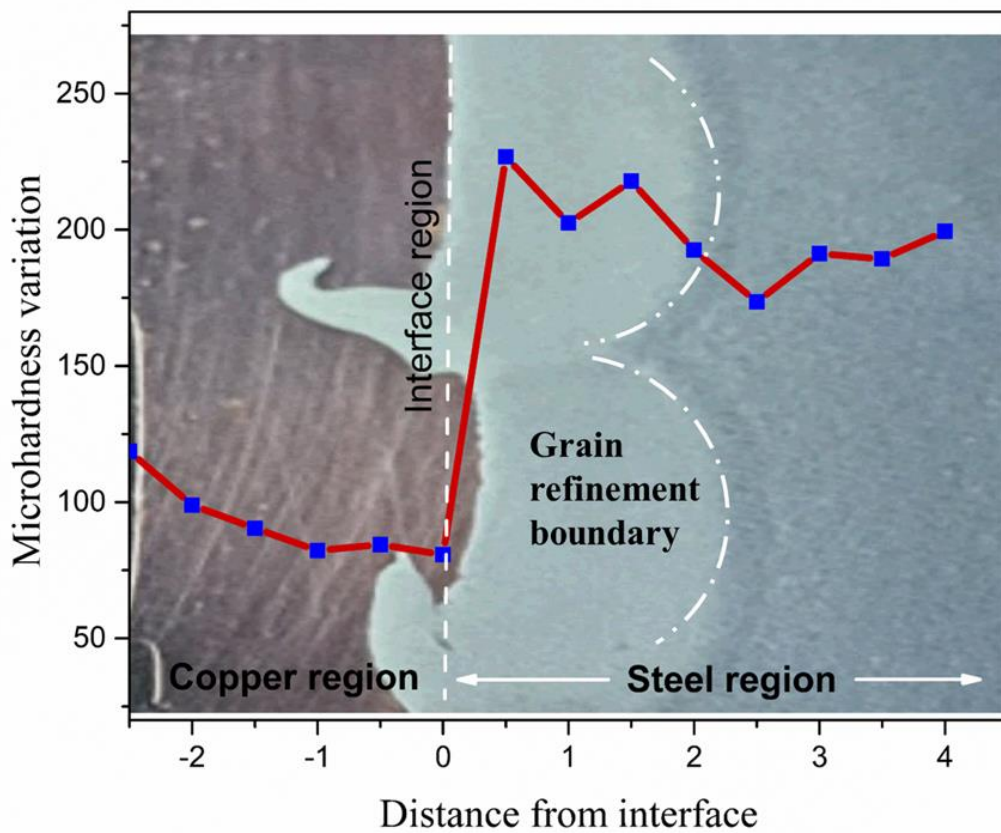
Figure 4-38 Microhardness variation across the interface from copper to steel

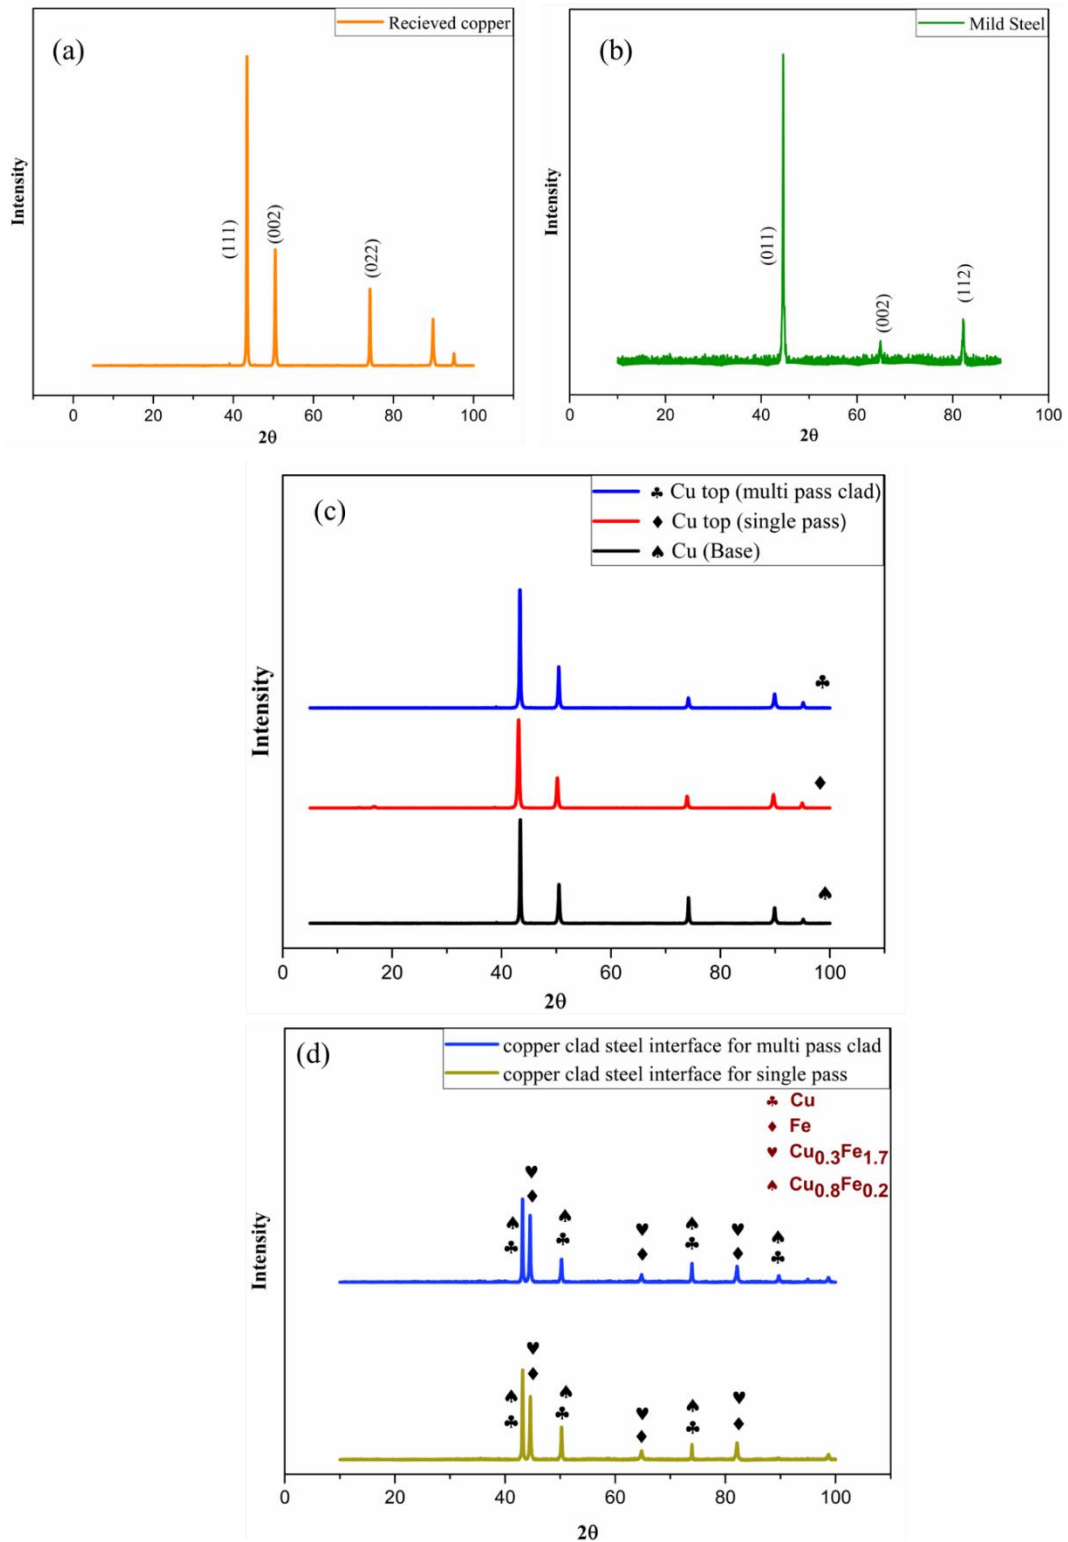
Figure 4-40 XRD peaks of (a) base copper (b) mild steel substrate (c) top surface of copper clad after single pass and triple pass clad top compared with XRD of base copper (d) transverse cross section indicating presence of intermetallics

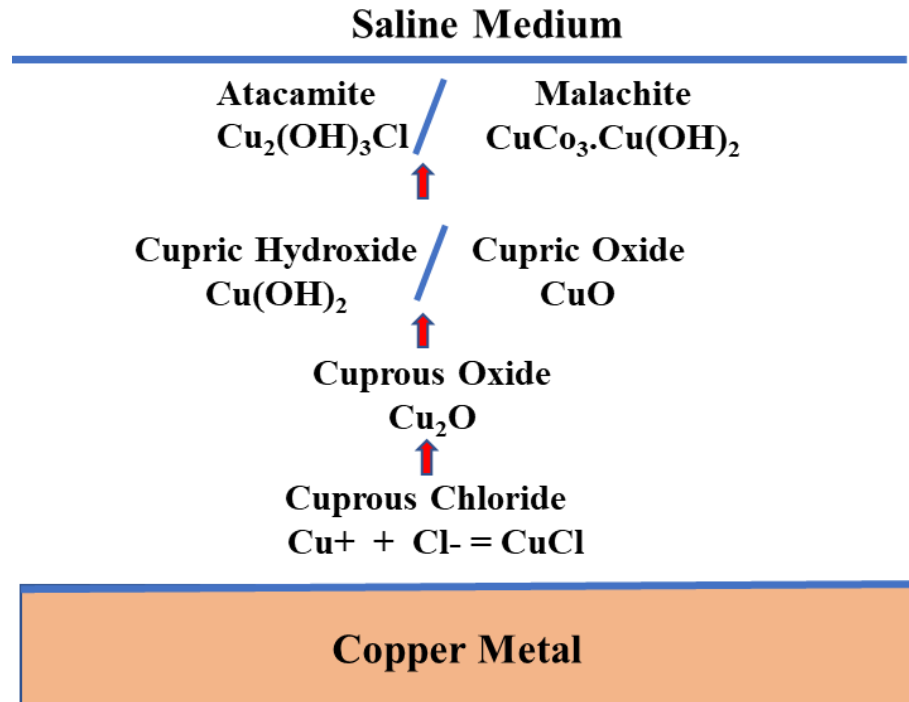
Figure 4-41 Stages of copper corrosion in chloride solution

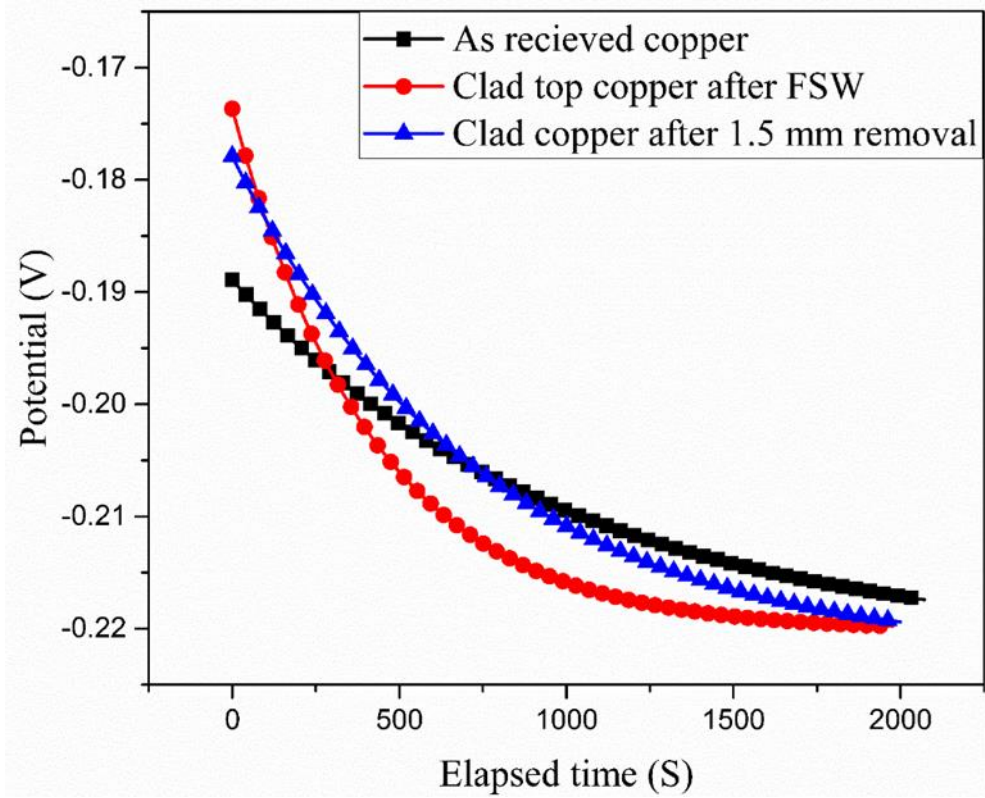
Figure 4-42 Open circuit potential variation for base copper, clad copper top, and clad top after 1.5 mm removal

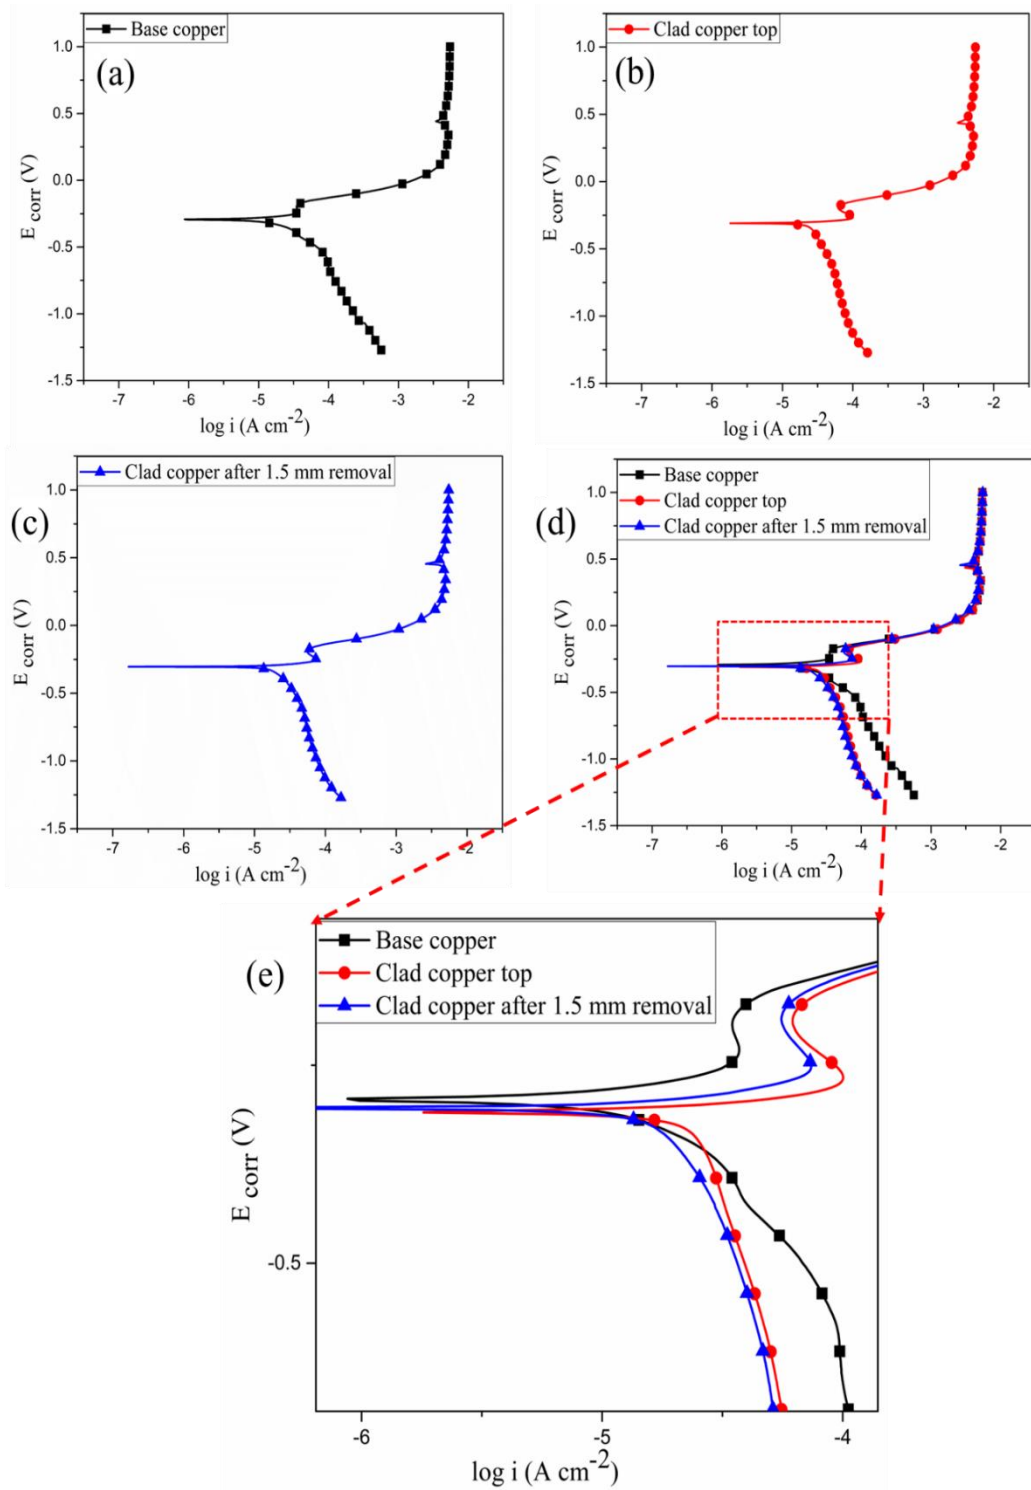
Figure 4-43 Tafel plots for (a) base copper (b) clad top copper (c) clad top copper after 1.5 mm removal (d) superimposed tafel plots (e) enlarged view of the same

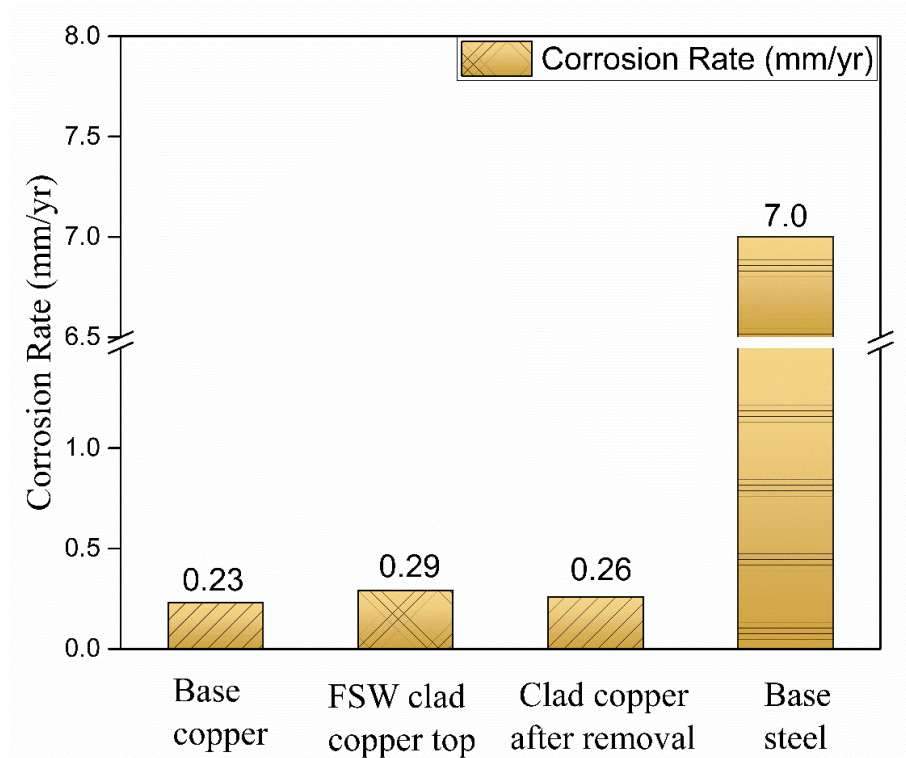
Figure 4-44 Comparison of corrosion rate of base copper, clad copper top, clad copper top after removal, vs corrosion of mild steel (taken from reference)[192]

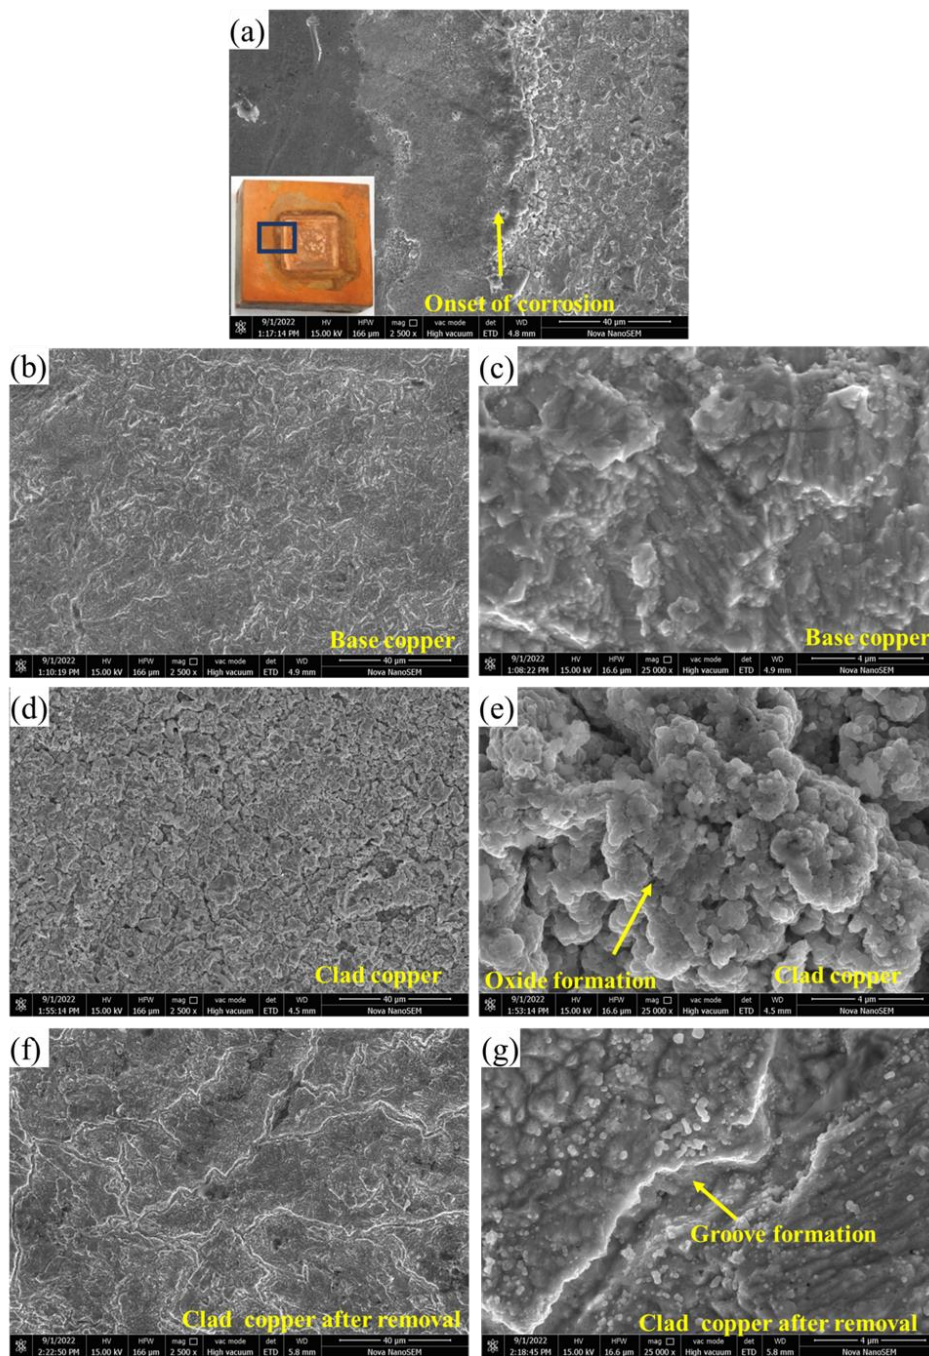
Figure 4-45 SEM images post corrosion (a) showing onset of corrosion boundary (b, c) base copper at low and high magnifications depicting smooth corrosion features (d, e) clad copper top depicting oxide formation (f, g) clad copper after 1.5 mm removal demonstrating groove path formation

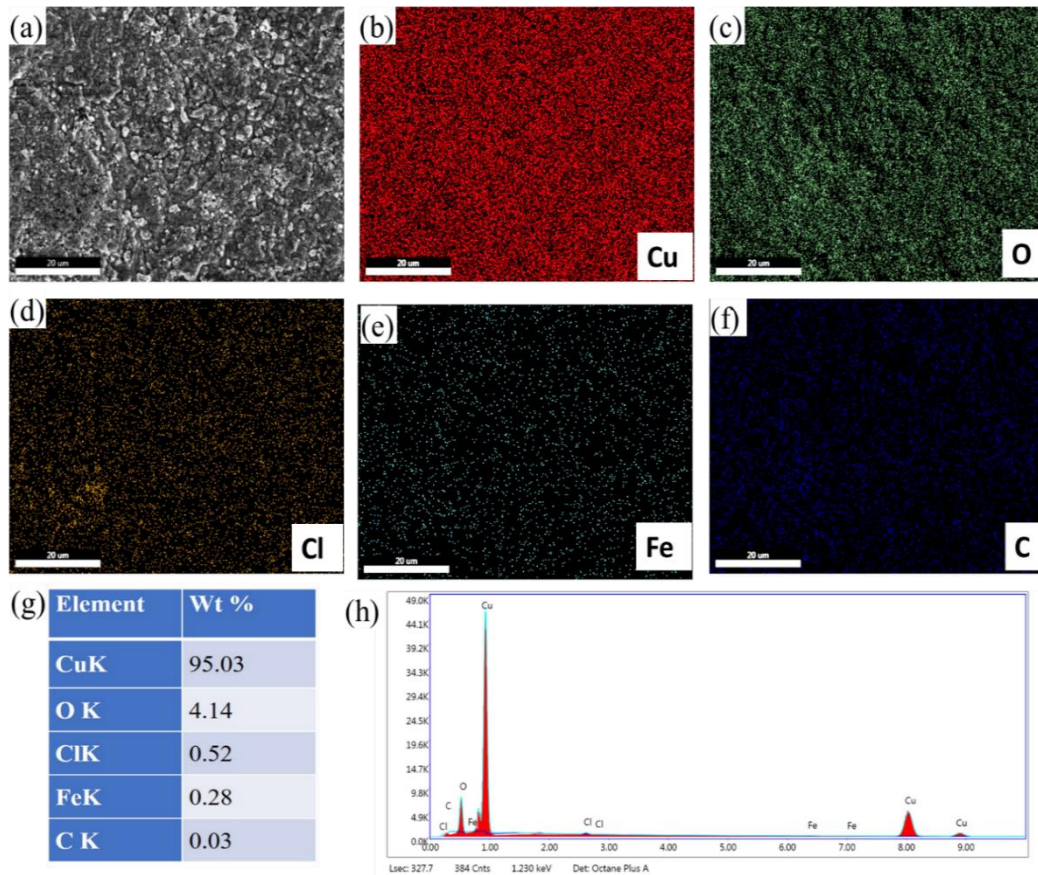
Figure 4-46 Demonstrating (a) SEM Image of corroded clad top copper (b) EDS map demonstrating copper (c) oxygen in the corroded region (d) chlorine (e) iron (f) carbon (g) EDS quantification (h) peak spectra for same

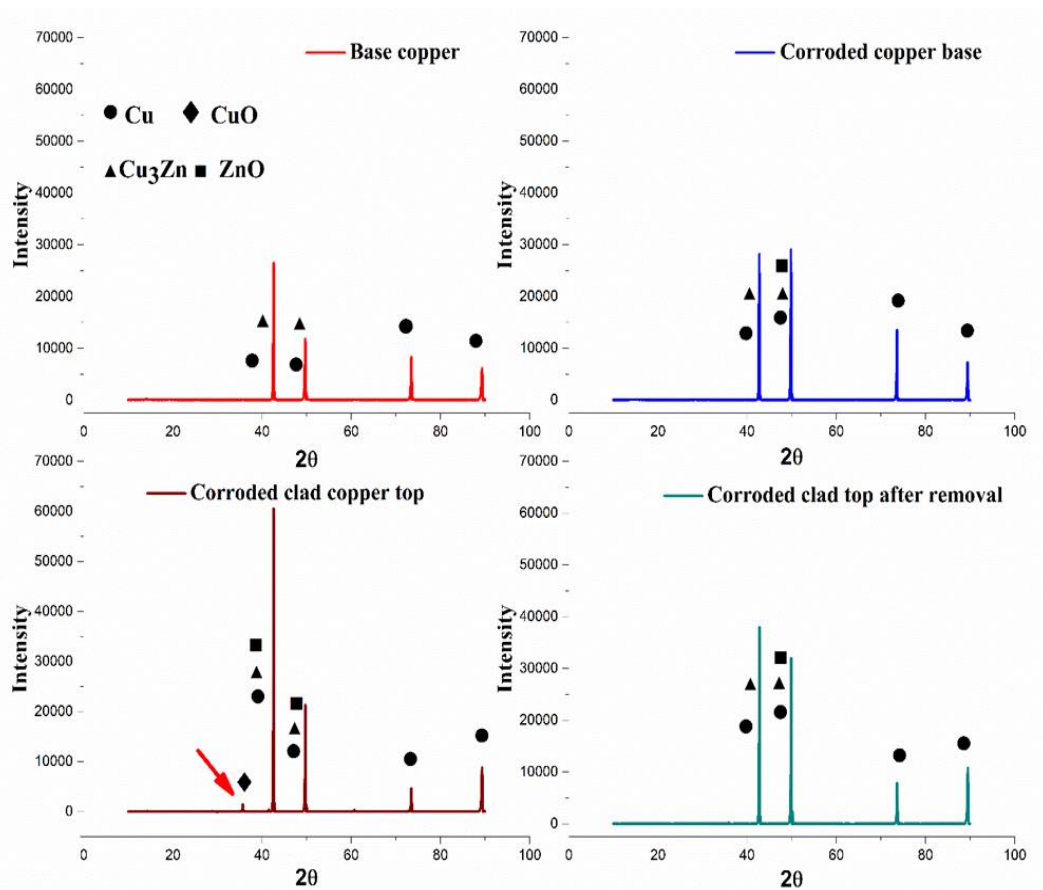
Figure 4-47 XRD peaks for (a) base copper (b) corroded base (c) corroded clad top copper (d) corroded clad top copper after removal

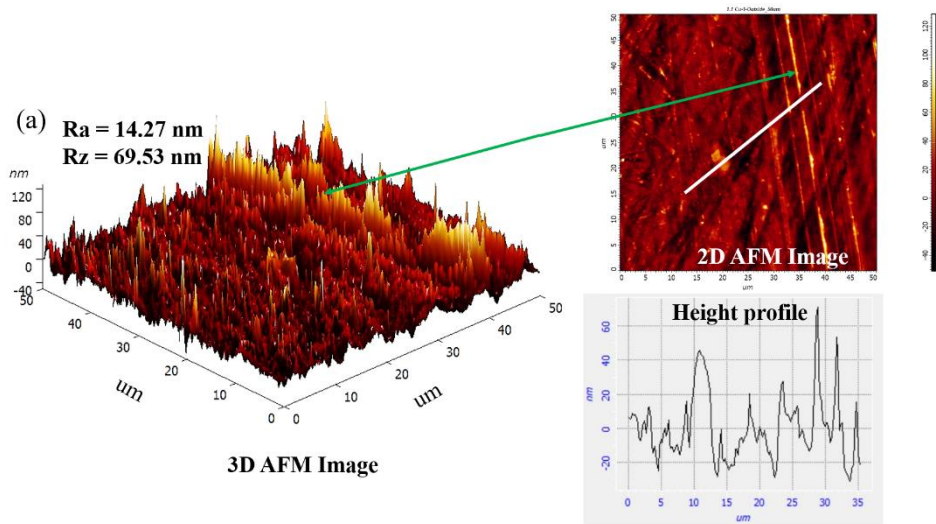
Figure 4-48 3D and 2D AFM images along with height profile for base copper

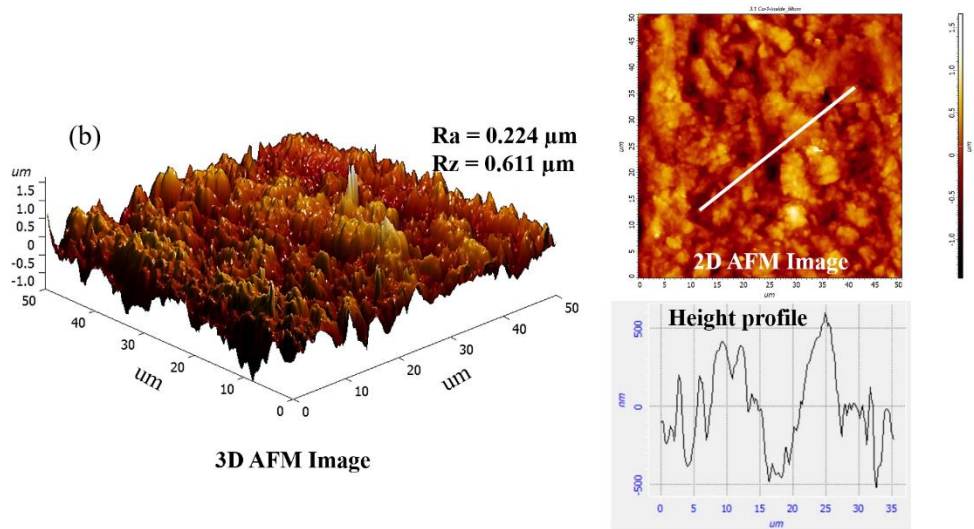
Figure 4-49 3D and 2D AFM images along with height profile for corroded base copper

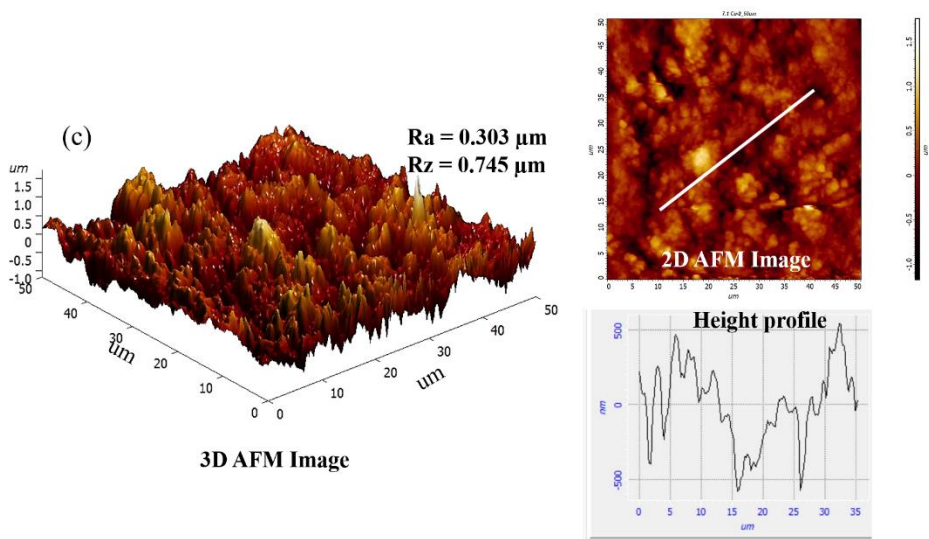
Figure 4-50 3D and 2D AFM images along with height profile for corroded clad top

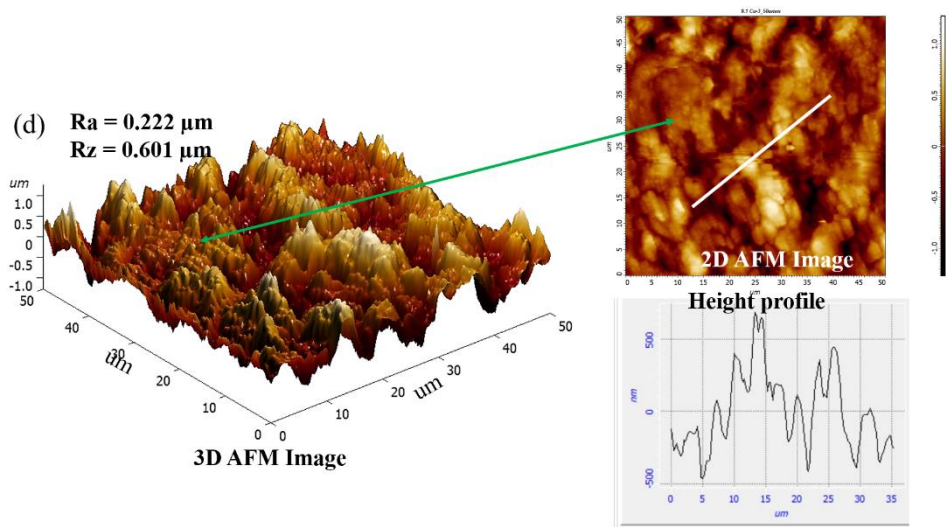
Figure 4-51 3D and 2D AFM images along with height profile for corroded copper top after removal
