## **FAILURE ANALYSIS OF CHAURAS BRIDGE AND SUCCESS OF GARUDCHATTI BRIDGE: A CASE STUDY**

### **3.2 FAILURE ANALYSIS OF CHAURAS BRIDGE**

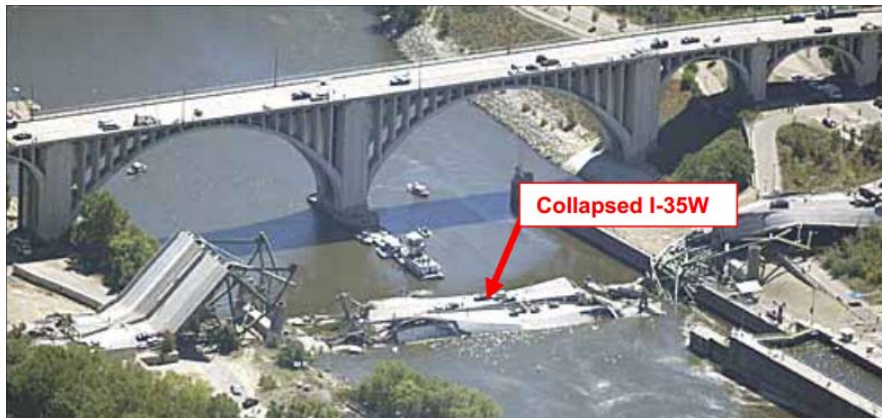
**Figure 3.1** View of the collapsed I-35W bridge (A. Astaneh-Asl, 2008)

One notable example of sudden collapse is collapse of I-35W bridge over the Mississippi River in Minneapolis, Minnesota on August 1, 2007 resulting in deaths of 13 people and injury to more than 100 others (M. Liao, *et. al.*, 2011). Figure 3.1 shows collapsed I-35W bridge (A. Astaneh-Asl, 2008).

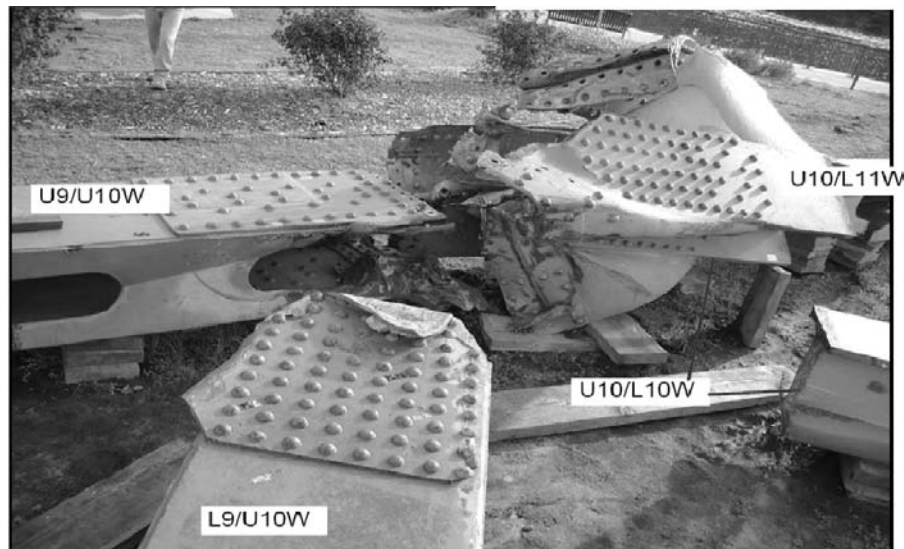
**Figure 3.2** Failure of gusset plate at U10 (M. Liao, *et. al.*, 2011)

All joints of the bridge were connected by 1 inch thick gusset plates, except top chord joint U10, where  $\frac{1}{2}$  inch thick gusset plates were used (Figure 3.2). Investigation and finite element analysis by many researchers concluded that, the undersized gusset plate at joint U10 was the cause of catastrophic and sudden failure (M. Liao, *et. al.*, 2011).

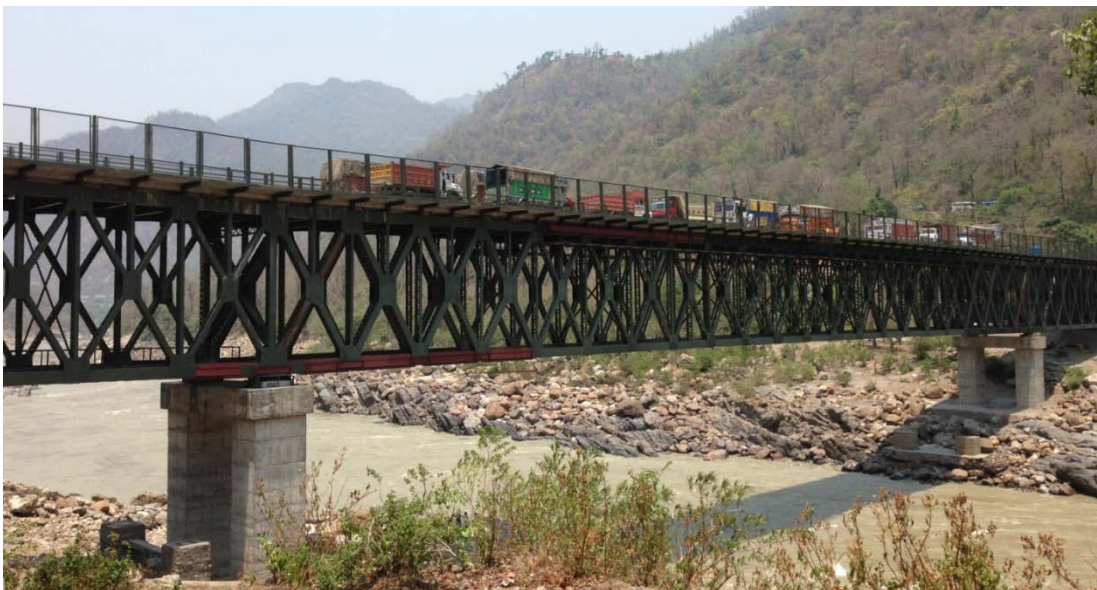
**Figure 3.17** Garudchatti bridge over Alaknanda river, India

The bridge with loaded trucks as per loading shown in Figure 3.15 is seen in Figure 3.17.

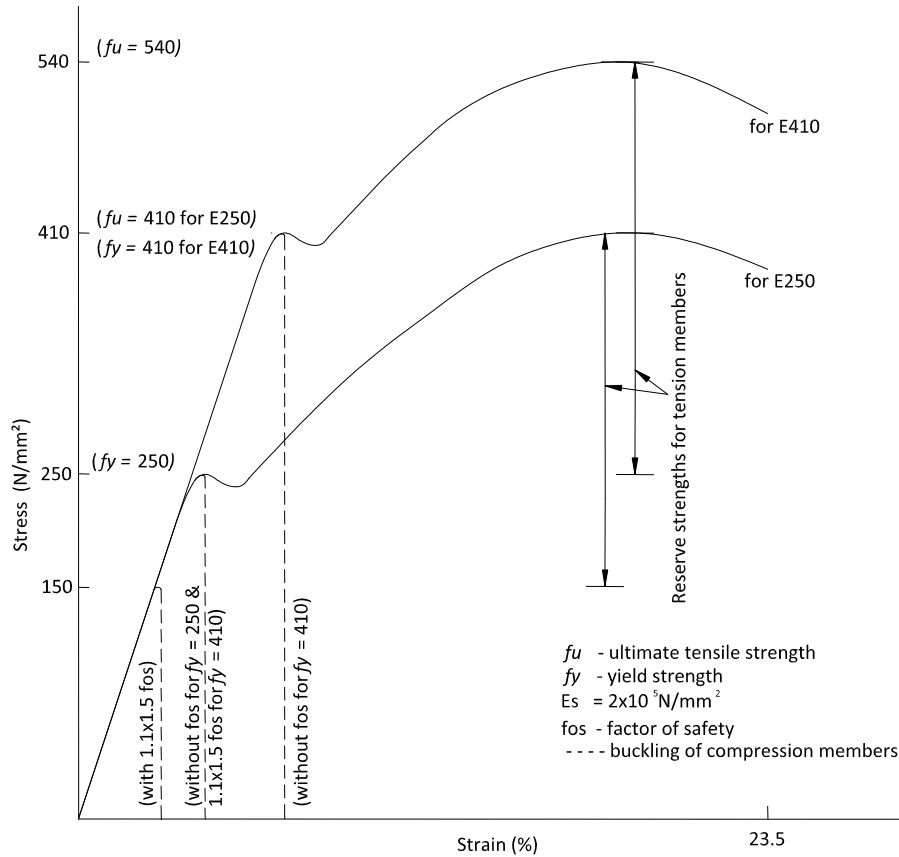
**Figure 3.18** Stress-Strain curves of compression or tension member for mild steel of grades E250 and E410

Structural steel of grade E250 used in Chauras bridge had ultimate tensile strength ( $f_u$ ) of  $410\text{ N/mm}^2$  and yield strength ( $f_y$ ) of  $250\text{ N/mm}^2$ . Permissible tensile stress in service condition for mild steel as per Indian standards is  $0.6 f_y$  ( $=150\text{ N/mm}^2$ ). For slenderness ratio less than 10 maximum permissible compressive stress is also  $0.6 f_y$  ( $=150\text{ N/mm}^2$ ), which decreases with increase in the slenderness ratio. Similarly, for E410 grade of steel yield strength is  $410\text{ N/mm}^2$  and ultimate tensile strength is  $540\text{ N/mm}^2$ . Permissible tensile stress and maximum permissible compressive stress for this steel is also  $0.6 f_y$  (Figure 3.18).

Tension and compression members of a steel truss have entirely different behaviour before failure (Figure 3.18). Compression members suddenly buckle and fail without any reserve strength in them beyond maximum buckling stress, while tension members have reserve strength after yielding up to the ultimate tensile strength.

Referring to Figure 3.18 and adapting 1.1 material safety factor and 1.5 fatigue factor, maximum permissible compressive stress in the serviceability condition for compression members of grade E250 and E410 may also be adopted as  $0.6f_y$  (IS: 800-2007).

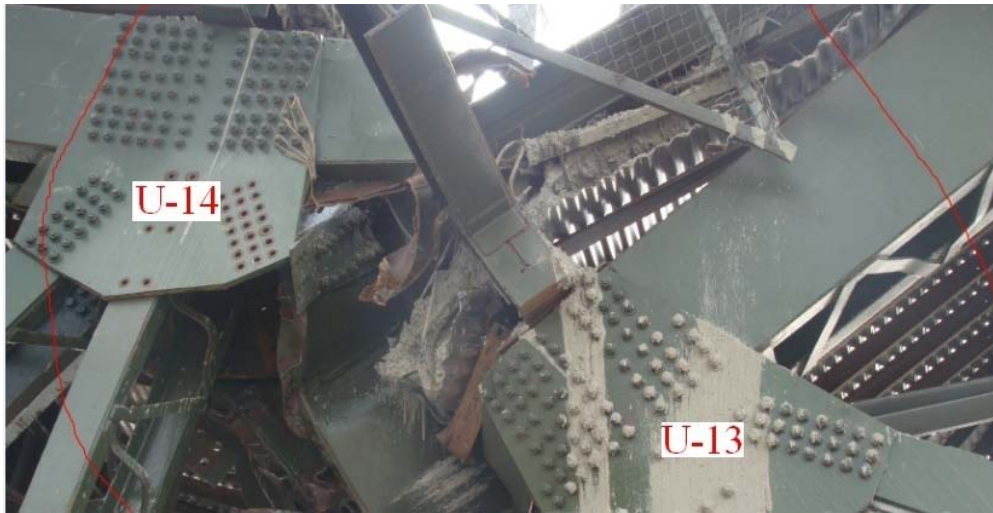
**Figure 3.19** Intact gusset plates at joints U13 and U14

Compressive force in member U13U14 was 3754.2 kN and corresponding stress in the gusset plate was 260.7 N/mm<sup>2</sup>. Gusset plates at joints U13 and U14 remained

intact at this high stress, whereas, member U13U14 buckled and failed at a lower stress of  $173.8 \text{ N/mm}^2$  as shown in Figure 3.19.

Thus, gusset plates if connected properly to the members and prevented from buckling can take compressive or tensile stress up to the ultimate strength of the plate.

In Chauras bridge, gusset plates connecting member U13U14 at joints U13 and U14 were subjected to high stress of  $249.0 \text{ N/mm}^2$ , but these plates did not fail due to their riveting with the members meeting at the joint, and thereby preventing buckling of the plates. Thus, gusset plates if connected properly to the members and prevented from buckling, can take compressive or tensile stress up to their ultimate tensile strength. Therefore, joints designed for service load are safe for the limit state of strength condition also.
