## CHAPTER 4: RESULTS OF FLOW FORMING

### 4.1 Results of flow Forming of Al6101

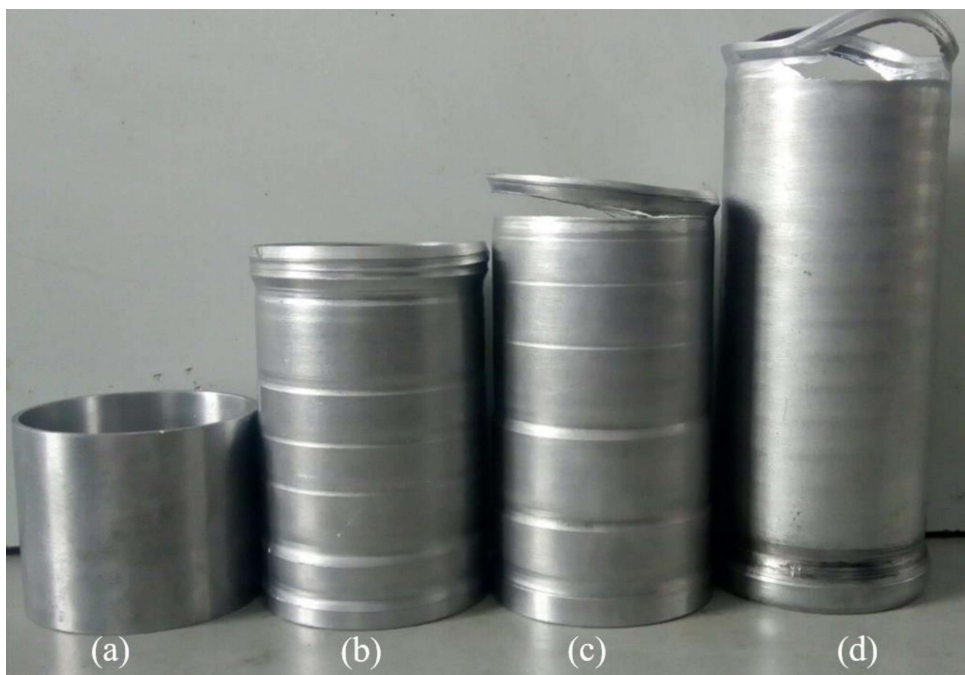
Figure 4.1: Al6101 samples (a) Preform (b) FF02 (c) FF01 (d) FF03

A total of 5 samples have been flow formed under various conditions. Figure 4.1 shows the flowformed Al6101 samples. The samples are named as FF01, FF02, FF03, FF04 and FF05.

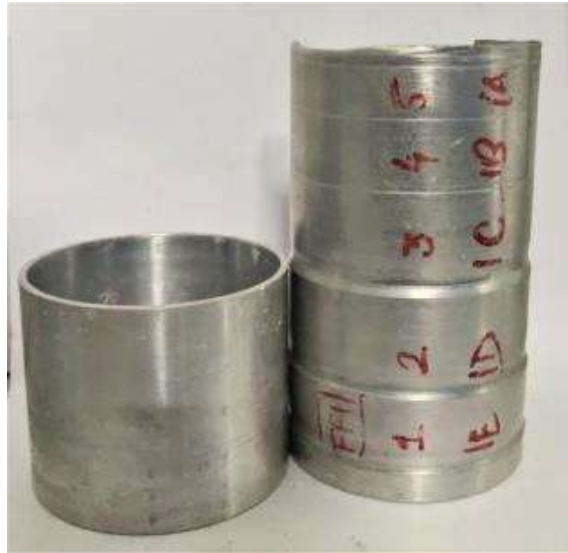
Figure 4.2: The preform and the flow formed product showing the different regions. IE represents the initial region (not flow formed) while regions 1A-1D denote the thickness reduction obtained in 4 different passes

FF01 represents the stepped cylinder formed in multipass flow forming. The different steps have been marked as IA to IE as shown in Figure 4.2. IA region maximum deformed region while IE refers to an undeformed region. The intermediate regions are marked as ID to IB from less deformed to more deformed regions.

During the process, the maximum and minimum thickness reduction was found to be 58.3 % and 8 % respectively. The thickness of the preform was reduced from the initial 2.6 mm to 1 mm in 4 steps. The regions are marked as 1A to 1E, where 1A involved a maximum thickness reduction of 58.3 % while 1D involved a minimum thickness reduction of 8 %. 1E represents the starting region which is not flow formed. Figure 4.2 summarizes the incremental thickness reduction per pass and the cumulative thickness reduction in the region.

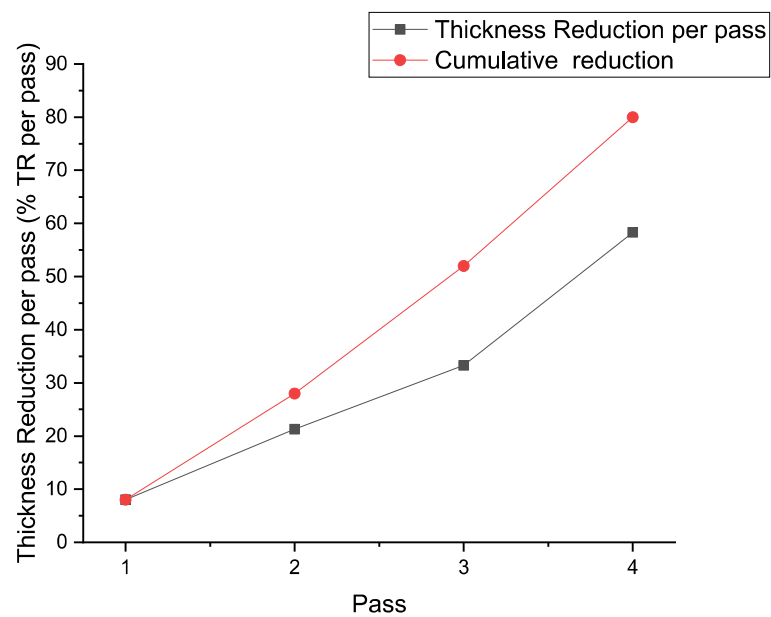
Figure 4.3: Thickness reduction per pass and cumulative thickness reduction. Pass 1 refers to 1D, pass 2 refers to region 1C and so on. Pass 4 refers to 1A

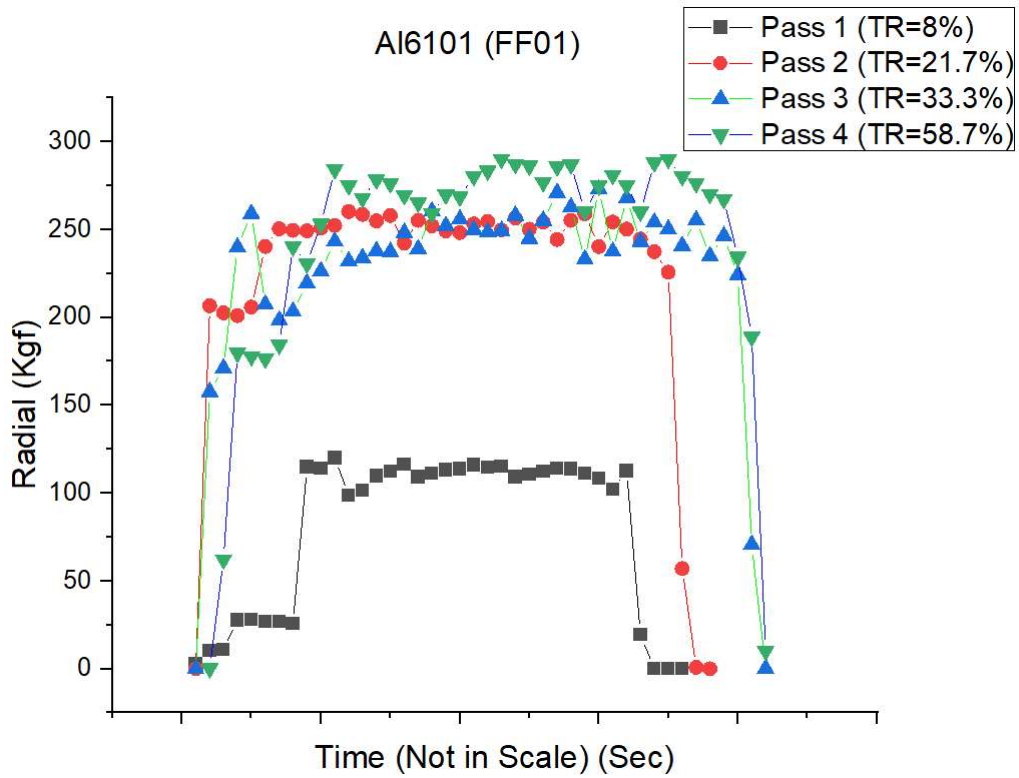
Figure 4.4: Variation of radial force during flow forming operation of sample FF01

Figure 4.4 to Figure 4.6 shows the variation of radial forces, circumferential forces, and axial forces respectively, at different percentage thickness reduction, to the time of completion of one individual pass.

It can be seen from Figure 4.4 to Figure 4.6, all the components of the flow forming forces that is, axial forces, the circumferential forces, and the radial forces is found to increase with the increase in percentage reduction. This can be explained on the basis that as the percentage reduction increases, the amount of material deforming and flowing along the radial and circumferential direction increases. As a result, the reaction forces on the roller increases, and hence the magnitude of each of the forces increases.

The radial force is found to be most significant in the flow forming process. Under the present experimental condition, the radial force was found to be more uniformly increasing, as compared to radial or circumferential force. The average magnitude of axial force is found to increase from 141.5 kgf at %TR=8 to 293.5 kgf at %TR=58.3%. However, the peak values observed in the investigation was found to be 310.2 kgf at %TR of 58.3%.

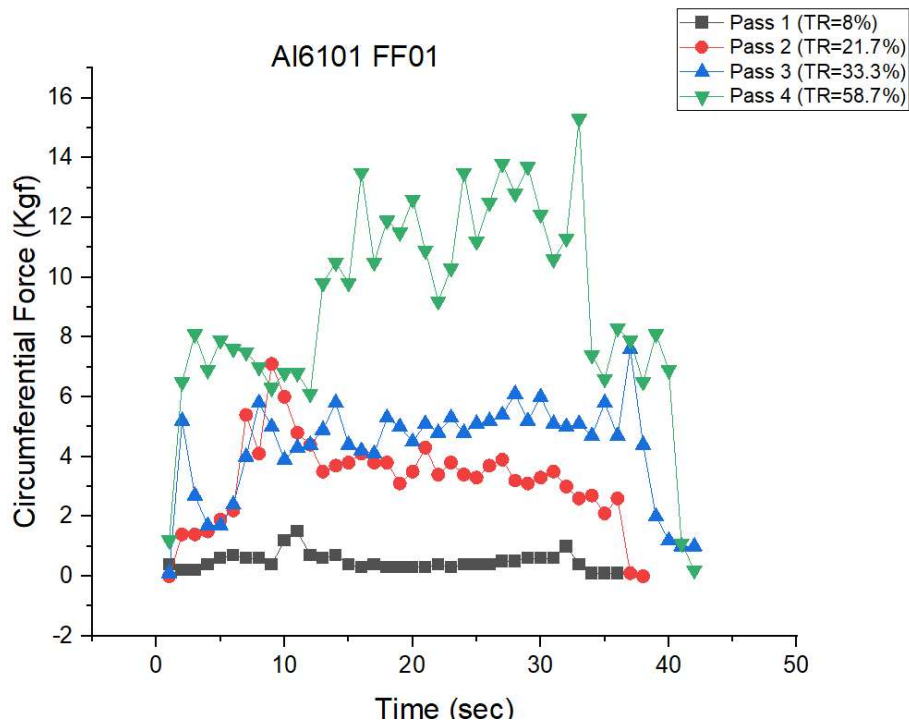
Figure 4.6: Variation of circumferential force during flow forming operation of sample FF01.

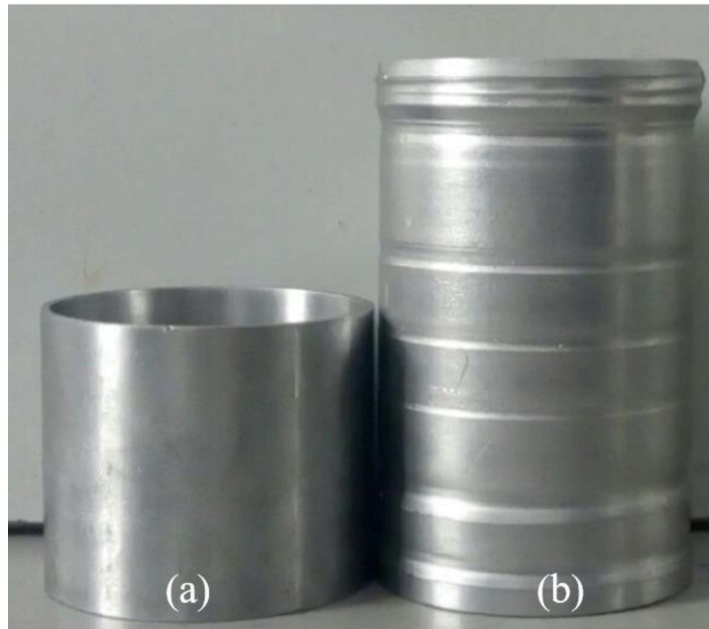
Figure 4.7: Flow formed FF02-Multistep flow formed sample (a) preform (b) Flow formed product.

During the investigation, FF01 was found to crack from the end while in flow forming of sample FF02 no crack was observed. The force in FF02 in subsequent steps and the thickness reduction were summarized in Table 4.3.

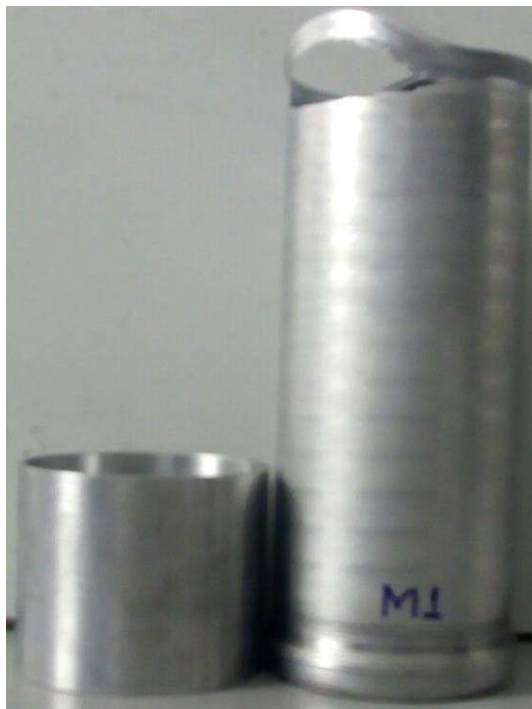
Figure 4.8: Preform and Flow formed FF03

The material flow during flow forming of sample FF03 was found to be uniform and resulted in a surface with surface finish with Ra of  $0.43 \mu m$ .

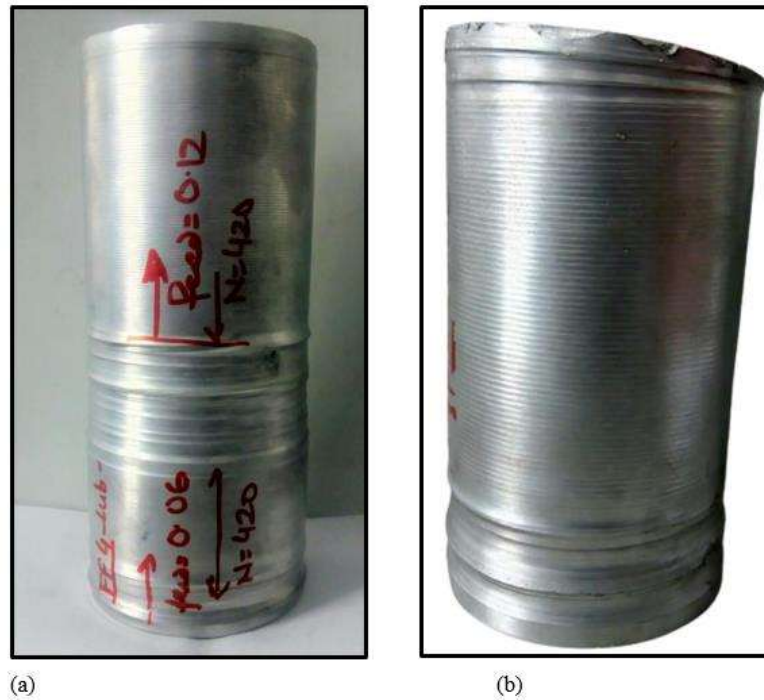
Figure 4.9: Flow formed samples FF04 and FF05

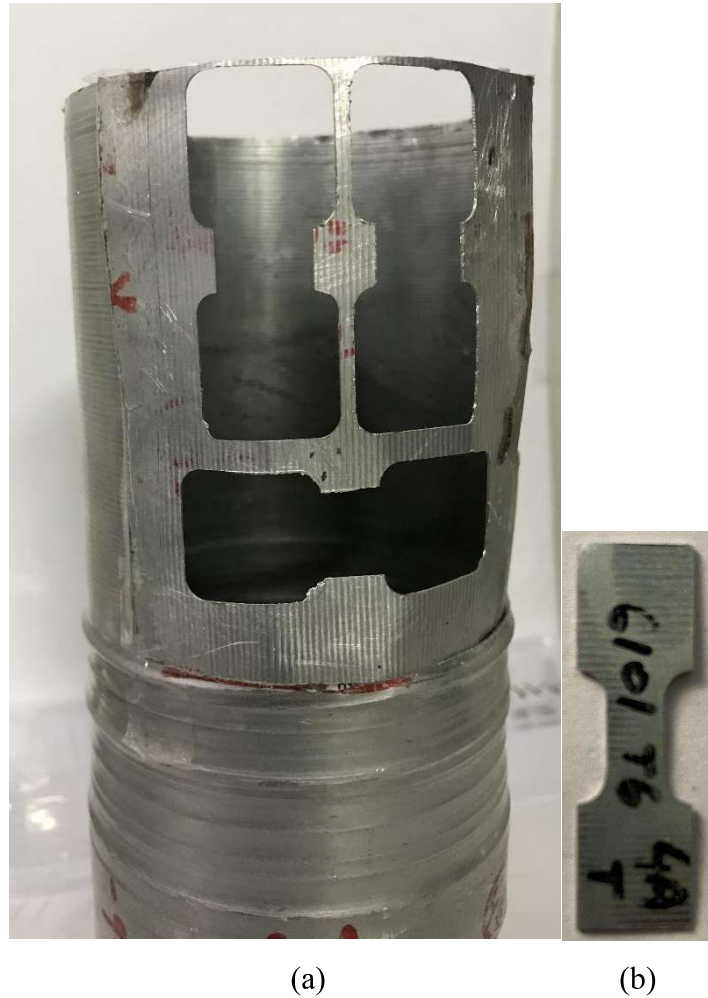
Figure 4.12: (a) Tensile specimen cut out from flow formed FF04. (b) One Tensile specimen

Tensile specimen was cut from the flow formed the samples. As the thickness of the flow formed samples were around 0.4 mm, hence miniature samples were prepared based on Barba's law.

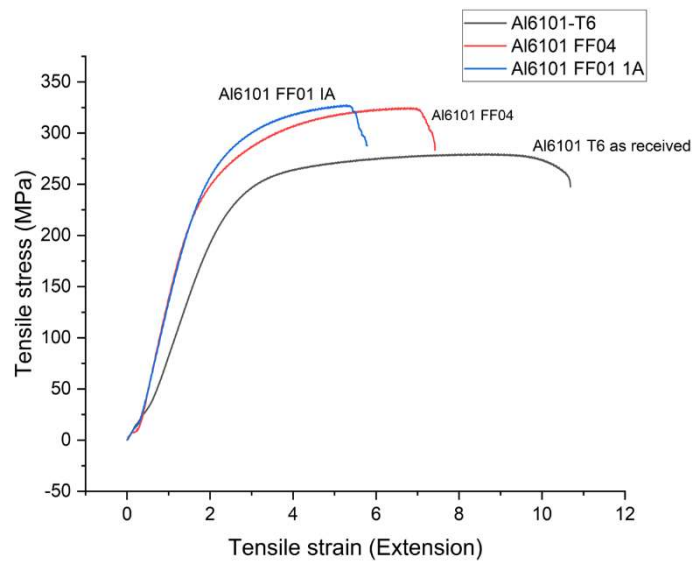
Figure 4.13: Engineering Stress- engineering strain curve of sample FF04

The tensile stress at yield (0.2% offset ) was found to be 248.03 MPa while the ultimate tensile strength was found to be 276.5 MPa and the elongation was found to be 10.64%.

crosshead velocity of 0.025 mm/min. The results of the tensile test of FF04 is shown in Figure 4.13.

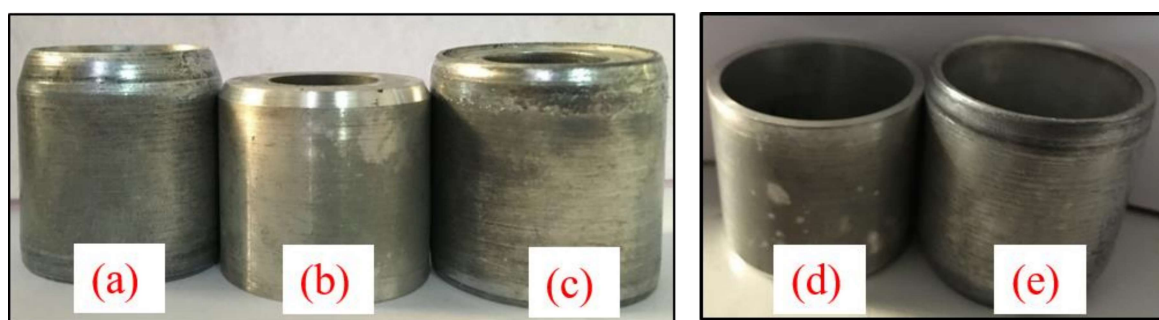
Figure 4.20: Flow formed 7F01 samples (a) 7F01 (without lubrication) (b) undeformed (c) 7F01-2 without lubrication (d) 7F01-3L (with lubrication.), (e) 7F01-4L(with lubrication)

Figure 4.20 shows the flow formed samples of Al7075 7F01 that were deformed in T6 condition in presence and absence of lubrication. It is clear from the figure that under the present investigation, both the samples were hard to deform. Even with lubrication, the

maximum elongation was about 20%. This shows that there was almost negligible effect of lubrication on flow formability of small preforms with higher hardness.

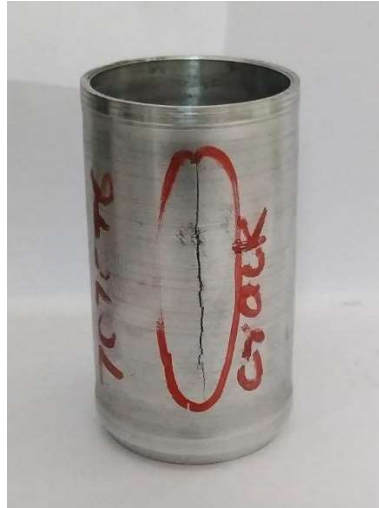
Figure 4.21: Flow formed 7F02 showing crack formation in the middle of the specimen.

It was observed that there was slipping of the tool was taking place over the surface without much deformation. Deformation was limited to the end resulting in thinning only at the end of the workpiece. On increasing rpm of the mandrel, the forces were found to increase but the deformation was not improved significantly. During the flow forming, there were two other problems that were faced. Due to increasing forces, the torque acting on the roller became so high that the tool post holding the roller assembly started missing and it turned under the action of load. Further, as the in feed was increased, the diametral growth was found to increase making the preform loose. Two changes were done to counter the problem, Whole of the tool post was removed and the lathe dynamometer holding the roller assembly was mounted directly in place of the tool post with help of bolts. This made the mounting more rigid. Secondly, the preform thickness was reduced from 2 mm to 1.5 mm. Another trial was done with a 1.5 mm preform (7F02) with T6 temper. The flow formed part is shown in Figure 4.21. The result shows that the preform underwent an increase of 60.4 % before a crack is formed.

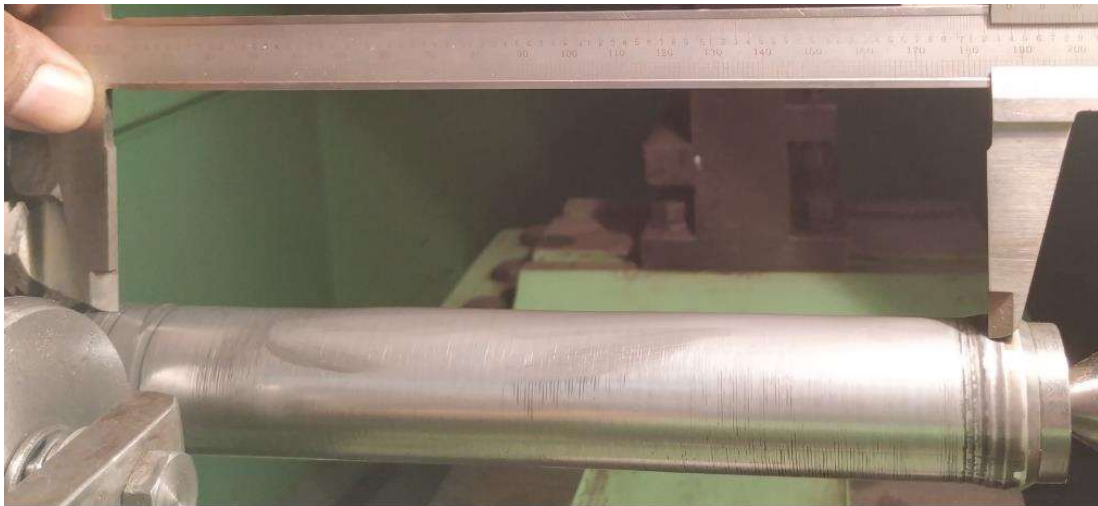
Figure 4.23 Flow formed Al7075 annealed sample 7F04

The flow forming 7F04 showed uniform elongation and didn't fail during the investigation.

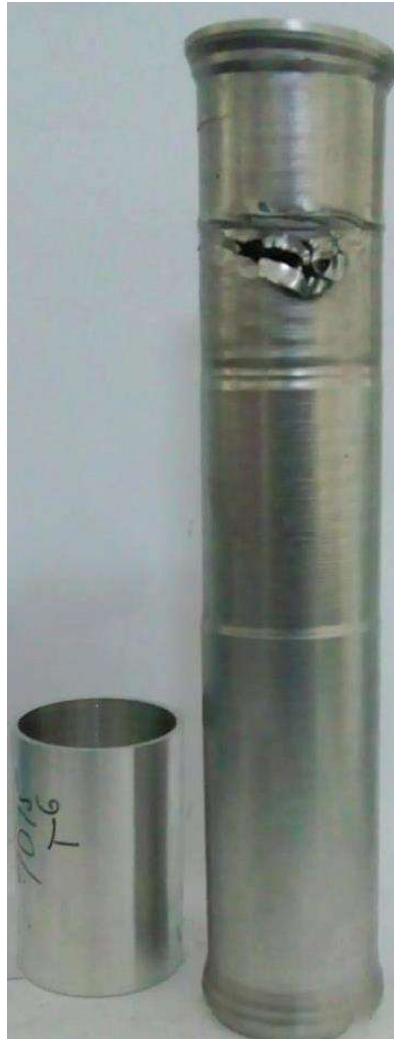
Figure 4.24: Flow formed 7F05

Figure shows the flow formed sample 7F05 which was flow formed in 4 steps.

7F05 was formed with constant feed but the start point of the roller was shifted to produce stepped product. The product failed in third step as shown in Figure 4.24. The fractograph of the fractured sample is shown in section 4.2.5.6.

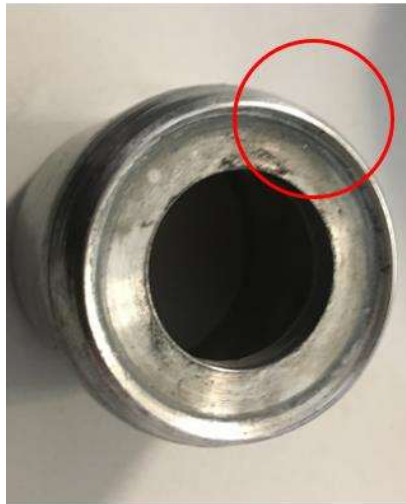
Figure 4.36: Backward flow defect leading to flange formation

The problem of flange formation was common while working Al2014 T6 and Al7075 T6 samples. The average flange length in Al7075 T6 was found to be around 2 mm. The flange length was found to increase when in-feed was increased. The problem was found to be more when chamfer was either not present or both chamfer length and chamfer angle was too small. In the present investigation, a chamfer angle of 30 degree and chamfer length of 5mm greatly reduced the problem in Al6101 T6 samples and in annealed samples of A7075 and Al2014.

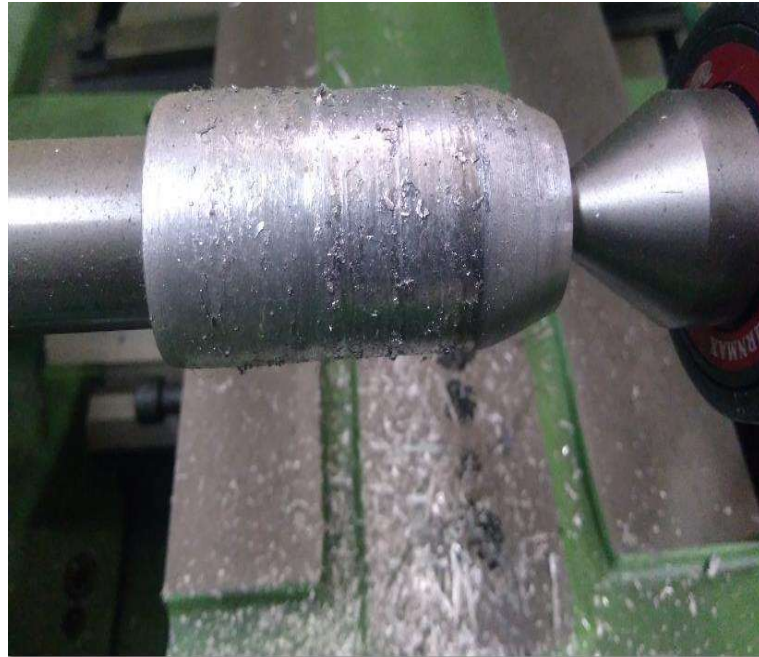
Figure 4.37: Defect: Chip formation during flow formation.

Chip formation is one problem that was encountered when the roller is not free to rotate about its axial movement. Small chips has been found in sample trials done on Al6063 preform and also in flow forming of Al7075in as received condition. ( Figure 4.37)

The problem of chip formation has been found to be more when the thickness of preform increases, resulting in higher force. The problem has been found in 7F01 samples when mandrel speed was 420 rpm or more and in feed was higher. However, this problem has not been observed after roller assembly was modified and bearings were introduced.

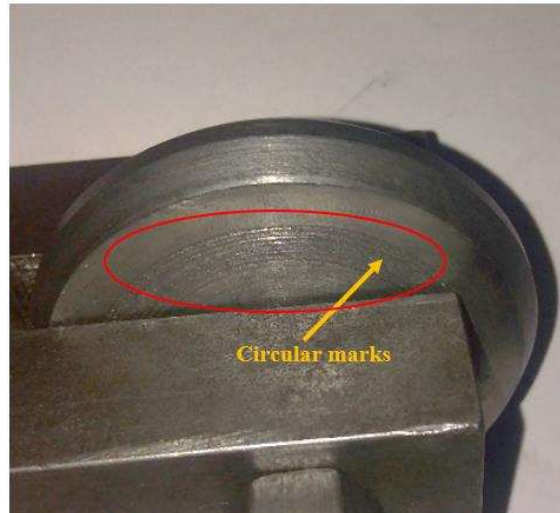
Figure 4.38: Defect: Circular marks in Roller

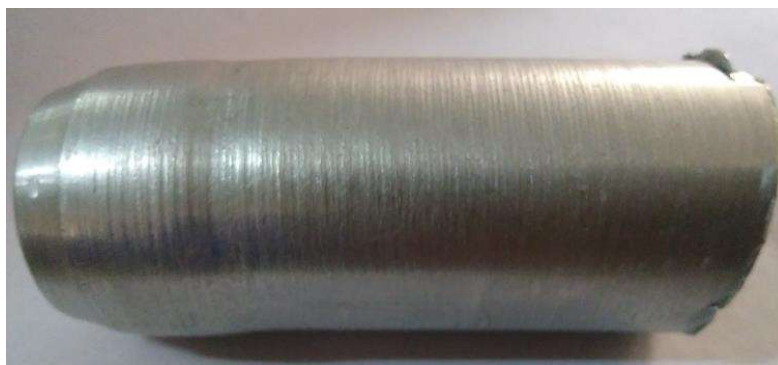
Figure 4.39: Bending of Job Flow formed Aluminium 6061(as received) with Roller attack angle of  $30^\circ$ . Rotation speed of 420 RPM.

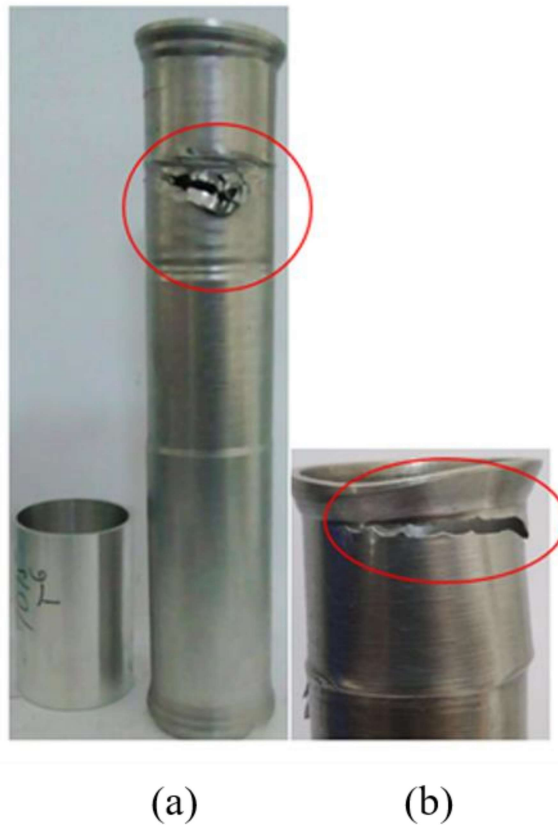
Figure 4.43: Flow formed 7F05 (a) preform and flow formed product (b) crack near the end and ovality at end section.

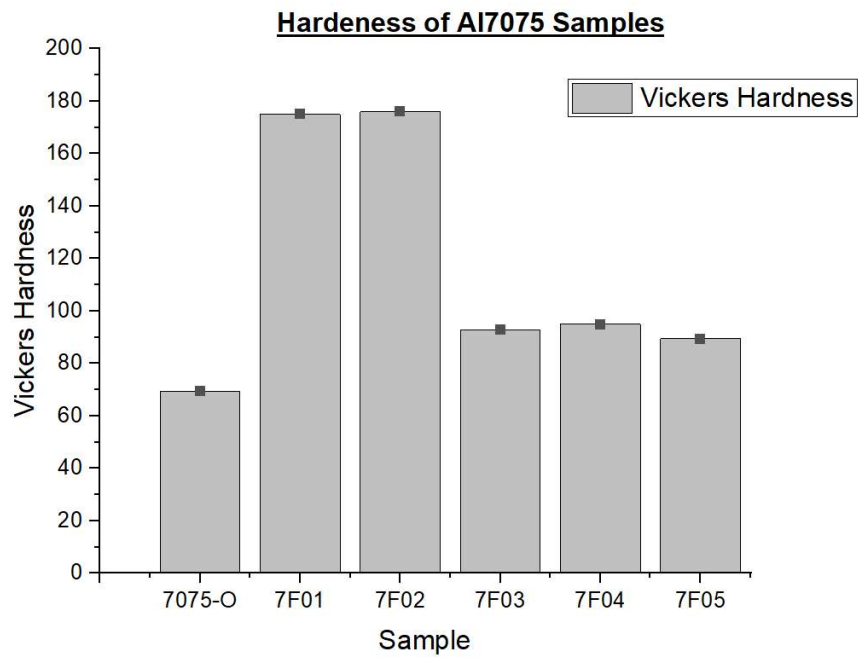
Figure 4.45: Hardness of undeformed and flow formed samples

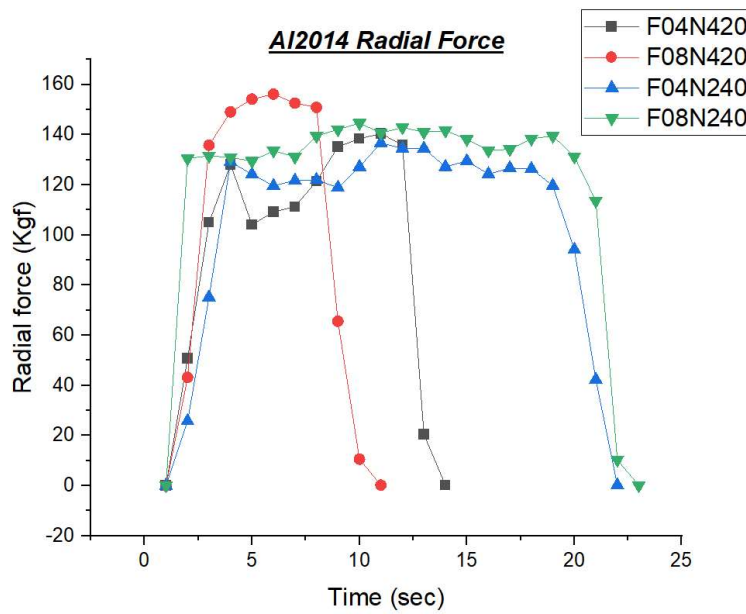
Figure 4.48: Radial Force variation in Al2014 flow formed sample.

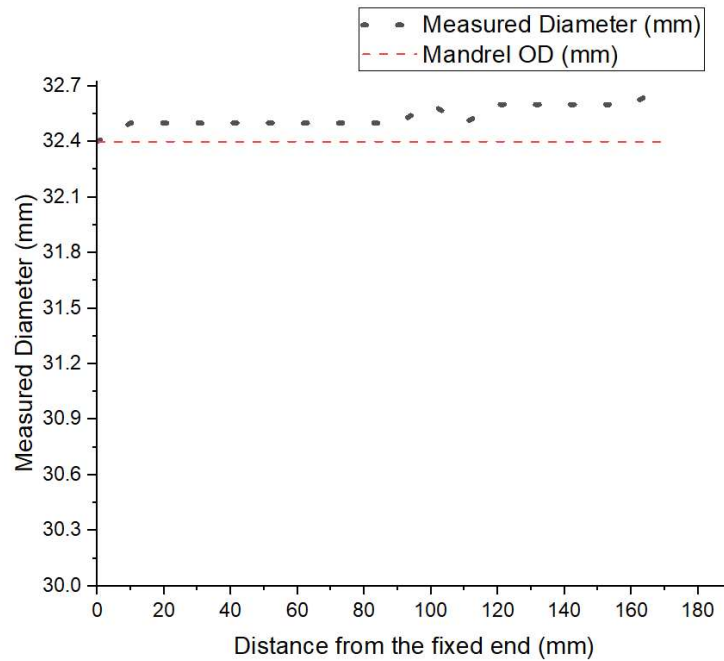
Figure 4.50: Diametral growth along the fixed end of the workpiece

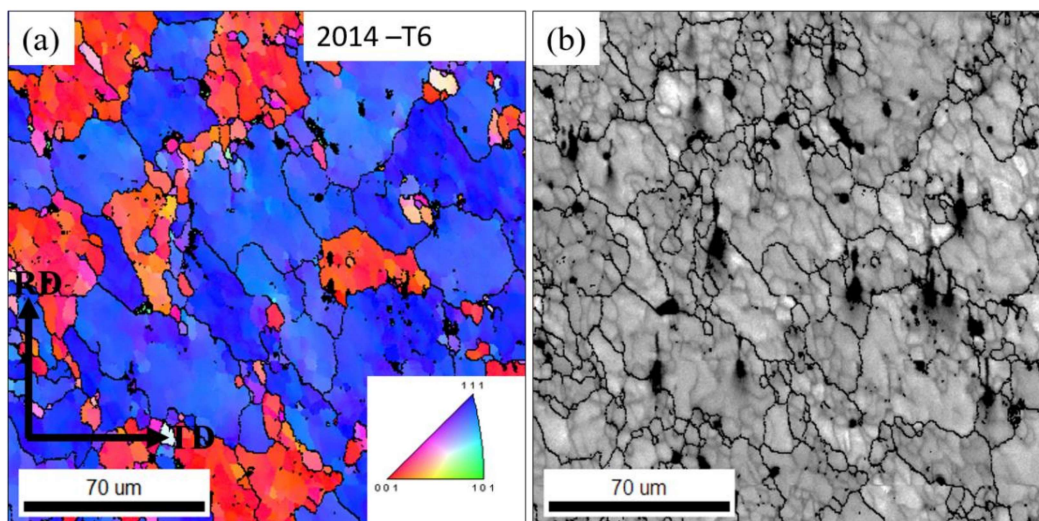
Figure 4.56: EBSD result: inverse pole figure for flow formed 2014-T6 sample (a) Inverse pole figure map (b) Image quality map (c) (001) inverse pole figure

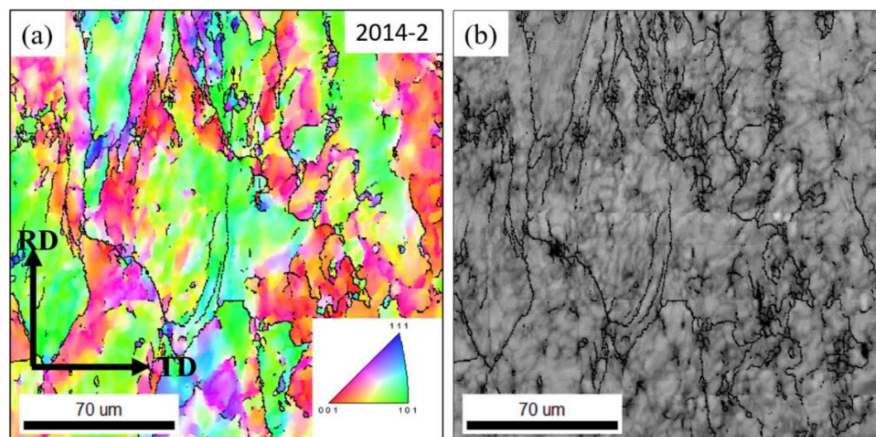
Figure 4.58: EBSD result of flow formed 2014-2 sample (a) Inverse pole figure map (b) Image quality map (c) (001) inverse pole figure

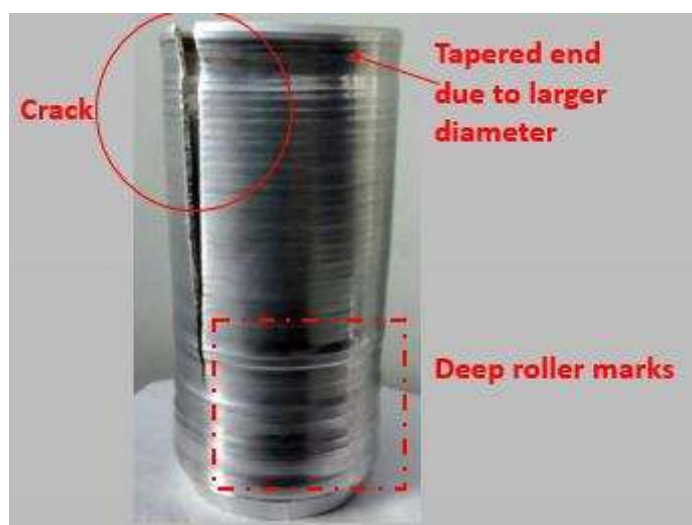
Figure 4.60: Defects in flow formed Al2014 product.
