Chapter 4

**Studies on Cu/ZrSiO₄ surface
composite fabricated by
friction stir processing**

Studies on Cu/ZrSiO_4 surface composite fabricated by friction stir processing

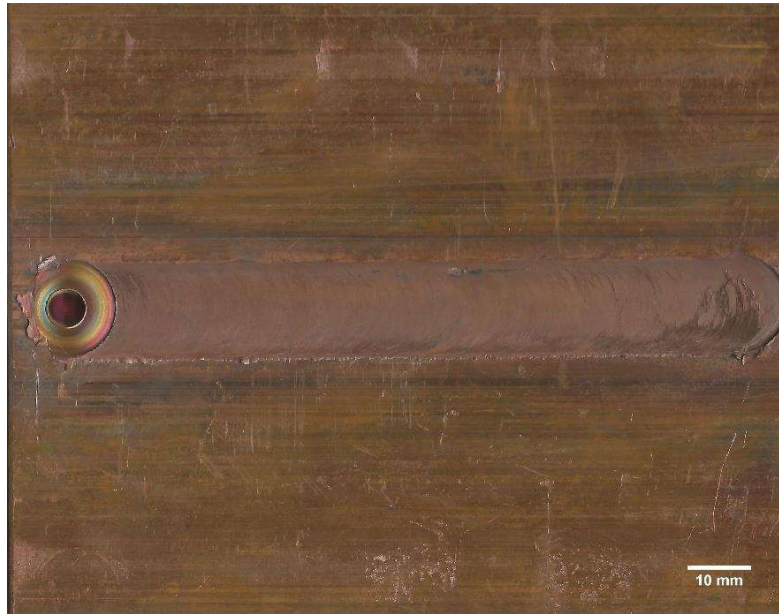
Figure 4. 1 Surface appearance of FSPed Cu/ZrSiO₄ surface composite

Various half-circled patterns which are characteristics of the FSPed plate having no depressions or discontinuities can be observed on the surface. Before conducting the final run at the aforementioned processing parameters, numerous trial runs were conducted to choose the optimized processing parameters for the production of the surface composite. The half-circled textures having no defects on the surface clearly validate the effectiveness of the chosen process parameters. The clean surface appearance with sound half-circled textures is necessary to produce defect-free composites by FSP. If there are any surface defects in the half-circled patterns, it will follow corresponding defects in the stir zone of the fabricated composite.

The macroscopic top view of the fabricated Cu/ZrSiO₄ surface composite is shown in Fig. 4.1, developed using the processing parameters rotational speed and a welding speed of value 1000 RPM and 40 mm/min.

behaviour of the circle-form, softened band layer per rotation of tool shoulder led to the formation of the surface ring like textures. Fig. 4.2 describes the cross-sectional macrostructure of SZ of the fabricated Cu/ZrSiO₄ surface composite.

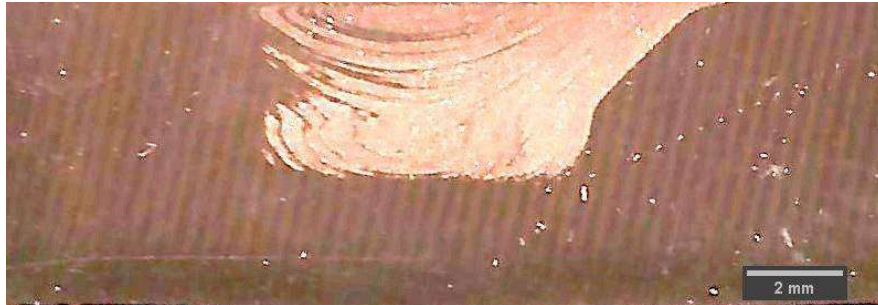
Figure 4. 2 Cross-sectional macrostructure of FSPed Cu/ZrSiO₄ surface composite

The grooves machined initially at the time of particle filling on the plate are not visible. Also, there are no macrostructure defects like tunnels and worm holes, evident from the SZ of FSPed composite, which clearly indicates the proper selection of process parameters in the present research work. This is due to the proper flow of sufficiently plasticized copper from advancing side of the tool to retreating side of the tool. The frictional heat generation between the specimen and rotating tool, can fully plasticize copper and propel them to flow violently, which transports the plasticized copper from advancing side to retreating side, causes the grooves to collapse and mixes the packed zircon sand particles with the plasticized copper and finally leading to the formation of the defect-free SZ, namely the Cu/ZrSiO₄ surface composite. It can be observed that the SZ resembles the basin like shape. In other words, the width of the SZ has reduced from the top surface to the bottom surface. The change in the width of the SZ from the top surface to the bottom surface may be attributed to the material flow during FSP.

shoulder up to certain depth while it is affected by tool pin below a certain depth. Hence, generally, in the case of, FSP of materials it is observed that the width of SZ reduces from the top surface to bottom surface. Besides these, it can be also observed that the SZ is asymmetrical about the rotational axis which is in agreement with the fact that generally in case of single pass FSP/FSW material tends to flow asymmetrically leads to asymmetry in the macrostructure of the SZ (Liu et al., 2014). This asymmetry of the macrostructure of SZ can be nullified by changing the rotational direction of the tool between consecutive passes of FSP as reported by various researchers (Dinakaran et al., 2017a). Various studies have been reported in which single passes of FSP resulted into symmetric macrostructure of SZ (Dinakaran et al., 2017c, Saravanakumar et al., 2017, Mahmoud et al., 2008).

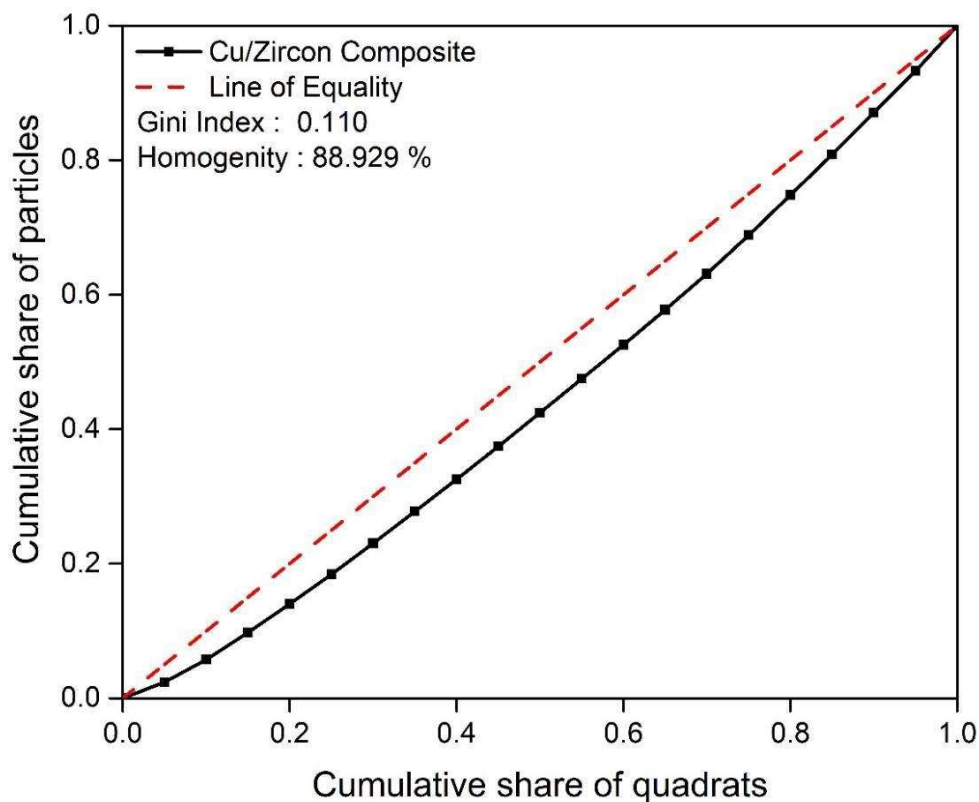
Figure 4.9 Homogeneity curve for zircon particles

From Fig. 4.9, it is clear that the homogeneity curve for zircon particles is very close to the Line of Equality. The calculated Gini Index and homogeneity value for the present case were found to be 0.110 and 88.92% respectively. Which means zircon particles were dispersed almost uniformly in the copper matrix and were almost equidistant from each other.

Where H is homogeneity and G is Gini Index (Rossi et al., 2014, Ding and Guo, 2001). The Gini Index was chosen for the calculations since it was conceived as a measurement of the distribution inequality of a given attribute. Since the value of the 'G' is related to the area below the Lorenz curve (A_L) by $G = 1 - 2A_L$, the homogeneity value is thus determined by $H = 2A_L$. The quantification of particle distribution was evaluated through Lorenz Curve is shown in Fig. 4.9.

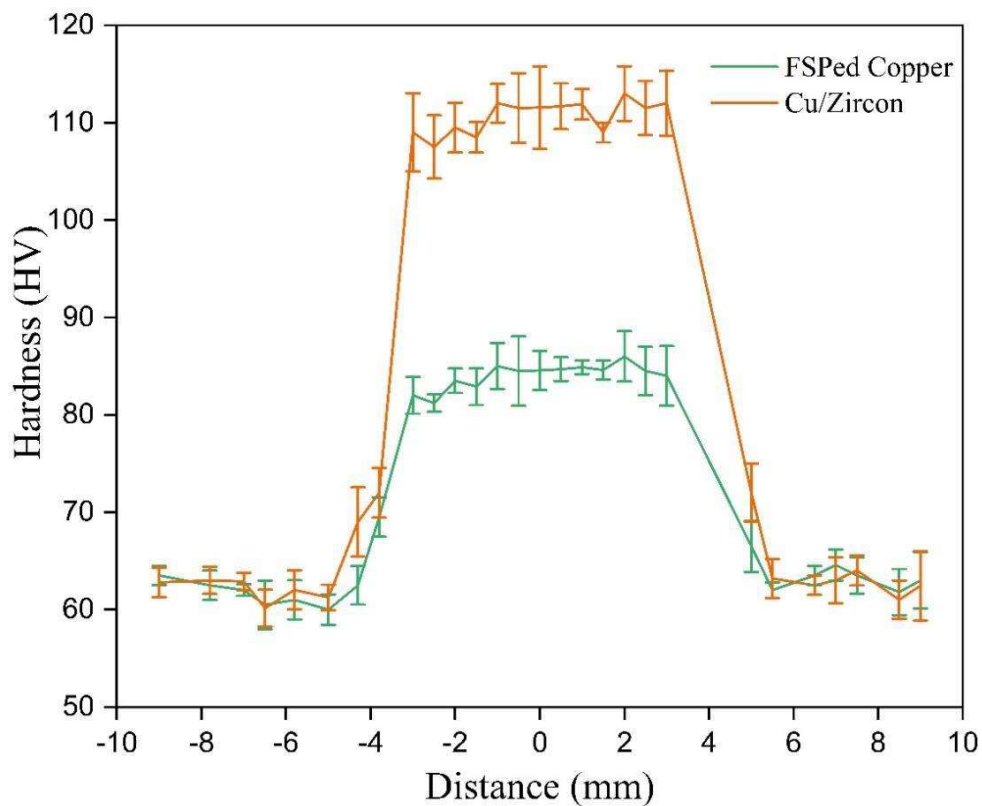
Figure 4. 11 Microhardness profile of FSPed copper with and without reinforcement

The profile of microhardness clearly shows that the hardness of the SZ improved significantly. The average hardness value of as received commercially pure copper

and fabricated Cu/zircon surface composite was estimated to be 67 HV and 110 HV respectively. The microhardness value of the FSPed copper without reinforcement has improved slightly in comparison of base copper. Dynamic recrystallization due to stirring action of pin led to decrease in grain size. Dynamic recrystallization also enhanced the generation of new dislocations due to plastic flow (Surekha and Elsbotes, 2011). The combined effect of reduction in grain size, generation of new dislocations and its pile up across grain boundaries led to increase in microhardness of SZ (Bauri et al., 2015). However, the increase in microhardness in case of the composite was more as compared to FSPed copper without reinforcement. This high value of microhardness in case of Cu/zircon surface composite as compared to friction stir processed copper was attributed to the pinning effect in the presence of zircon particulates, thermal mismatch and different deformation behaviour of copper and zircon particulates which generated additional dislocations (Lin et al., 2012). Zircon particulates were separated well in the copper matrix. Thus the pinning effect was intense which led to an increase in microhardness.

Besides these, the scattering of hardness values within the SZ of FSPed Cu/ZrSiO₄ composite was found to be minor, implying that the tool stirring efficiently dispersed the zircon particles in a reasonably uniform manner. Obviously, this is in absolute agreement with the microstructure analysis results (Fig. 4.3).

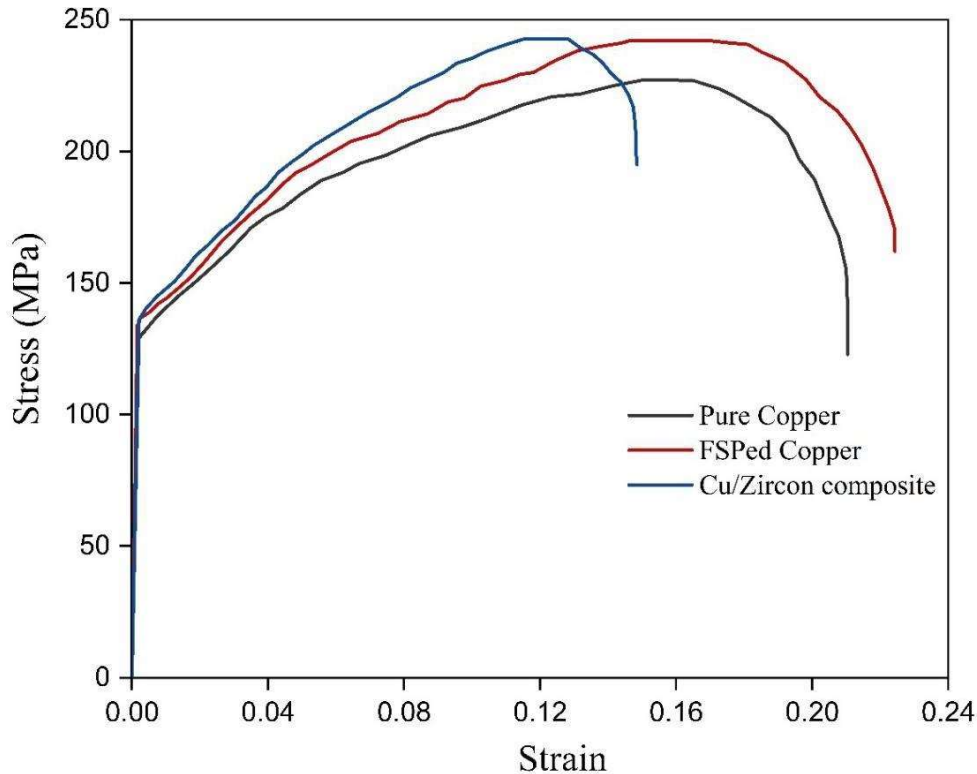
Figure 4. 12 Stress-strain curves of base copper, FSPed copper and FSPed composite

Clearly, compared with the tensile strength of the base copper, FSPed copper was slightly stronger. This can be attributed to the finer grain size in FSPed copper. Due to smaller grain size, the more grain boundaries exist in the material. Grain boundaries act as obstacles during the plastic deformation process. Further, FSPed Cu/ZrSiO₄ composite showed considerably higher strength than the FSPed copper which had comparable grain size. The yield strength and tensile strength of the composite was estimated to be 136 ± 4.2 MPa and 242 ± 3.9 MPa respectively. Whereas, it was 134 ± 3.6 MPa and 233 ± 4.6 MPa in case of FSPed copper. The yield and ultimate tensile strength of the fabricated Cu/ZrSiO₄ composite have improved

in comparison of FSPed copper. This clearly shows that apart from grain refinement zircon particle reinforcement also contributed in strength improvement. The improvement in strength of FSPed Cu/ZrSiO₄ composite is believed to be because of the following strengthening mechanism: As mentioned earlier, the FSP of Cu/ZrSiO₄ composite led to drastic grain refinement which improves the tensile strength of the composite according to famous Hall-Petch relation (Grain refinement mechanism). Secondly, the reinforced zircon particles distribution was uniform throughout the stir zone and also some of them were changed in nano-sized which acts as an obstacle for dislocation movement due to pinning effect and hence further increased the stress to overcome subsequent dislocation movement (Orowan strengthening). Thirdly, the SEM micrograph (Fig. 4.6 c) reveals that at the interface of Cu/Zircon there is no interruption i. e. no micro pores are formed and also, no other phases except copper and zircon were detected (Fig. 4.10). This means the bonding between copper and zircon particle were excellent which allow tensile load applied to be efficiently transferred from the matrix to strong zircon particles by interfacial shear strength and hence improving strength (Shear lag mechanism). Lastly, the large difference in expansion of thermal coefficients between copper and zircon sand leads to the generation of additional dislocations which further hindered the movement of dislocations and results into improved strength (thermal expansion dislocation strengthening).

The percentage elongation of the FSPed copper has improved as compared to base copper can be observed from Fig. 4.12. The improvement in ductility of FSPed copper without reinforcement with respect to base copper may be attributed to the formation of fine equiaxed grains with low dislocation density in FSPed copper, thereby leading to the improvement of work-hardening capability

(Barmouz et al., 2011a). Also, the circuitous path to the crack propagation due to the presence of a large number of grain boundaries in FSPed copper may also contribute to enhanced plastic flow and ductility. However, the percentage elongation in case of FSPed Cu/ZrSiO₄ composite has decreased with respect to base copper. The reduction in ductility of the fabricated composite is attributed to higher hardness and strength due to the presence of hard zircon particle. The reinforced zircon particles resist the passage of dislocations by either creating stress field in the matrix or by inducing large differences in the elastic behaviour between the matrix and particulate (Barmouz et al., 2011b) and resulted in ductility reduction.

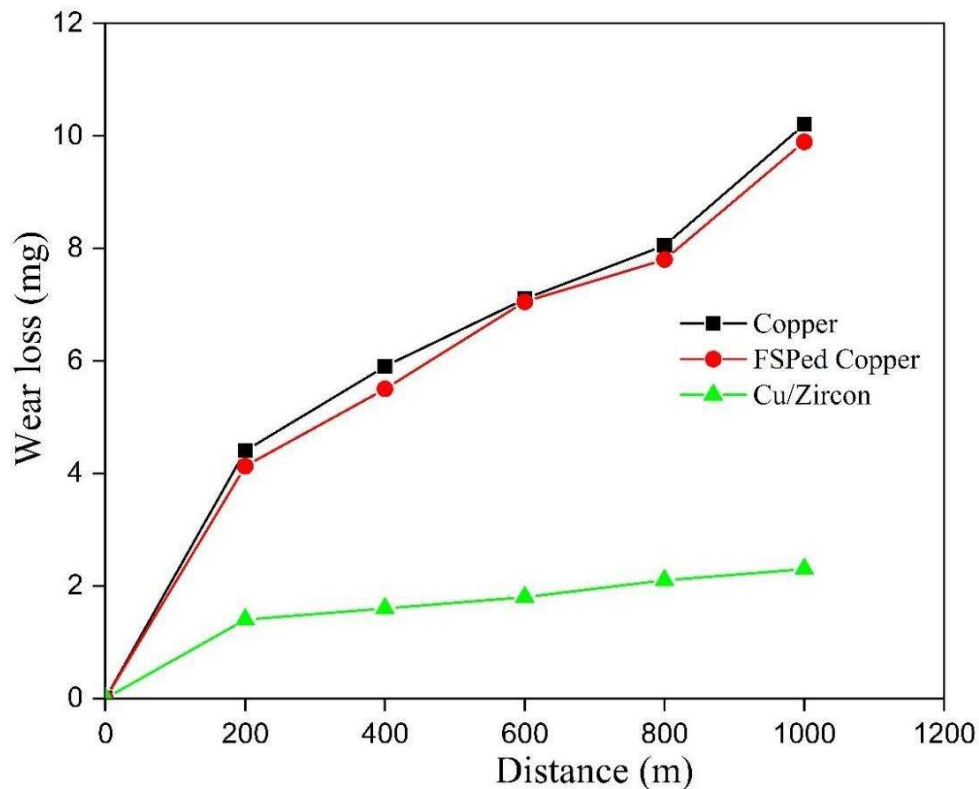
Figure 4. 14 Wear loss v/s distance profile of base copper and FSPed copper with and without reinforcement

It was observed that the wear loss was more in case of pure copper as compared to Cu/zircon composite. It can also be observed that wear resistance of FSPed copper was almost same as that of base copper which is supposed to be due to higher hardness of the processed copper. The observed wear rate of pure copper and Cu/zircon composite were 1.02×10^{-5} g/m and 0.23×10^{-5} g/m respectively. The increase in wear loss exhibited almost a linear relationship with time in case of Cu/zircon composite. Fig. 4.15 shows the variation of friction coefficient of as received commercially pure copper, processed copper and Cu/zircon fabricated surface composite with time.

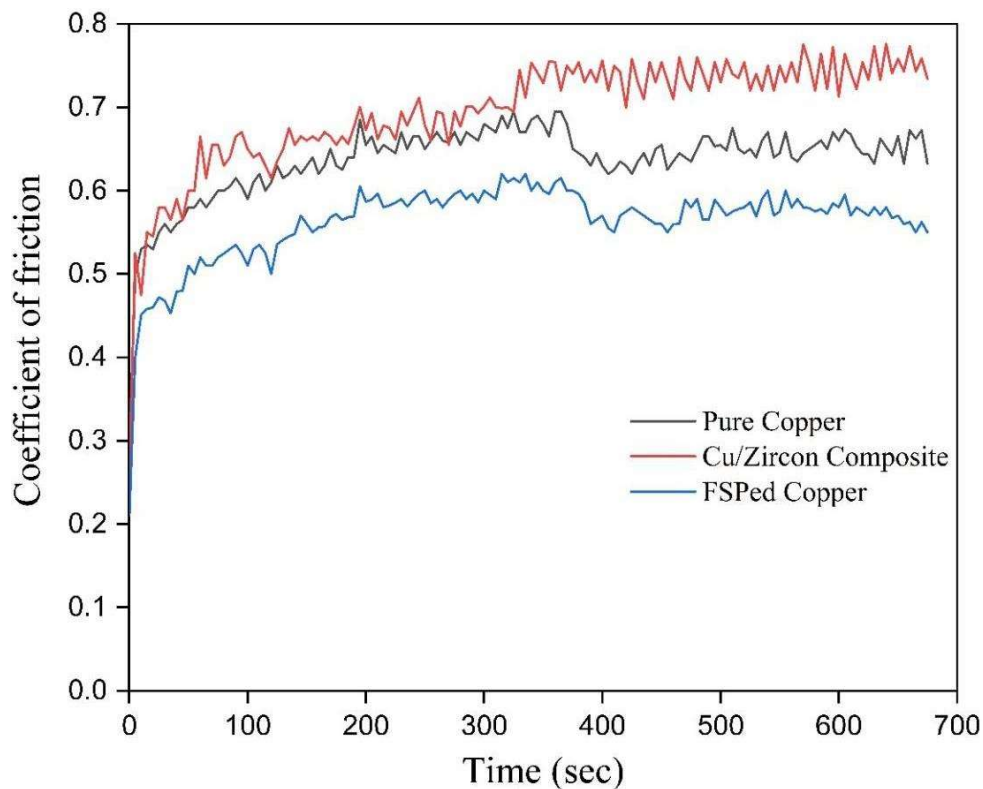
Figure 4. 15 Friction coefficient variation with time

Friction coefficient of Cu/zircon composite was observed to be higher as compared to pure copper whereas, the friction coefficient of FSPed copper is in between these two. It was also observed that the fluctuation in friction coefficient

was almost the same in the case of pure copper and fabricated composite. In the case of pure copper, it initially increased and then decreased as time progressed as can be observed from Fig. 4.15. However, in the case of Cu/zircon surface composite, friction coefficient increased first and then attained a constant value after some time. Friction coefficient of Cu/Zircon surface composite was slightly more as compared to pure copper. Incorporation of Zircon particles in copper led to an increase in abrasion resistance as the superficial hardness of composite was more as compared to pure copper. Thus resistance to sliding increased with the incorporation of Zircon particles which increased friction coefficient. In the case of pure copper, a thin tribo layer was formed on the surface of the composite and counter body due to smearing of wear debris (Barmouz et al., 2011b). But in the case of Cu/Zircon surface composite, tribo layer formation was prevented due to Zircon particles and any layer formed was abraded by Zircon particles. Thus pure copper showed less fluctuation in friction coefficient as compared to Cu/ Zircon composite. Fig. 4.15 (a) shows the SEM image of the worn surface of pure copper. Grooves resulting from ploughing effect was observed in Fig. 4.15 (a). Delamination was also observed in Fig. 4.15 (a). The surface morphology of Cu/Zircon composite was different from pure copper due to decrease in adhesion in Cu/Zircon composite. Adhesion caused delamination pits in pure copper. This led to severe material removal from the surface of pure copper. However, in the case of Cu/Zircon composite, the presence of hard Zircon particles debilitated the effect of adhesion (Zhang et al., 2006). Thus adhesive wear was very less in case of Cu/Zircon composites as was observed from Fig. 4.15 (b). The microhardness of Cu/Zircon composite was also higher as compared to pure copper which increased its resistance towards abrasive wear. It was observed in Fig. 4.15 (a) and (b) that
