4.1. General

4.2. Case A

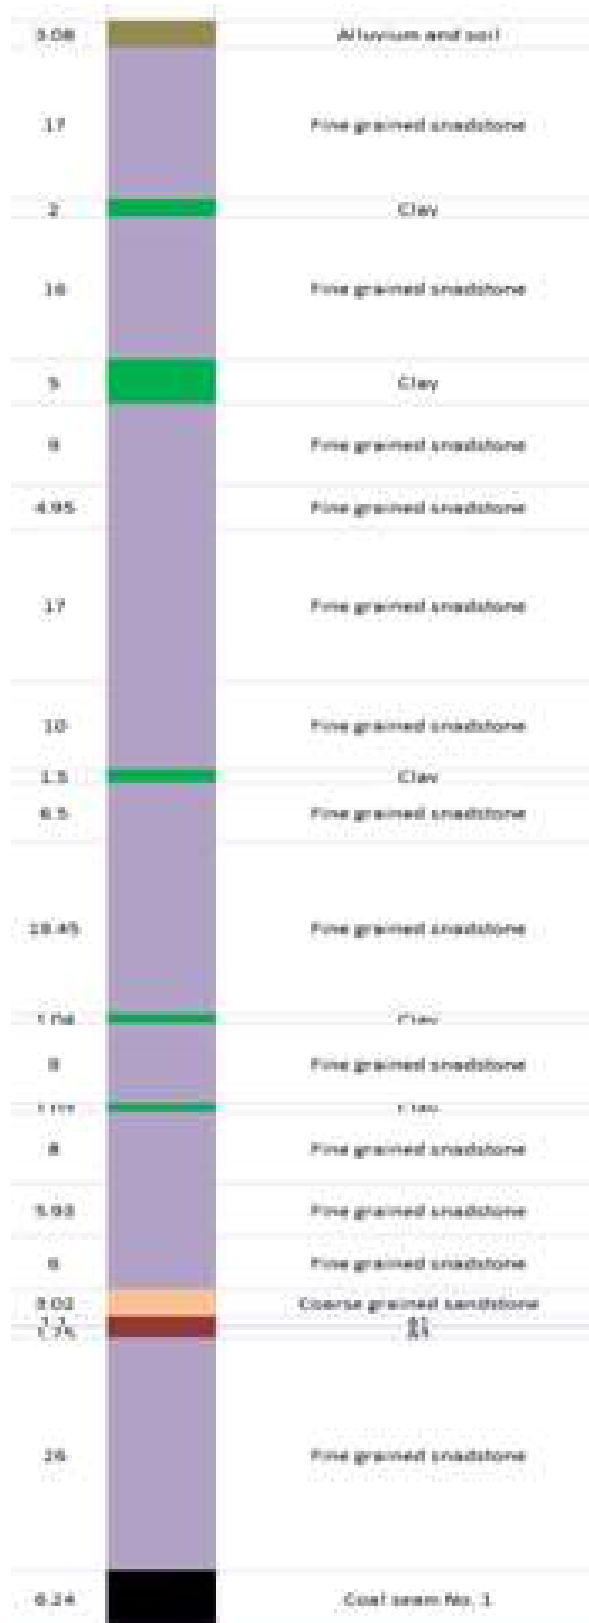
Fig. 4.1 Borehole log of the strata in 'Case A'

The bord and pillar panel of Case A belongs to a coal mine of Godavari Khani Coalfields. The mine is located in Telangana's Peddapalli district under Singareni Collieries Company Limited (SCCL). The latitude and longitude of the mine were about 18°N and 79°E, respectively. The working seam (Coal seam No. 1) is present in the panel at a depth of about 180 m - 220 m. The seam inclination is 1 in 9 towards N 60° E, and the thickness varies from 5.0 m to 6.25 m. A thick bed of fine-grained sandstone of about 26 m is present as immediate strata. Fig. 4.1 shows the borehole

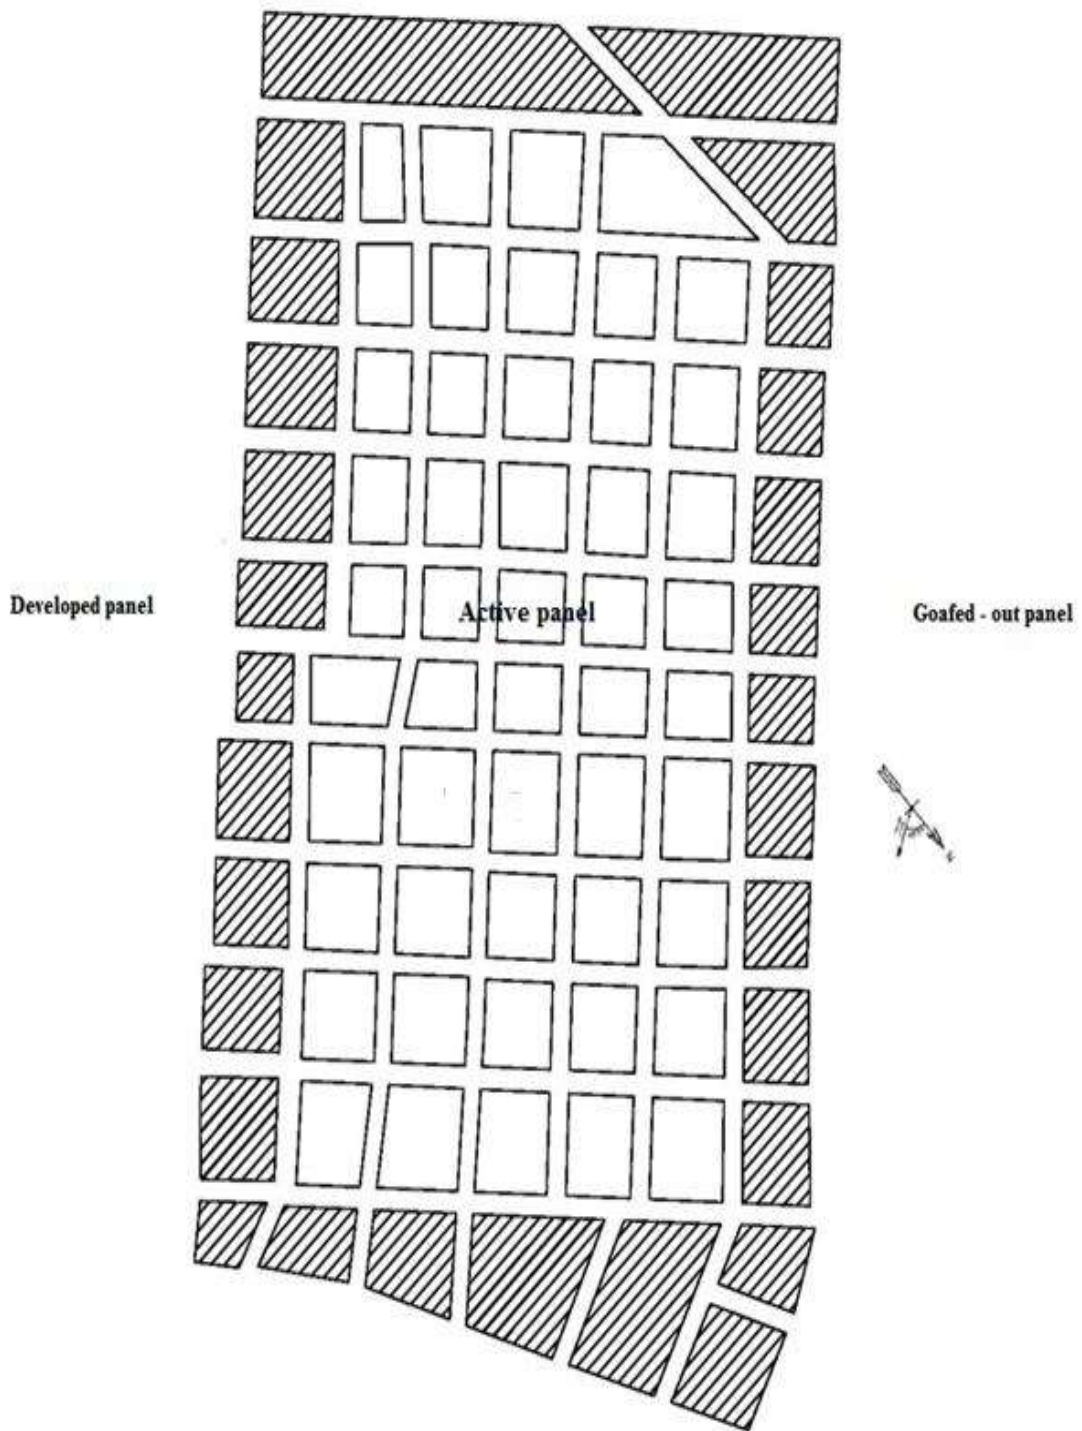
Fig. 4.2 Layout of the panel in 'Case A'

log of the strata in the considered panel. The panel has been developed in the middle section of the coal seam with six heading using conventional mining techniques (drill and blast). The average width and height of the galleries in the panel were 3.5 m and 3.0 m. The panel consists of a 5 x 10 array of pillars with an average dimension of 26 m X 26 m (center to center). The average length and width of the panel were about 310 m and 180 m, respectively. A completely extracted panel was present on one side of the considered panel, whereas a developed panel was present on the other side. Fig. 4.2 shows the typical layout of the panel.

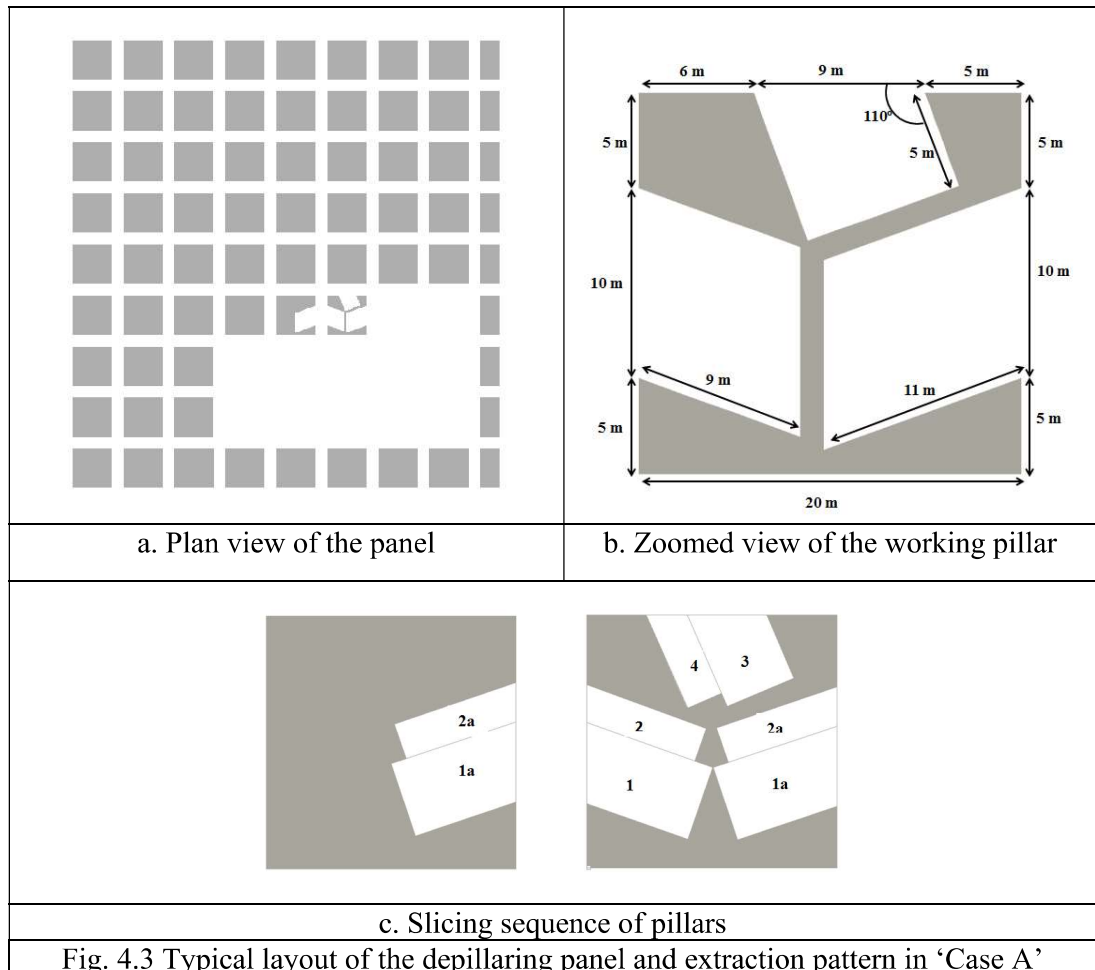
Fig. 4.3 Typical layout of the depillaring panel and extraction pattern in 'Case A'

The depillaring operation has been commenced in the panel using *CM* technology, adopting a straight line of extraction. The galleries were widened from 3.5 m to 6.0 m for easy maneuvering of the machine and heightened from 3.0 m to 4.5 m. The pillar size after widening and heightening the galleries becomes 20 m x 20 m (corner to corner). The panel adopts the fish-bone pattern of extraction during the final extraction of coal. The pillars have been sliced from three sides, leaving an in-bye rib of about 5 m before slicing. The slicing angle was about 70°. The width of the final snook was about 5.5 m. Fig. 4.3 shows the panel's typical layout and pillars under extraction.

Fig. 4.3a shows the plan view of the panel at a depillaring stage where two and a half rows of pillars were extracted. Fig. 4.3b shows a typical structure of the remnant pillars after complete slicing. The slicing operation was performed in two consecutive pillars simultaneously in this extraction pattern, and the sequence of slicing follows slice 1 - slice 2 - slice 1a - slice 2a - slice 3 - slice 4, as shown in Fig. 4.3c.

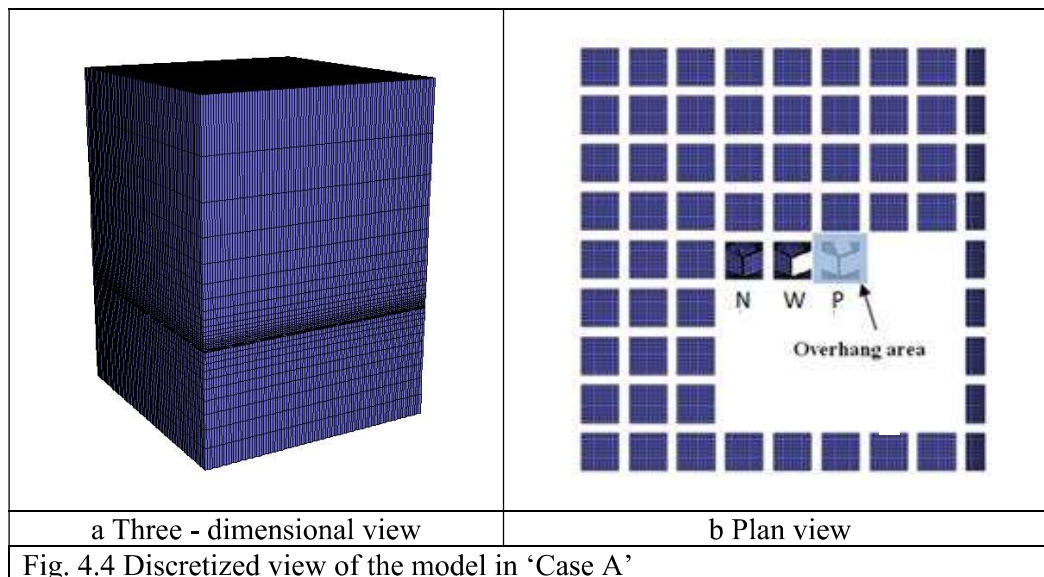
A three-dimensional numerical model of the panel having a sufficiently large size has been prepared in the study to assess the stability of the structures (pillars/remnants) during the depillaring operation. The panel has been constructed using brick elements, which comprise coal pillars, roof, and floor. Fig. 4.4 shows the discretized view of the model. Fig. 4.4a shows the three-dimensional view of the model, and Fig. 4.4b shows the plan view at the mid-level of the coal seam for a typical depillaring stage.

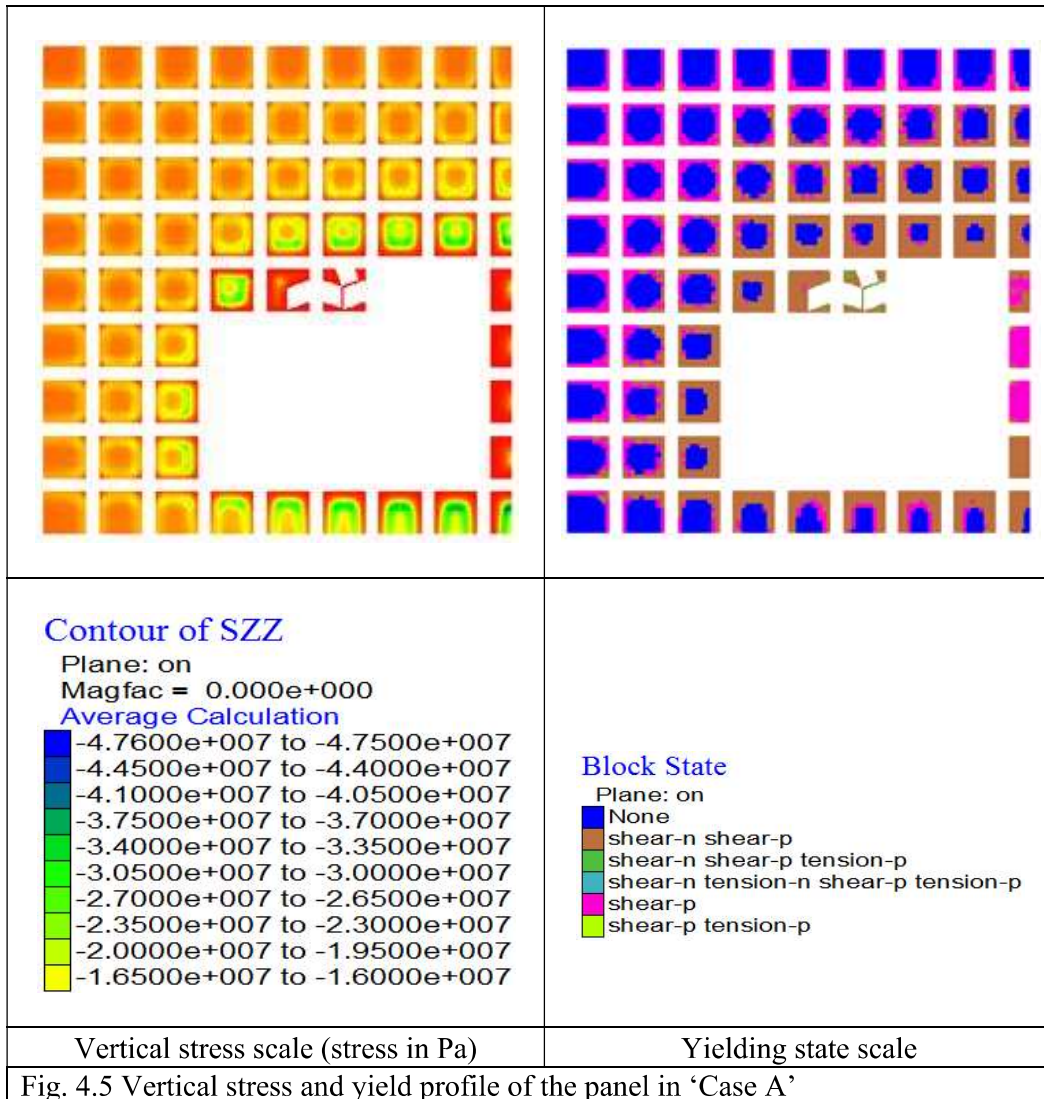
Fig. 4.5 Vertical stress and yield profile of the panel in 'Case A'

The simulation results have been obtained in terms of vertical stress and yielding profile at the mid-level of the coal seam (fig. 4.5). Here, yielding refers to the failed element (which goes into residual phase) of the pillars. An unstable mining condition has been observed during the extraction of Pillar ‘W.’ A similar mining condition has also been observed in the field. The vertical stress profile shows the influence of goaf

is up to one row of pillars, and the barrier pillars towards the goaf side yields ultimately, as seen in Fig. 4.5. After the failure of barrier pillars, the continuity overlying strata gets disturbed, leading to a reduction in the strata stiffness. It is worth noting that the range of influence zone (R) is higher for the stiffer strata and vice versa. Thus, after the failure of the barrier pillars, a considerable load has been distributed to the pillars near the goaf edge. The pillars nearby goaf show high vertical stress of about 12.5 MPa and yield about 6 m from the sides. The pillars away from the goaf show a symmetrical stress distribution and yield about 2 m from the sides. The far end pillars show the average vertical stress of about 8 MPa, equivalent to the tributary area load. The previously extracted pillar ('P'), the working pillar ('W'), and the next pillar ('N') have been critically analyzed using the simulation results. The average vertical stress on the focused pillars (Pillar 'P,' 'W,' and 'N') has been calculated at different stages of depillaring using program codes of *FLAC^{3D}*. The pillar 'P' and 'W' were completely yielded at the concerned depillaring stage and show the residual strength of about 0.50 MPa and 1.65 MPa, respectively. The pillar 'N' yields about 75% and shows average vertical stress of about 11.26 MPa. The numerical simulation techniques as discussed in section 3.4 has been adopted for determination of the pillar strength. The strength of the pillar, in this case, has been obtained as 12.5 MPa. The *FOS* of the next pillar 'N' at the concerned depillaring stage has been calculated as 1.1, as seen in Table 4.2.

18 due to unsafe mining conditions. The model also shows similar behavior at the depillaring stage where pillar no. 19 (pillar 'W') has been extracted, as indicated through the vertical stress and yield profiles of the panel (Fig. 4.5). The *FOS* of the next intact pillar has been evaluated as 1.1, which shows further extraction of the pillar in the panel is not safe concerning the strata issues.

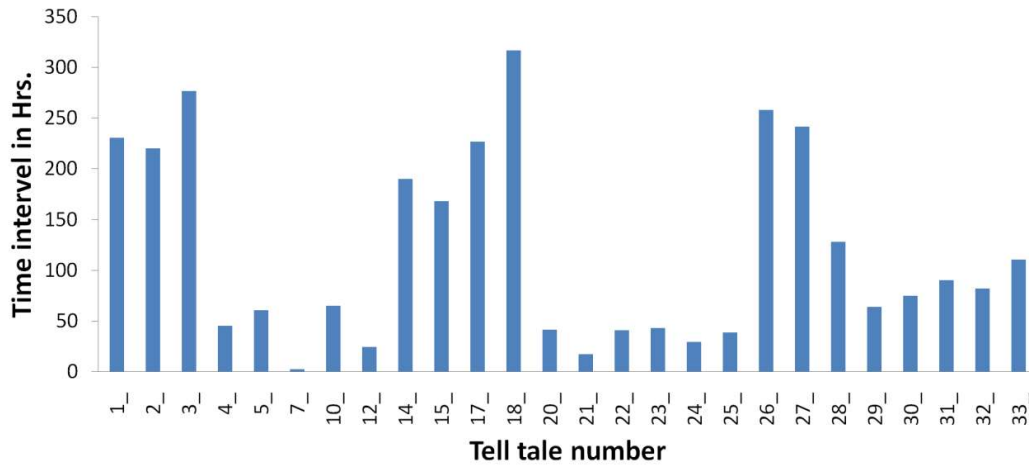
Fig. 4.6 Time interval between flashing of AWTT and roof fall in 'Case A'

It has been observed that the panel experiences adverse strata issues during the extraction of the second and third row of the pillars. Fig. 4.6 shows the interval between the *AWTT* warning and roof fall in the panel during depillaring. The average duration between *AWTT* warning and fall time has been separately calculated as 48 hrs (excluding the abnormal observation), which indicates the average stand-up time of the remnant pillars. Rotary tell-tale (*RTT*) indicates the dilation in the roof. About 73.5 % of *RTTs* have shown dilation value less than 5.0 mm, and about 16.5 % of *RTTs* have shown the roof dilation in the range of 5 mm – 10 mm. About 10 % of *RTTs* have recorded a dilation value of more than 10.0 mm. The stress cell installed at pillar no. 13 recorded the maximum 130 kPa (i.e., about 0.13 MPa) induced stress value at the time of final extraction from the pillar. It is to be noted that the induced stress recorded is very less which might be because of the already yielded pillar side.

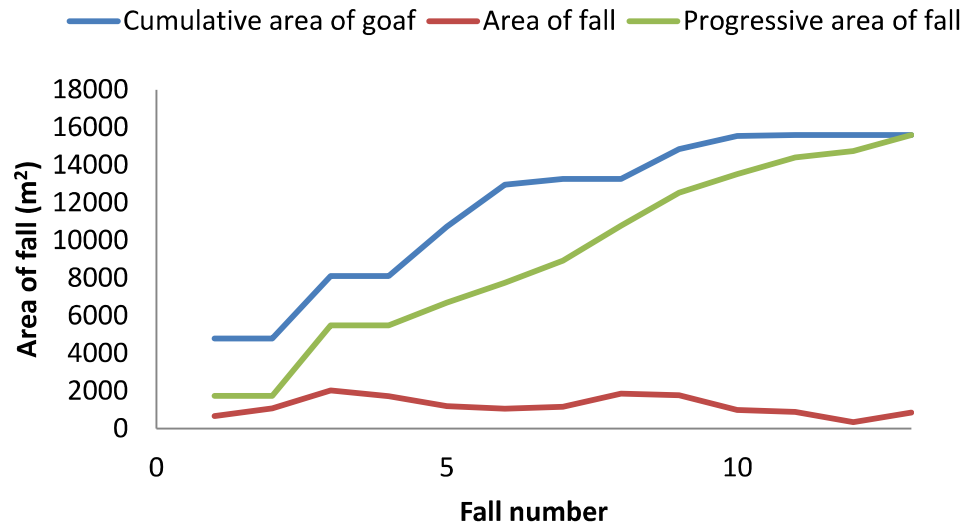
Fig. 4.7 Natural roof falls in the panel during depillaring in ‘Case A’

The observation of natural roof fall has been recorded in the study concerning the time, area of fall, and overhang area before and after the fall. The average area of natural fall has also been calculated as 1468 m². Fig. 4.7 shows the detail of falls in terms of cumulative area of goaf, progressive area of falls, and area of falls. Fig. 4.8 shows the bar chart of overhang just before and after the respective fall.

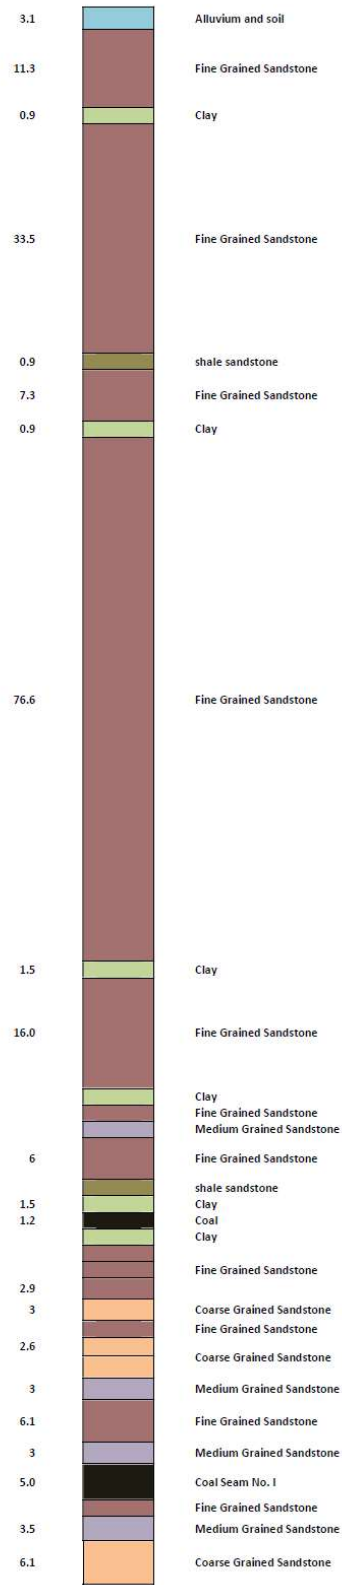
Fig. 4.9 Borehole log of the strata in 'Case B'

The panel selected in 'Case B' also belongs to the Godavari Khani coalfields, and the mine is located in Telangana's Peddapalli district under Singareni Collieries Company Limited (*SCCL*). The working coal seam (seam No. I) lies at a depth of about 190 m to 230 m within the panel. The dip of the seam is about 1 in 8.5 towards N 60° E. The average thickness of the seam is about 5.0 m. It has been observed that most of the strata consist of fine-grained sandstone. Coarse to fine-grained sandstone layers of about 3.0 thick are present up to the height of 30 m from the roof of the working seam no. I. Fine-grained sandstone layer of 16 m thick followed by 76.0 m has also been observed. The strata have been classified as moderately competent strata. Fig. 4.9 shows the borehole section present in the panel.

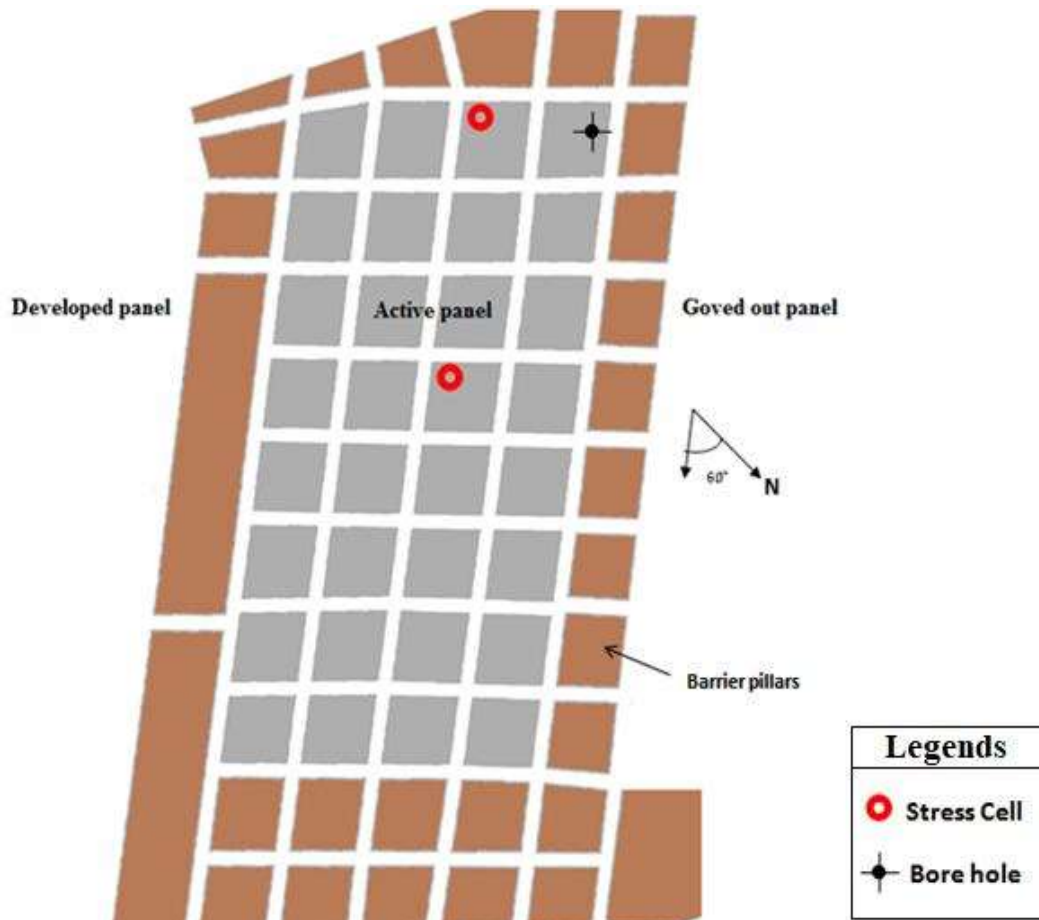
Fig. 4.10 Layout of the panel in 'Case B'

The coal seam has been developed in the panel along the middle section with five headings using conventional drilling and blasting techniques. The average width and height of the galleries in the panel were 4.8 m and 3.0 m. The average width of the pillars in the panel was 35 m (center to center). The panel consists of 4 x 8 pillars with four pillars along its width and ten pillars along its length (excluding barriers). The average width and length of the panel were about 175 m and 315 m, respectively. A goved out panel was present on one side of the considered panel, whereas a developed panel on the other side. Fig. 4.10 shows the layout of the panel.

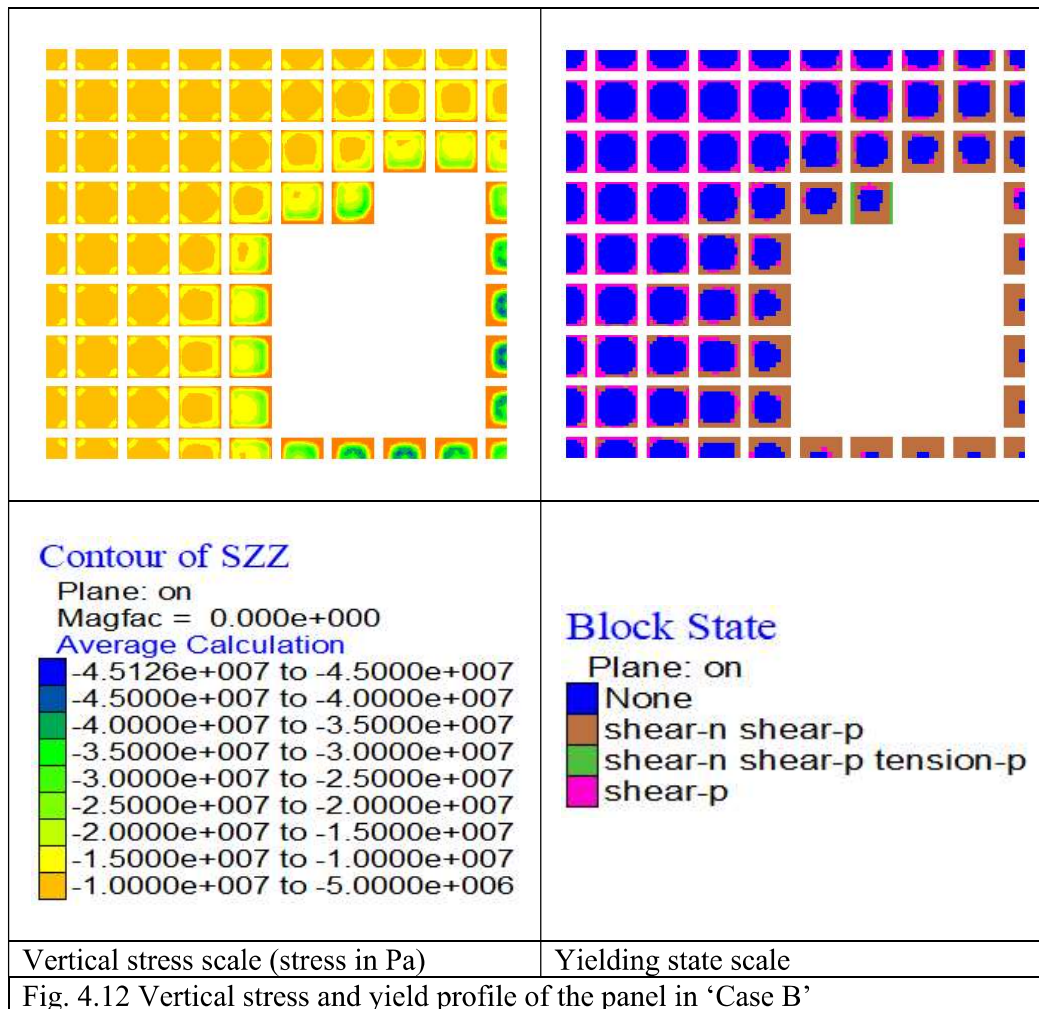
The simulation results have been obtained in terms of vertical stress and yielding profile of the panel. The status of pillars (including barriers) has been accessed at different stages of depillaring using program codes of *FLAC^{3D}*. Fig.4.12 shows the vertical stress and yielding profile of the panel at the middle level of the pillars. It has been observed from the simulation results that the pillars nearby goaf shows high stress and yield conditions at a depillaring stage before splitting/slicing of pillar no. 19. The working pillar 'W' (i.e., pillar no. 19) experienced an average vertical stress value of about 12.5 MPa, at this stage shows considerably (about 70%). The strength of the pillar has been determined separately using numerical techniques (as discussed in section 3.4) and has been obtained as 17.0 MPa. The *FOS* of the working pillar 'W' has been calculated as 1.3, as seen in Table 4.4. The working pillar 'W' seems marginally stable at this stage; thus, splitting the pillars may experience the strata issue. The immediate next pillar, 'N,' also shows considerable yielding, as seen in Fig. 4.12. The average vertical stress on the next pillar 'N' has been determined as 11.9 MPa. The barrier pillars, which are surrounded by goaf from both sides, show high yielding (about 90%). The maximum vertical stress of about 45 MPa has been observed on the barrier pillars, surrounded by the goaf from both sides (as seen by blue color in Fig. 4.12). Considerable side yielding has been observed in a couple of pillars. Therefore, the splitting of the pillars is somewhat tricky. The simulation results show difficult mining conditions at this stage (i.e., before splitting/slicing of pillar no. 19), and extraction of the working pillar (pillar no. 19) is somewhat tricky.

The field investigation reveals that the extreme loading conditions have been observed during the extraction of pillar no. 19, which can also be seen from the vertical stress and yield profile of the panel (Fig. 4.12). The depillaring operation has

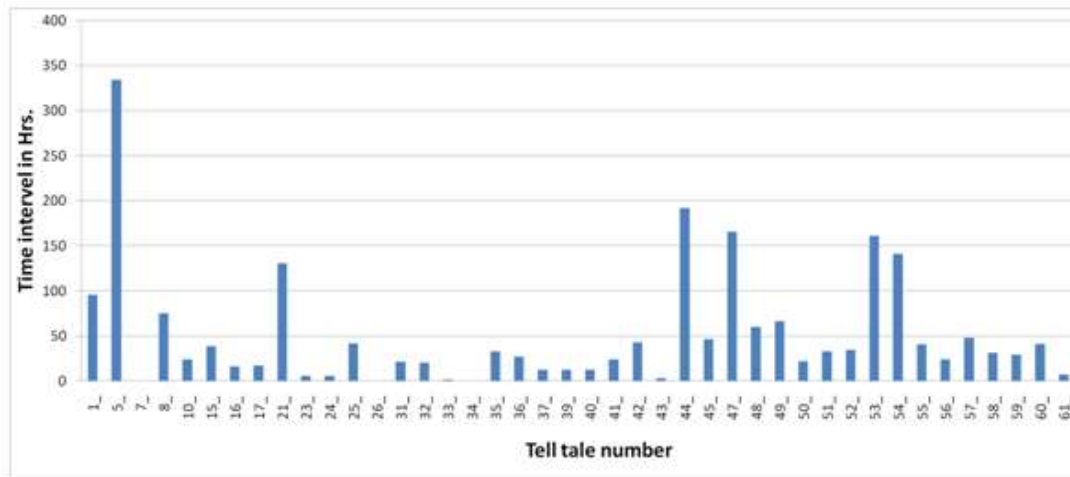
Fig. 4.13 Time interval between flashing of *AWTT* and roof fall in ‘Case B’

in the *AWTT* during the extraction of pillar no. 30 to pillar no. 32. Significant side spalling has also been observed after splitting these pillars. Therefore, these pillars have not been extracted completely. Fig. 4.13 shows the interval between the *AWTT* warning and roof fall in the panel during depillaring. It has been observed from Fig. 4.13 that the average stand-up time for the remnant pillars is about 42 hours.

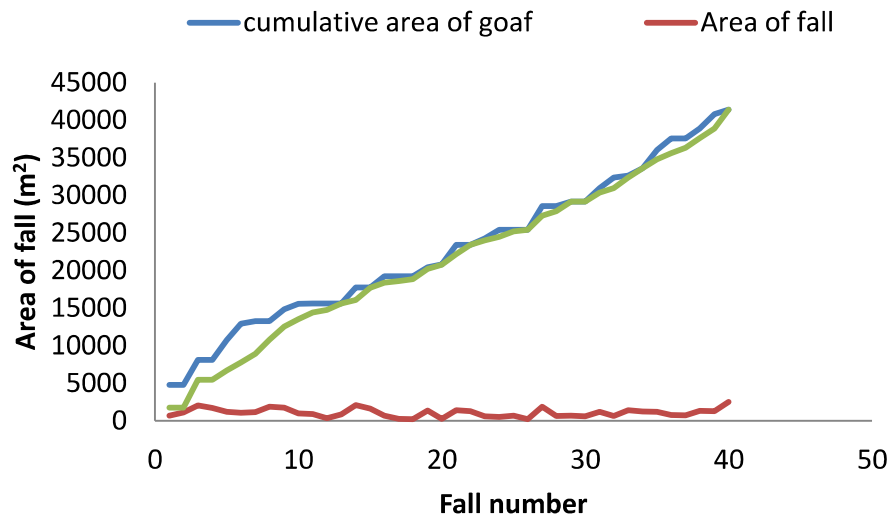
Fig. 4.14 Natural roof falls in the panel during depillaring in ‘Case B’

The main roof fall has occurred after extraction of pillar no. 18 with an area of exposure of 13008 m² and advancement length of about 108 m. The time, area of fall and overhang area before and after the fall has been recorded during depillaring. Total no. of 40 natural falls had taken place in the panel. The average area of natural fall has also been calculated as 1035 m². Fig. 4.14 shows the detail of falls in terms of cumulative area of goaf, progressive area of falls, and area of falls. Fig. 4.15 shows the bar chart of overhang just before and after the respective fall. The average area of overhang just before the fall is about 2145 m².

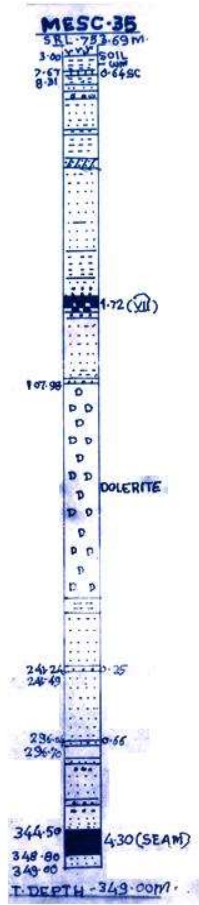
Fig. 4.16 Borehole of the strata in 'Case C'

The bord and pillar panel of Case C belongs to the coalfields of Central India. The mine is located at the Baikuntpur area in sub-division of Kobra district, Chattisgarh, under South Eastern Coalfields Limited (*SECL*), a subsidiary of Coal India Limited (*CIL*). The coal seam in the panel was present at a depth of about 320 m – 340 m. The seam thickness varies from 4.0 m to 4.8 m. An important geological feature above the coal seam has been observed in the form of a 75 m -163 m thick and strong Dolerite sill, at a depth of about 200 m. A layer of shale of substantial thickness is present below the dolerite sill. Coarse-grained sandstone of about 5.4 was present as immediate strata. These are bound to create difficulty in the caving. Fig. 4.16 shows the borehole log of the area near the considered panel. The panel was developed with six headings using drill and blast techniques. The width of the pillars in the panel was 45 m (center to center). The width and height of the galleries in the panel were 4.8 m and 3 m, respectively. The panel consists of 70 pillars, and the size of the panel was 270 m x 675 m. The panel is surrounding by the goaf from both sides. Fig. 4.17 shows the typical layout of the panel.

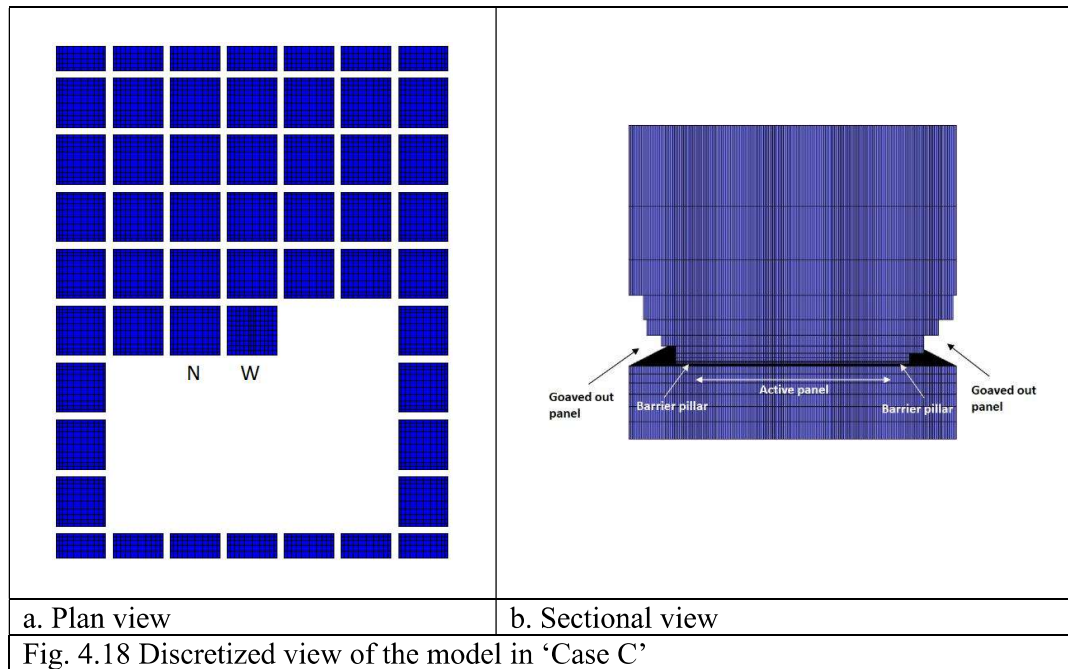
Fig. 4.18a shows the model's plan view at a depillaring stage where two and a half rows of pillars were extracted. Fig. 4.18b shows the model's sectional view at the middle of the panel, showing the extended strata incorporated in the model. The coal seam and roof have been joined with the 'attach' command of *FLAC^{3D}*.

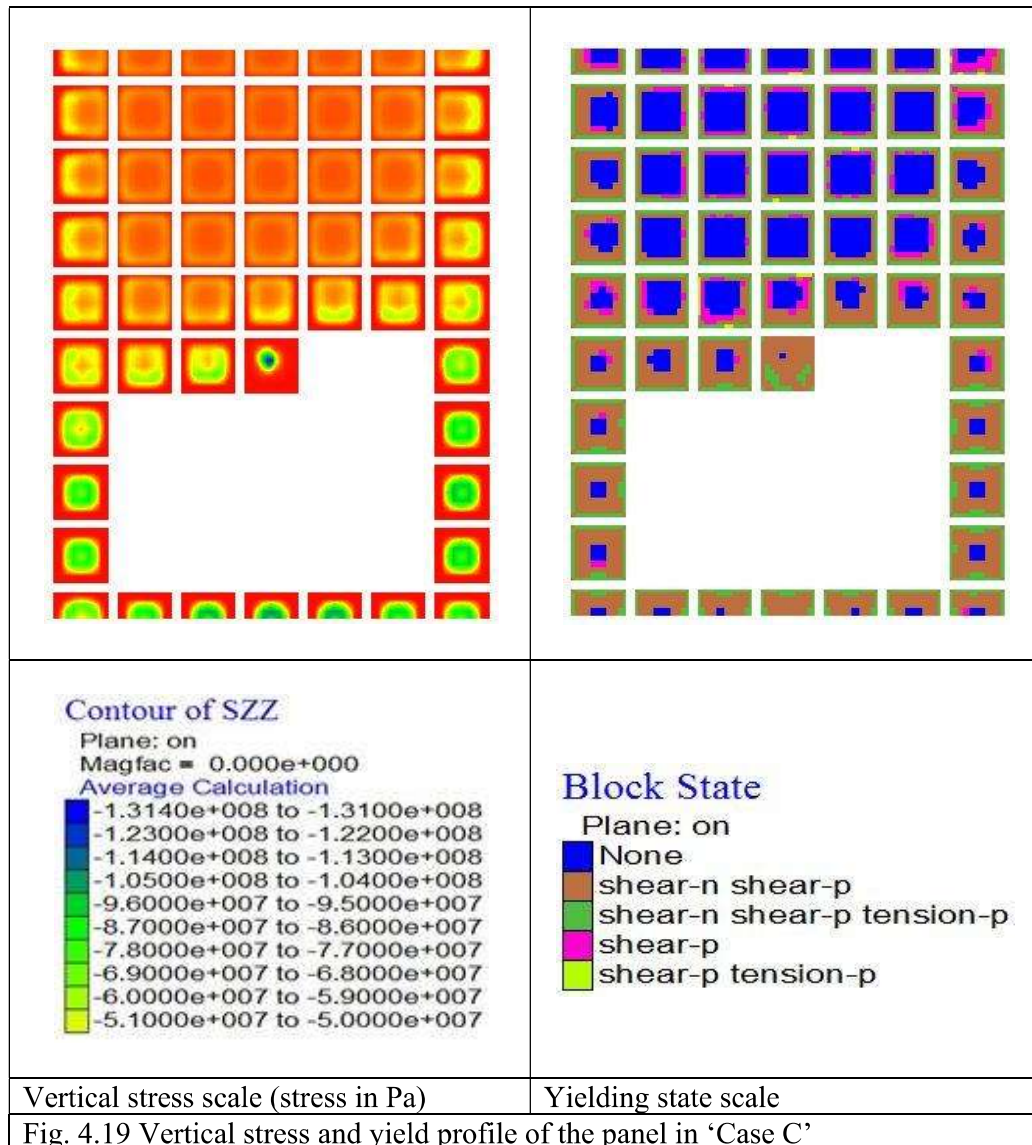
The simulation results show that a considerable load has been distributed to the pillars near the goaf edge, especially the working pillar (‘W’). The working pillar is marginally stable at this depillaring stage; thus, splitting the pillars may experience the strata issue. The average vertical stress on the next pillar ‘N’ has been observed as 22.1 MPa. The *FOS* of the next pillar ‘N’ has been calculated as 1.2, as seen in

Table 4.6. Almost all barrier pillars show high yielding, and the barrier pillars exposed to the goaf from both sides show a yield percentage of about 85%, as seen from Fig. 4.19. The maximum vertical stress on the barrier pillars has been observed as 60 MPa. The average stress value on the barrier pillars has been observed as 23.5 MPa.

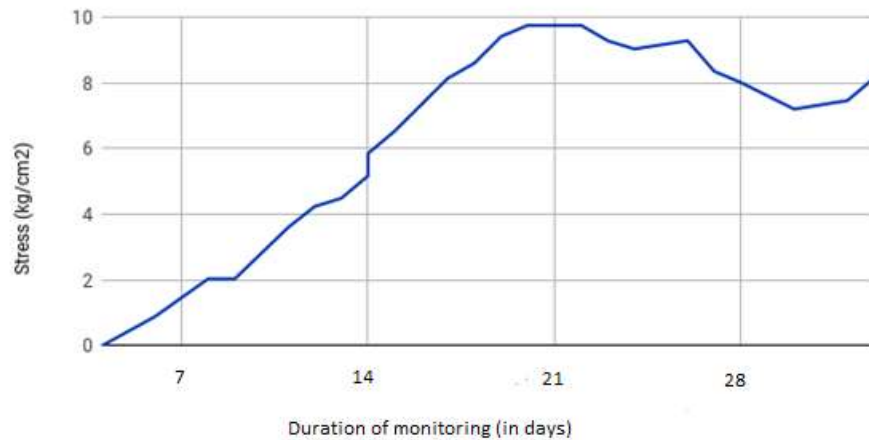
Fig. 4.20 Induced stress on a pillar no. 13 during the depillaring operation

The field investigation reveals that the strata issues emerge in the panel during extraction of pillar no. 11 (situated in the third row of pillars). Several stress cells have been installed in the panel to monitor the induced stress on the pillar during the depillaring stages. Fig 4.20 shows the induced stress on pillar no. 13 during the extraction of the first row of pillars. It has been observed from the stress cells that the induced stress value generally lies between 20 kg/cm² to 25 kg/cm². Advanced

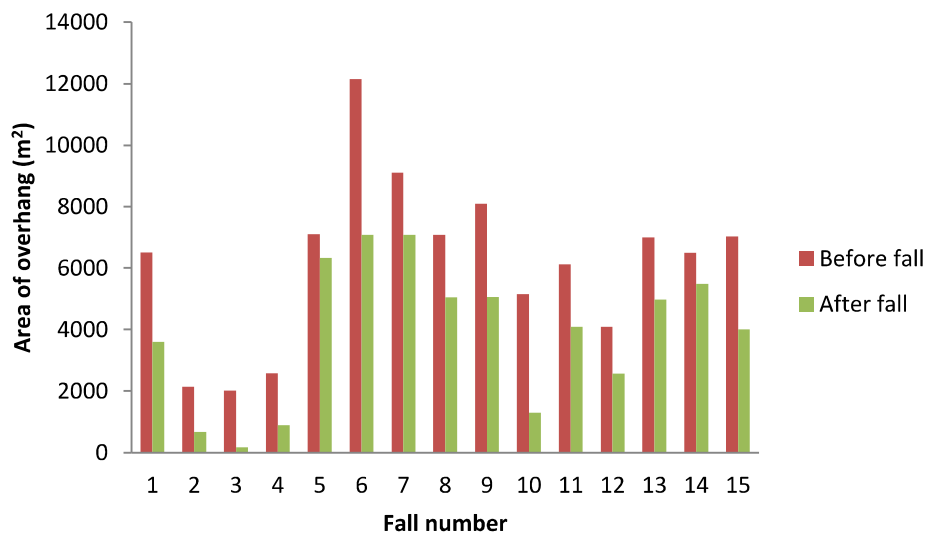
Fig. 4.21 Area of overhang before and after roof fall in 'Case C'

The natural roof falls have been recorded in the study in terms of average overhang area before and after fall. The average area of natural fall has also been calculated as 2285 m². Fig. 4.21 shows the bar chart of overhang just before and after the respective fall. The field investigation reveals that excessive side spalling has been observed during the extraction of the fourth row of pillars. About two rows of pillars (pillar no. 18 – pillar no. 30) have been left in the panel after the extraction of pillar no. 17 to restrict the influence of the active goaf on the workings. Similar mining conditions have been observed in the model as indicated through the vertical stress and yield profile of the panel (Fig. 4.19). The working pillar 'W' (pillar no. 18) undergoes its residual phase before splitting/slicing operation and almost yields entirely, indicating an unstable mining condition.
