7.1. Introduction

In this chapter, the feasibility of the developed Stability Analysis and HAZARD RATING (SAHARA) system for the dump slope structures was verified through case studies. A total of six cases from three different mines were analyzed using the SAHARA system. The results were compared with the conclusions of the scientific reports, existing conditions and outcomes of the survey department of the mines.

7.2. Case Study of Mine “X”

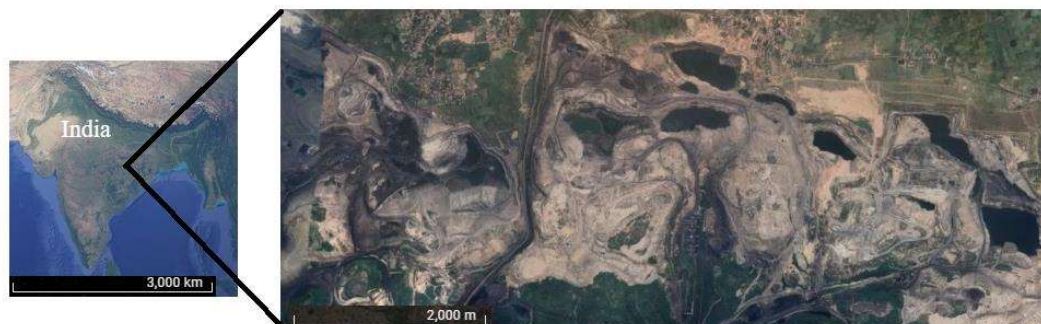
Fig. 7.1 Mine “X”, opencast coal mine (SECL), Chhattisgarh, India.

The Mine “X” has an area of about 19.03 square kilometres in the south-central part of the Korba coalfield in the Korba district of Chhattisgarh, India, as depicted in Figure 7.1. It is included in the Survey of India Topo-sheet No. 64 J/11 and is bounded by latitudes 22°18'00" N to 22°21'42" N and longitudes 82°32'00" E to 82°39'30" E. It is a mega opencast project in the thick seam zone. The coal produced in 2014-15, 2015-16, and 2016-17 were 41 million tonnes (Mte) per annum. The OB extracted in 2014-15 was 45.44 million cubic meters (Mm^3), in 2015-16 was 44.01 Mm^3 and in 2016-17 was 47.07 Mm^3 . The general topography of the mining area is gently undulating and varies 288-328 m above mean sea level. The coal block exhibits a rolling strike throughout the area. The strata, including the coal seams, show a broad E-W trend. The strata, in general, show a southerly dip. The general dip of the strata varies from 2°-4° in the Central & North-Eastern part. The strata dip goes from 6°-8° in the South-East and Western parts (IIT-BHU 2021).

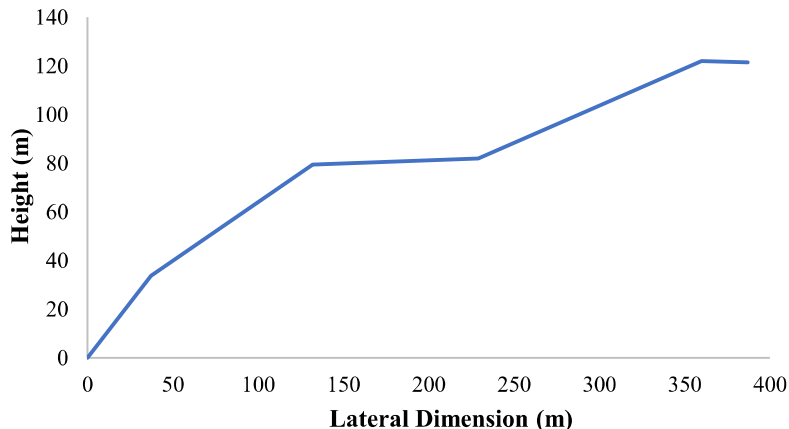
Fig. 7.2 Internal Dump A, Mine “X”, India (IIT-BHU 2021)

The profile coordinates of the internal Dump A were obtained from the survey department of the mine and are represented in Figure 7.2. Dump A had three benches. The height of the first, second, and third benches were 34, 46, and 40 m, respectively. There was an elevation of 2 m along the bench width between the second and third benches. Hence, the total dump height was 122 m. The bench slope angle of the first bench was 28° , the second bench was 51° , and the last bench inclined 22° with the horizontal plane. The bench width was absent between the first and second bench, and a bench width of 97 m was provided between the second and third bench. The OB dump material possessed cohesion of 21 kPa, friction angle of 28° , and density of 1760 kg/m^3 (IIT-BHU 2021). In the second bench, the bench slope angle was in an unstable state, and bench width was also not provided between the first and second bench. The second bench was more susceptible to failure, but the heights of all three benches were located in the critically stable state range. Therefore, the overall stability of the dump slope structure was analyzed based on the three different cases. The bench height, slope angle, and width were changed in each case as per the bench configuration, and the remaining parameters were the same.

Table 7.1 summarizes the determined rating and PoF using Table 6.8 with due consideration of all seven stability governing parameters of cases 1, 2, and 3. In all three cases, the geotechnical properties were found near the boundary value of a stable and critically stable state. In geometrical parameters, all cases had bench height in the critically stable state range, but the bench slope angle and width were in the unstable state in case 2. The summation of rating was in a stable state for cases 1 and 3 with PoF in a critically stable state. The summation of the rating and PoF of case 2 were 45.45 and 100%, respectively.

The overall actual and predicted condition of internal Dump A is described in Table 7.2. The internal Dump A had FoS of 0.76, XDIS of 35000 mm, and SSI of 50 as per the scientific report (IIT-BHU 2021). The stability state range classified in Table 5.3 also predicted the same stability state as found in the scientific report. The summation of the rating would be less than 64.1 and PoF would be greater than 41.3% in unstable state conditions as per Table 6.9. The lowest value of rating and greatest value of PoF were considered among the three cases to assess the worst scenario. Thus, the rating was 45.45

with a PoF of 100%, and the overall stability state of internal Dump A was unstable. Hence, the predicted stability condition matched well with the actual condition.

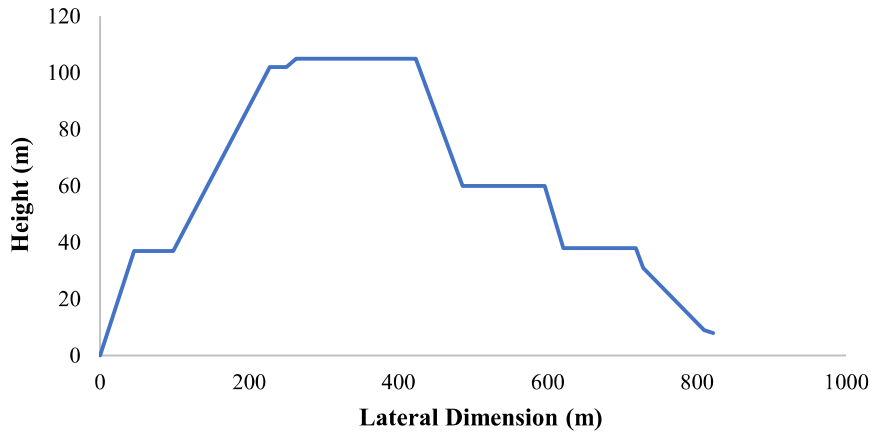
Fig. 7.3 Internal Dump B, Mine “X”, India (IIT-BHU 2021)

The configuration of the internal Dump B with a total dump height of 105 m is displayed in Figure 7.3. The dump structure had two benches with critical parameters, and the parameter of one bench belonged to an unstable state. Therefore, three cases were designed to analyze the stability of the dump slope structure. Case 1 carried a bench height of 37 m, bench slope angle of 38.83° , and bench width of 100 m. In case 2, the bench height was 65 m with a bench slope angle of 26.58° and a bench width of 52 m. The bench height (45 m) was in the critically stable state, and the bench slope angle (35.56°) and bench width (112 m) were placed in a stable state condition in the last case. The geotechnical properties were the same as adopted in internal Dump A.

The rating and PoF of Dump B were calculated based on the stability rating and hazard quantification chart. The rating of cases 1, 2, and 3 were 75.82, 76.52, and 77.23, respectively (Table 7.3). A slight difference existed in the rating of each case. The rating of each case followed the range of stable state but was present close to the transition state of stable to critically stable. However, a notable contrast was observed in the PoF of each case. Case 1 and 3 had PoF of 0.93% and 3.59%, but it increased rapidly to 35.92% in case 2. The magnitude of PoF of each case followed the range of critically stable state conditions.

The actual condition and performance measuring parameters of Dump B were extracted from the scientific report (IIT-BHU 2021) (Table 7.4). The safety factor was close to 1 with a maximum horizontal displacement of 4 mm and shear strain increment of 0.0007. The safety factor and PoF adhered to the critically stable state condition based on the prediction, but the horizontal displacement and shear strain increment complied with the stable state condition. Since dump slope system components were considered in the series system, shifting the stability state of one parameter to a critically stable or unstable state may lead to instability. Similarly, it was perceived that alteration of one performance measuring parameter towards the instability state might cause the failure of the dump slope structure. Thus, the stability state of the dump slope was forecasted as critically stable and it coincided with the observed actual stability condition.

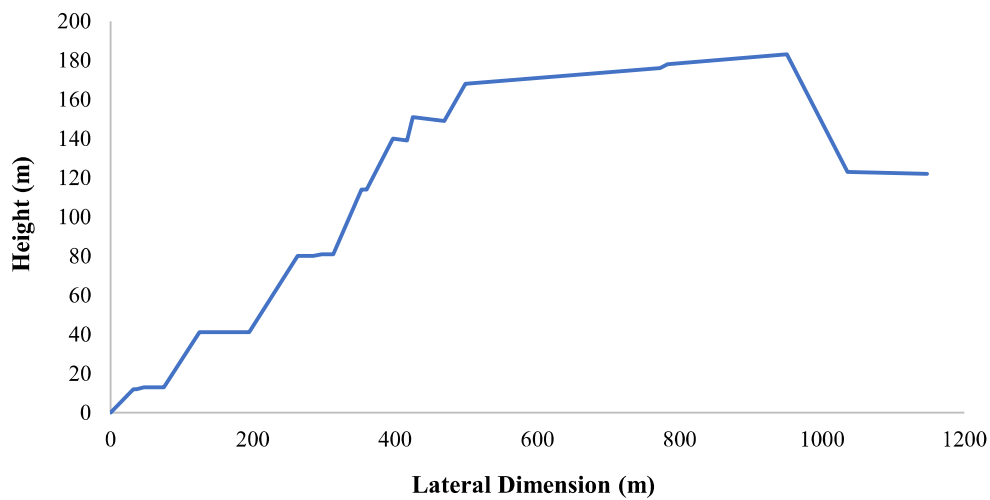
Fig. 7.4 Internal Dump C, Mine “X”, India (IIT-BHU 2021)

The total dump height of the Dump C slope structure was 183 m. Figure 7.4 illustrates the cross-section based shape of the Dump C slope. The dimensions of the benches were not consistent from the bottom to the top of the dump slope. The dump had one high bench on the right side of 60 m with a bench slope angle of 35.24°. During the analysis of the Dump C profile, it was noticed that the dump consisted of four major critically stable cases including the right side 60 m bench. The geometrical and geotechnical details

of all four cases are discussed in Table 7.5. Case 1 had the highest rating and lowest PoF among all cases. Cases 2, 3, and 4 produced ratings close to each other, but there was a huge difference in the PoF. Case 3 depicted the highest PoF of 79.74%, followed by Case 4 with a PoF of 41.92%, and the PoF of Case 2 was 8.78%. The rating of case 1 placed it in a stable state condition while the remaining cases were situated in a critically stable state condition. The PoF of cases 1, 2, and 4 came under a critically stable state while case 3 was in an unstable state.

The current circumstances of Dump C are reported in Table 7.6 and compared with the predicted results. The Dump C was on the verge of instability as it possessed a FoS of 1.06. The XDIS was 20 mm with an SSI of 0.0025. The XDIS moved a little bit ahead of the stable state limit while SSI was at the boundary line of stable and critically stable state condition. The proposed criteria of FoS, XDIS, SSI, and rating classified the stability status of Dump C as critically stable. However, the instability could occur if presumed spatial variability exists as PoF was spotted in an unstable state.

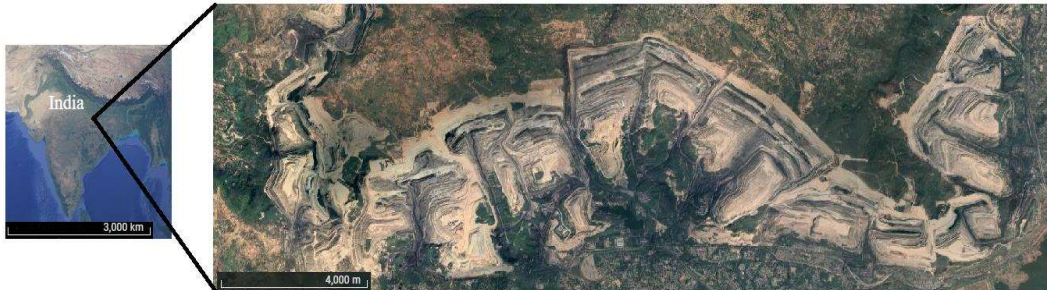
Fig. 7.5 Mine “Y”, opencast coal mine of Singrauli coalfields (NCL), India

Mine “Y” is situated in the south-central part of the Moher sub-basin of Singrauli coalfields in the Singrauli district of Madhya Pradesh in India (Figure 7.5). The Singrauli coalfields cover a total area of 2202 sq. km. The Singrauli main basin spread over 1890 sq. km. The Moher Sub-basin covers the remaining 312 sq. km. area. A large portion of the Moher Sub-basin lies in the Singrauli district of Madhya Pradesh and a small part is situated in the Sonebhadra district of Uttar Pradesh. There are 10 highly mechanized operating opencast mines in the Moher Sub-basin (Northern Coalfields Limited, 2021). Mine “Y” is bounded by latitudes 24°06’3.29” & 24°11’16.37” North and longitudes 82°35’28.23” & 82°39’50.12” East. It has a hilly plateau with a varying elevation between 400-450 m above mean sea level, and some area has an elevation greater than 500 m. The

mine has total geological and mineable coal reserves of 504.61 and 483.01 MTe, respectively with an overburden of 1776.65 Mm³ and an average stripping ratio of 3.68 m³/te. The coal seam has a flat gradient of 2° - 3° (CMPDI 2019).

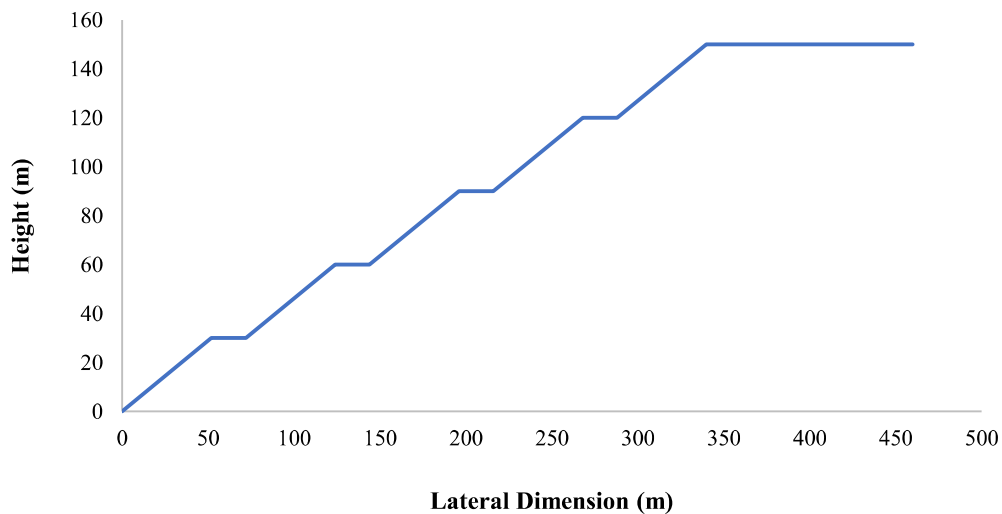
Fig. 7.6 Profile of proposed external Dump D (IIT-BHU 2017)

IIT-BHU (2017) proposed the design approach for external dump D, Mine “Y”. The total dump height was 150 m, comprising 5 benches, and all benches were symmetrical (Figure 7.6). Each bench had a height of 30 m with a bench slope angle of 30°. Each bench was separated from the other by providing a bench width of 20 m. The overall slope angle was maintained at 23.8°.

The bench width and geotechnical parameters followed the critically stable state range, as expressed in Table 7.7. However, the friction angle and density were close to the stable state. The cohesion and bench width were situated approximately in the middle of a critically stable state. According to Table 6.6, the bench slope angle has the strongest influence on the dump slope structure, followed by friction angle and bench height. The cohesion and density affect the dump slope stability but are not as intense as the bench slope angle, friction angle and bench height. Moreover, the bench width is also placed in the middle of the ranking among the parameters.

The rating of the D dump slope was situated in the stable state condition due to maintaining the highest influencing parameters in the stable state to mitigate the effect of the critically stable state parameters. Thus, maintaining the bench slope angle, bench height, and total dump height in a stable state condition kept the summation of rating in the stable state category. The PoF crossed the stable state range slightly due to the presence of four parameters in a critically stable state and adopted a range of uncertainty.

The proposed dump D was stable as FoS was 1.37, XDIS was 4 mm, and SSI was 0.0015 (IIT-BHU 2017). All the predicted performance measuring parameters agreed with the stable state condition except PoF (Table 7.8). The PoF moved ahead slightly from the stable state range and was placed in a critically stable state due to consideration of the high range of spatial variability of geotechnical parameters. However, the magnitude of PoF will be reduced if a low range of uncertainty exists in the dump D.

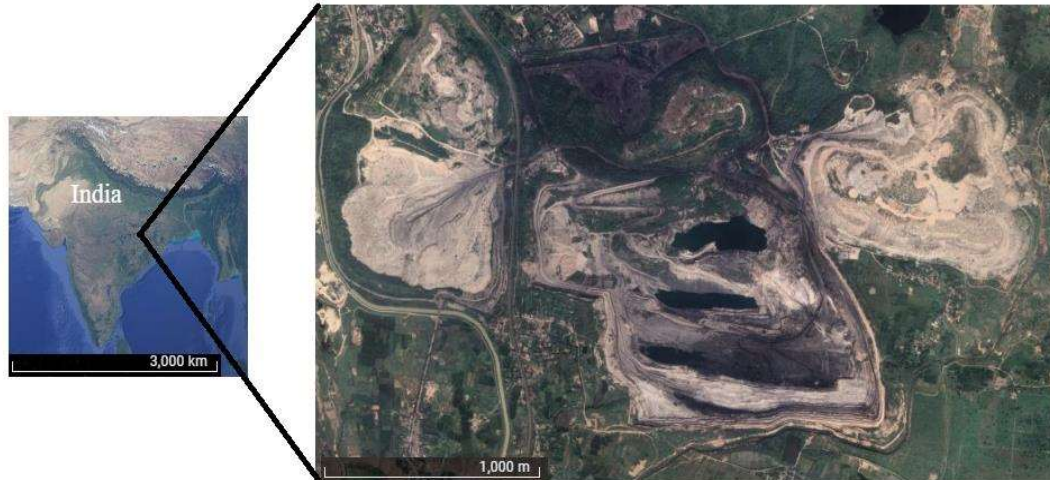
Fig. 7.7 Mine “Z” opencast coal mine (SECL), Korba, Chhattisgarh, India

Mine “Z” has an area of about 1018.925 hectares and is located in the southeastern part of the Korba coalfield in the Korba district of Chhattisgarh, India, as depicted in Figure 7.7. It started in the year 1966 with a total mineable reserve of 101.50 Mt. It is included in the Survey of India Topo-sheet No. 64 J/11 (1:50000) and is bounded by latitudes 22°19'00" N to 22°19'30" N and longitudes 82°42'30" E to 82°44'30" E. The area has levelled plain terrain and a local steep approach towards the streams and nallahs in the northeastern plain. The average elevation of the mine block varies between 274 to 293 m. The mine has a general elevation towards the West direction, but the highest elevation is towards the block of Nort-East and lowest towards the South-West area. In 1966, the mine was planned to produce 1.0 Mte Per Annum (MTPA). The production was set to 2 MTPA

in 1976 based on the report of CMPDIL. The production was 4.90 MTPA in 2020 and expanded to 5.25 MTPA in 2022 (CMPDI 2018, Ministry of Coal 2022).

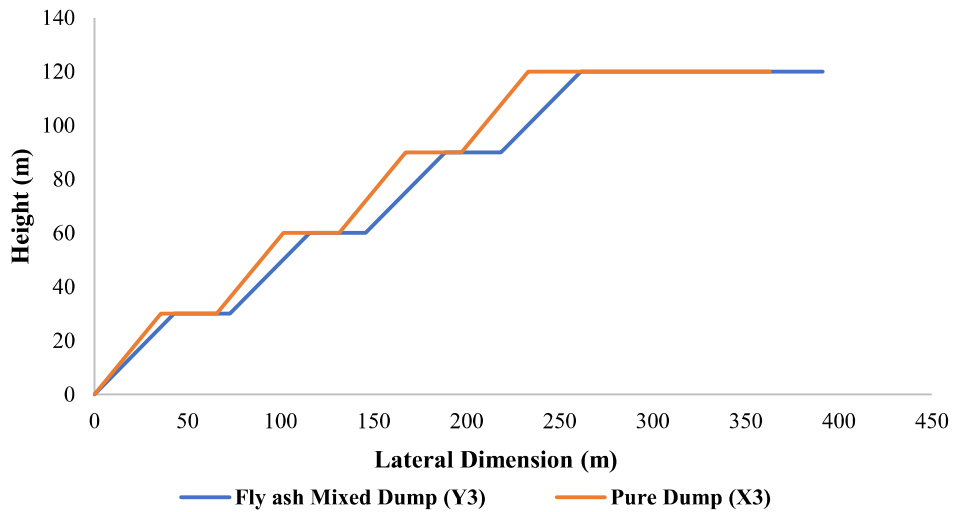
Fig. 7.8 Dump slope structure profile of Mine “Z” opencast coal mine (IIT-BHU 2019b)

IIT-BHU (2019b) formulated the design of two dump slope structures, one for the pure dump material (E) and the other for the fly ash mixed dump slope (F). The total dump height of both the dump slope was 120 m as represented in Figure 7.8. The cohesion, friction angle, and density of Dump E were higher than Dump F (Table 7.9). Therefore, the bench slope angle of Dump E was steeper than Dump F. The bench height was equal to the bench width, i.e., 30 m in both the dump slope structure. The bench slope angle was 40° in pure dump slope and 35° in fly ash mixed dump slope. The difference between the rating and PoF of both dump slopes was minimal. The rating of both dump slopes followed the stable state range. However, the PoF of dump E and F was situated in a critically stable state but very close to the boundary point of a stable and critically stable state.

The actual condition of the proposed design of Dump E and F was stable (IIT-BHU 2019b). The comparison of the actual and predicted condition of pure and fly ash mixed dump was summarized in Table 7.10. The safety factor, horizontal displacement, and shear strain increment of the Dump E coincided with stability state criteria. The safety factor and shear strain of dump F are also in a stable state condition. However, horizontal

displacement slightly exceeded the stable state and entered a critically stable state condition. The scientific report mentioned that the horizontal displacement exceeded the stable design limit at the skin of the slope surface, but the expected zone of instability was negligible. The rating of both dumps was placed in the stable state category, and the PoF was located in a critically stable state. The difference between predicted PoF was small and close to the boundary of stable state condition. The forecasted PoF would only occur when such a spatial variation of geotechnical properties exists in designed dump slope structures. Thus, the overall predicted condition of both the dumps was stable, and it followed the outcomes of the scientific report.
