Chapter : 5 Trial Operation on a Running Motor Mounted Blower

5.2 The Equipment Details

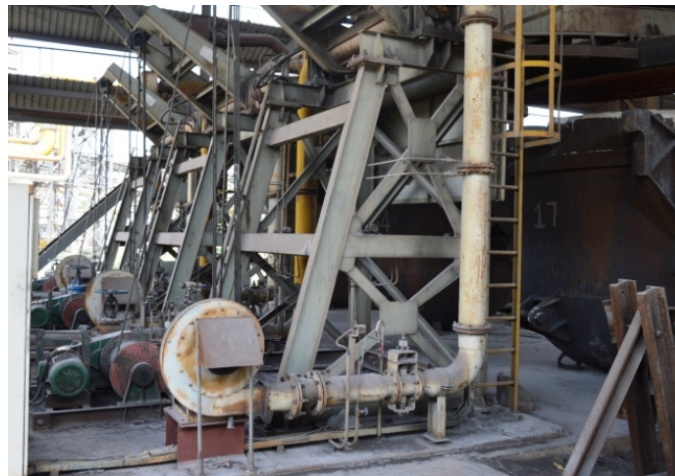
Figure : 5.1 Motor Mounted Centrifugal Blowers for the Burners

The blowers supply the combustion air to the gas burners for the heating and drying of the refractory items of the hot metal ladles after relining or repair. The blowers are all centrifugal type and directly mounted on motor. The motor and the blower block are mounted on a common frame which is bolted on the I-beam base frame which is bolted to the concrete base.(Figure :5.2)

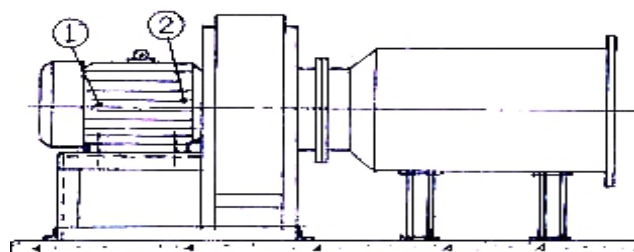
Fig: 5.3 Vibration Measuring Points at MNDE & MDE- Marked 1 & 2

Vibration monitoring of the centrifugal blower were done in all three axes at motor drive end (MDE) and motor non-drive end (MNDE) bearings at the measuring points as shown in Figure:5.3

The Vibration measurement of the motor non-drive end (MNDE) and at the motor drive end (MDE) bearings are shown in Tables:5.3

this case . So phase analysis was done which showed that there is an approximately 180° phase difference between vertical measurements on machine foot base plate and machine base itself. This clearly indicated there is structural looseness and even if there is any mass unbalance it is not dominant at present. From the study of the above spectrums (Figure :5.4 to Figure:5.9) it is observed that all the spectrums are of **Type: A** except for Figure:5.7 of motor drive end bearing vibration of horizontal axis and the reason can be of rotor unbalance of which there is an indication but not dominant because of the vibration due to base weakness. From the above discussion we can now draw a conclusion for the machine defect which is generating the abnormal vibrations.

From the above discussion we can conclude that the reason for high vibration of the blower and the motor were due to structural weakness only as checking the tightness of the base bolts indicated there were no specific mechanical looseness. Phase analysis has also indicated the same. However there is a possibility of blower rotor unbalance but that will be dominant after rectifying the structural weakness of the centrifugal blower. As in the experimental set-up it has been verified that channel structural base is the best option for the steel base frame for a motor mounted blower it was decided to replace the I- beam of the present base with same size steel channel but keeping all other parts like the common base plate of motor and blower same.

During a suitable shut down the 300mm I beams was removed and replaced with 300 mm channel frame. The base frame drawing is enclosed (Appendix-E). Only

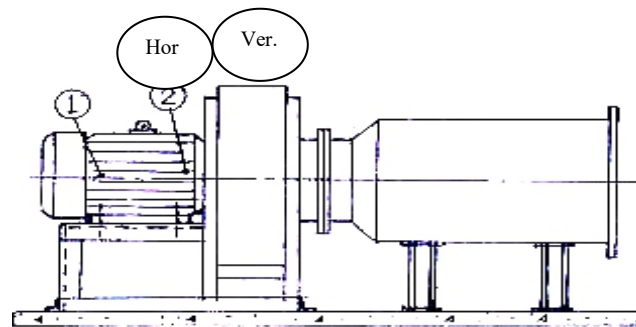
Fig: 5.18 Position in the Blower Drive –End bearing for Phase Analysis

Motor drive end bearing (No:2) which is nearest to the impeller was taken as the reference point for measuring the phase difference between the bearing horizontal (Horizontal .) and the vertical (vertical)axis (Figure:5.18)
