Chapter:3 Problems & Analysis of Motor Mounted Centrifugal Blowers.

3.2 Case Study -1: Combustion Air Blower of a Furnace (DBL-10)

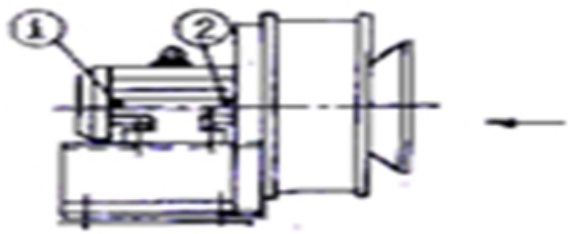
Fig: 3.13 Schematic sketch of the Blower Mounted on Motor and the specifications.

phase analysis indicated that the vibration increase was due to structural looseness of the base.(Fig:3.21 & Fig:3.22)

In this Case Study -2 the blower base frame was made of box structure by welding two channels face to face. Unlike Case Study -1(DBL-10) this blower vibration was observed from the initial monitoring period which ultimately led to the failure of the base. After repair and modification of the base and adding further stiffeners the vibration amplitude had come down and remained constant over the period. The solution to the problem was making the base more rigid by welding stiffeners and this corrective action was taken more on shop floor intuition than based on any mathematical calculation.

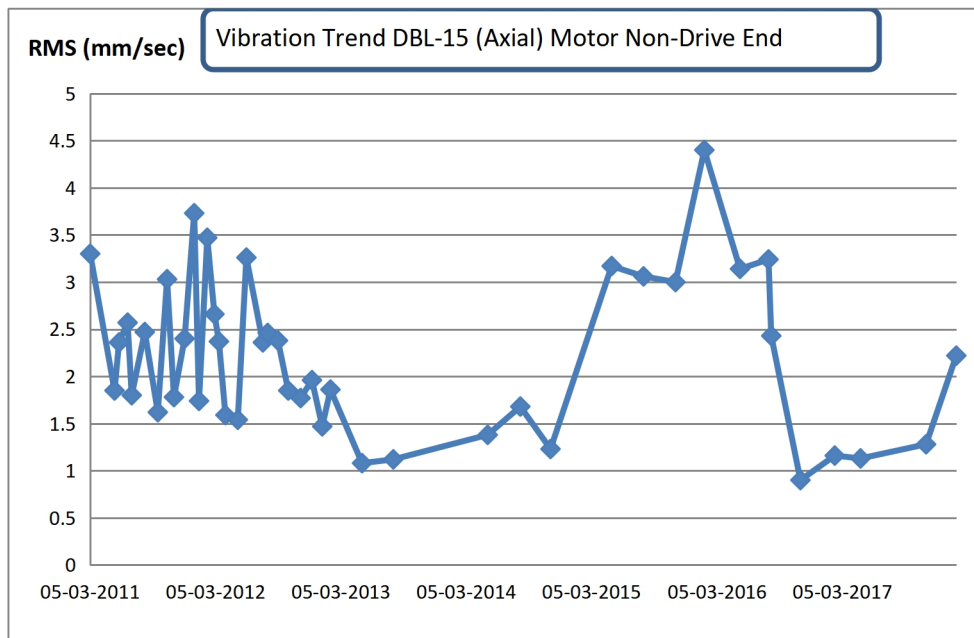
Fig: 3.25 Vibration Trend of DBL-15(axial) of MNDE bearing

Unlike the previous two case studies (Case Study-1 & Case Study-2) this vibration problem could not be solved by welding stiffeners to make the base frame more rigid. The box structure was unable to absorb the vibration generated by the high speed blower and as a result due to continuous high vibration the base bolts get loosened and needs frequent tightening.

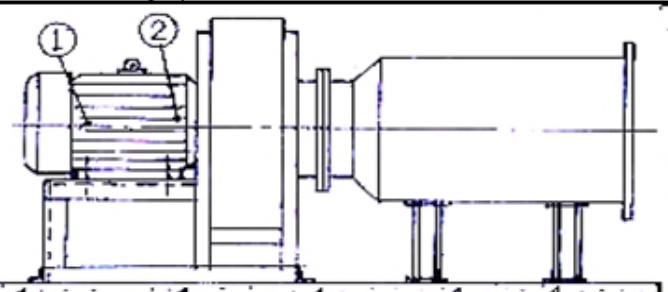
Fig: 3.32 Schematic sketch of the blower DBL-25 with other specifications.

The blower is mounted on the motor and both are on a common base supplied by the manufacturer. Like the blowers in the previous case studies this blower and the motor on the common base has been mounted on a in-house fabricated base frame which has been bolted to the bolts grouted in the concrete base as shown in the Fig:3.33

Like the previous two case studies (Case Study-1 & Case Study-2) this vibration problem of structural looseness was observed and as the structure could not be changed the structure had to be made more rigid with welding of stiffeners. Like the other case studies the base frame was fabricated from available material at site and in

this case it was unequal angles. The root cause of the failure was weak structure and due to increase of vibration amplitude the base had failed twice in the seven year period and after rectification of the crack in the base stiffeners had to be welded to make the base rigid.

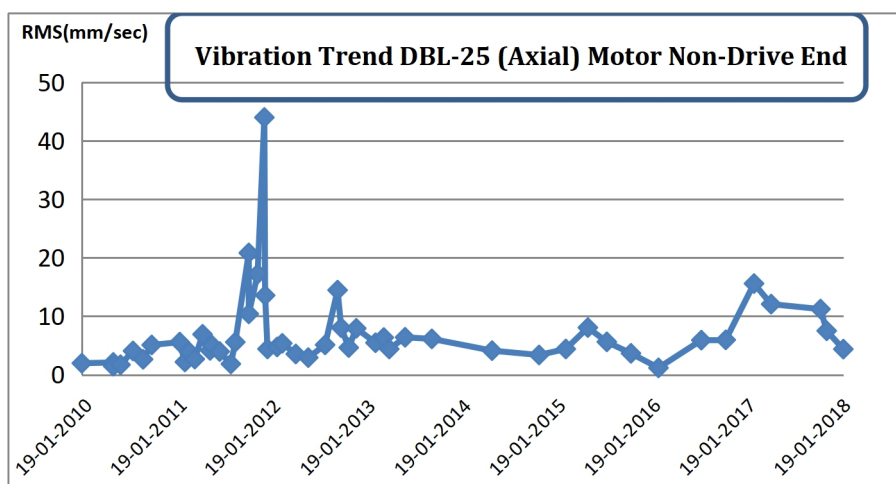
Fig: 3.34 Vibration Trend of DBL-25 (Axial) of MNDE Bearing

stability in the vibration trend but after an year of operation there was another failure of the base frame which had to be further repaired and to bring back rigidity additional stiffeners were further welded (Fig: 3.42)

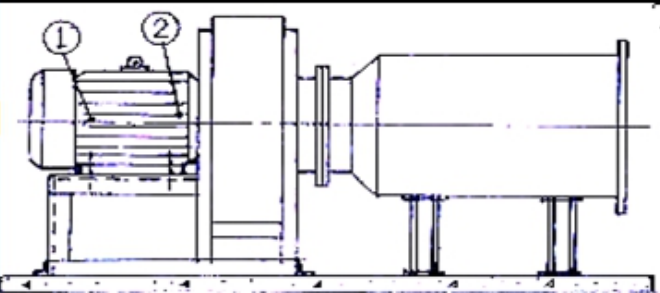
Fig: 3.43 Schematic Sketch of the Blower and Specifications

The blower is mounted on the motor and both are on a common base supplied by the manufacturer. Like the blowers in the previous case studies this blower and the motor is mounted on an in-house fabricated base frame which has been bolted to the foundation bolts grouted in the concrete base as shown in the Fig:3.44
