CHAPTER 5:
EROSION BEHAVIOR OF
DUAL PHASE STEELS AT
DIFFERENT IMPACT
ANGLES AND VELOCITIES

EROSION BEHAVIOR OF DP STEELS AT DIFFERENT IMPACT ANGLES AND VELOCITIES

This chapter presents the results on the erosive wear of medium carbon normalized (N), dual phase (DP) and fully martensitic (FMS) steels at different velocities (30 m/s, 60 m/s, 90 m/s and 120 m/s) and impingement angles (15°, 45°, 75°, and 90°) with Al₂O₃ as an erodent. The results on microstructural and sub-surface analysis conducted to understand the mechanisms of material removal are also included in the chapter. The chapter also contains a comprehensive discussion on the observed erosive behavior of different steels correlating it with the microstructural features seen on the surface and sub-surface of the eroded steels apart from their mechanical properties. A mechanism of material removal has also been proposed for N, DP and fully martensitic steel having different microstructures.

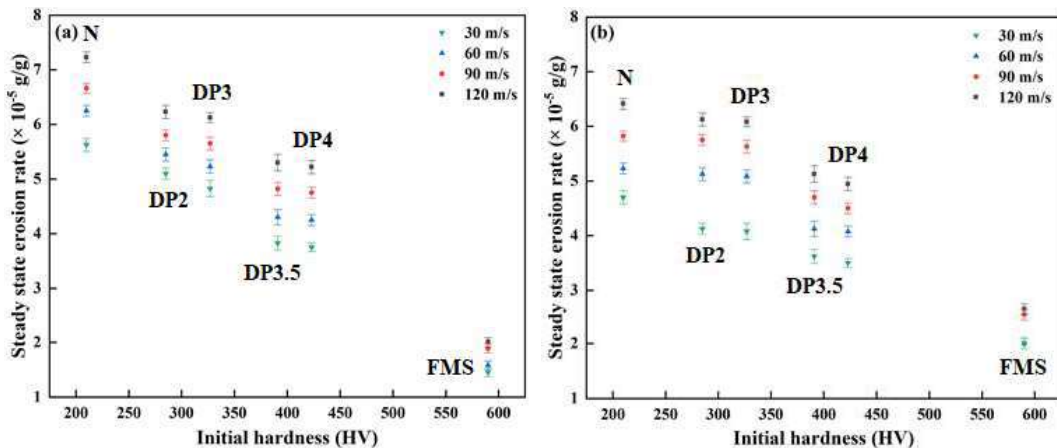
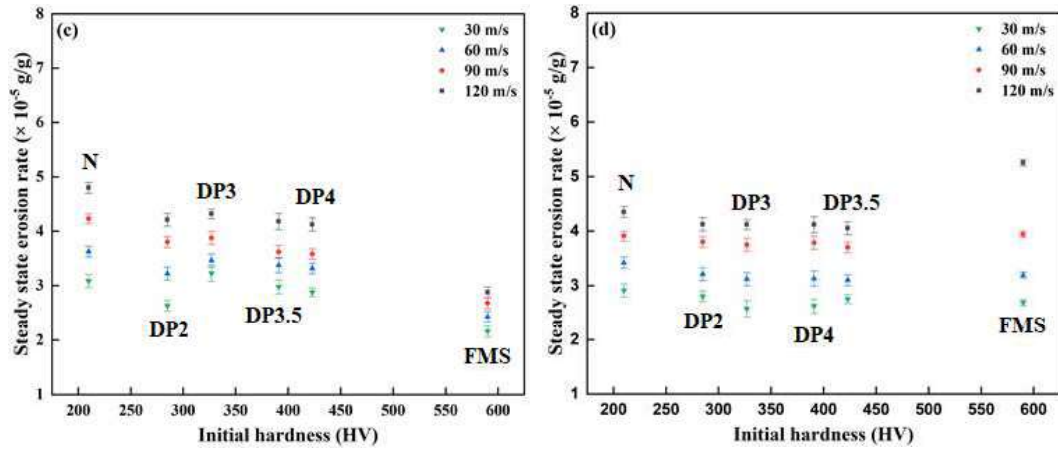
The variation of steady state erosion rate with initial hardness for various impact velocities of (30 m/s, 60 m/s, 90 m/s and 120 m/s) at different angles of impingement is illustrated in Figs. 5.2 (a through d): Consequently, it is evident that at a given angle of impact, the steady state erosion rate of all the materials, including N steel, DP steels and FMS, reduces with increasing hardness. The maximum weight loss of 1.42×10^{-3} g is observed for N steel (210HV3) at particle velocity of 120 m/s and 15° impact angle which is 8 %, 16 % and 29 % higher corresponding to that at 30 m/s, 60 m/s and 90 m/s, respectively. FMS (590 HV3) has shown the minimum weight loss of 2.84×10^{-4} g (FMS) at 30 m/s impact velocity and 15° impact angle which is 9 %, 30 % and 38 % lower than that observed at 60 m/s, 90 m/s and 120 m/s as seen from Fig. 5.2. DP steels have shown the erosion rates lying between this of N steel and FMS. However, as one progresses from DP2 to DP4 steel among DP steels, the erosion rate decreases with increasing hardness, as seen in Fig. 5.2 (a). A similar trend of variation is also observed from a 45° angle of impact as illustrated in Fig. 5.2 (b). However, the rate of decrease of

erosion rate is relatively less at an impact angle of 45° than at 15° as evident from a comparison of Figs. 5.2 (a) and (b).

It was evident that the erosion rate of N steel and DP steels are almost same at 75° angle of impingement and at relatively lower velocities of 30 m/s and 60 m/s indicating that there is no effect of hardness as seen from Fig. 5.2 (c). However, N steel has a marginally higher erosion rate than DP steels at relatively higher velocities of 90 m/s and 120 m/s. The effect of hardness on erosion rate could be seen beyond a hardness of 423HV3 corresponding to DP4 steel only as seen from Fig. 5.2 (c) which indicates a decrease in erosion rate till FMS. One may also observe that the decrease in erosion rate beyond DP4 is higher at relatively higher velocities of 90 m/s and 120 m/s as compared to 30 m/s and 60 m/s. All the materials have shown almost the same erosion rates for all the velocities at an impact angle of 90°, as shown in Fig. 5.2 (d), reflecting no effect of hardness on material loss except for FMS at 120 m/s which has shown the highest erosion rate.

Figure 5.2 Variation of steady state erosion rate with initial hardness for impact velocity of 30 m/s, 60 m/s, 90 m/s, 120 m/s, and at an impact angles of (a) 15°, (b) 45°, (c) 75°, and (d) 90°, respectively

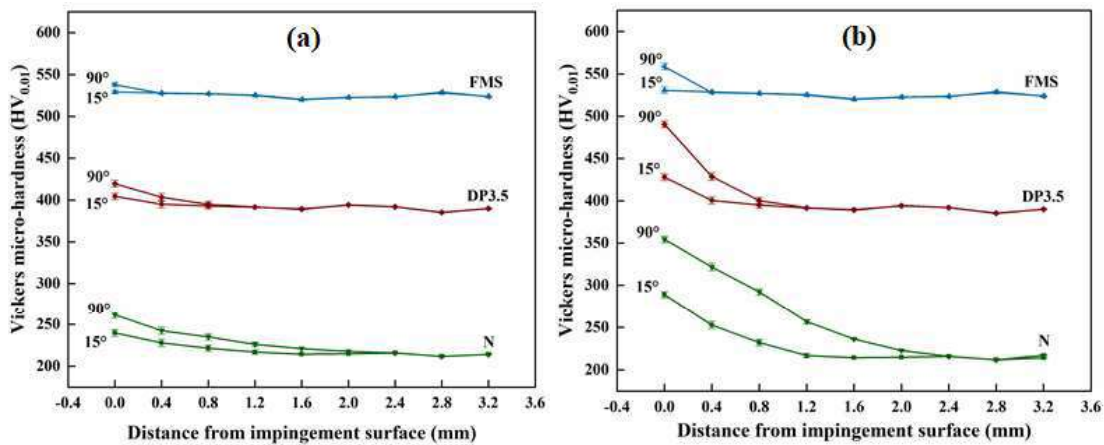
Figure 5.12 Micro-hardness profile of the eroded specimens of the N steel, DP3.5 steel and FMS at 15 and 90° angle of impact at (a) 30 m/s and (b) 120 m/s impact velocity

An increase in steady-state erosion rate with increasing velocity at normal incident angle for N steel, DP steels and FMS as seen in Figs. 5.3 ((a) - (d)) may be attributed to the erosion caused by alumina particles depending on the impact velocity and angle. The repetitive impact of erodent on the surface of steel results in work hardening and subsequent fragile fracture of material, which may be inferred from the occurrence of plastic deformation below the eroded surface in N steel, DP3.5 steel and FMS as depicted in Figs. 5.9, 5.10, and 5.11. The extent of deformation depends on the energy absorbing capability of the steel, which in turn, is governed by the microstructure [40,95,109]. One may observe that the depth of deformation is largest for N steel and lowest for FMS due to their toughness values. It should be noted that the depth of deformation for DP3.5 steel lies in-between. The highest erosion rate shown by FMS for relatively higher velocities of 90 m/s and 120 m/s at normal angle of impact may be attributed to its brittle nature which renders it poor capability to deform and hence, a lowest depth of plastic deformation which is reflected by moderate hardness gradient, see Fig. 5.12 (b).
