#### **Erosive wear properties of CNTs, GO, and (CNTs/GO) hybrid coated carbon FREC using Taguchi orthogonal array**

#### **6.1 Erosion test**

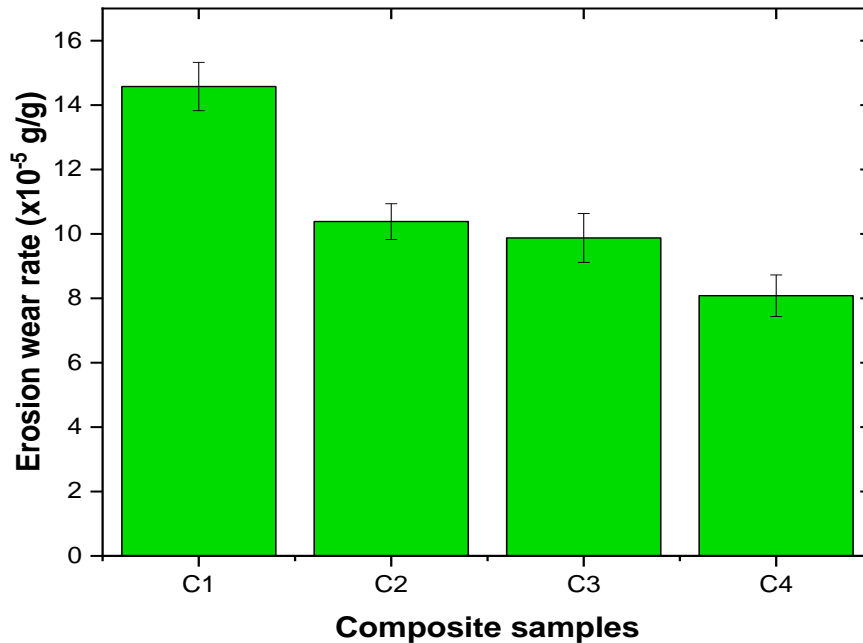
**Figure 6.5** Erosion wear rate of C1, C2, C3, and C4 polymer composites at impact velocity of 60 m/s, discharge rate of 4 g/min, and an impingement angle of 60°.

Figure 6.5 illustrates the erosion wear rates of polymer composites C1, C2, C3, and C4 under uniform test conditions, including an impact velocity of 60 m/s, discharge rate of 4 g/min, and an impingement angle of 60°, facilitating direct comparison among the composites. Notably, C2, C3, and C4 composites exhibit reduced erosion wear rates compared to C1, attributed to the incorporation of CNTs, GO, or a combination of both as coatings on the carbon fiber within the polymer composite. The enhancement of interfacial adhesion by these coatings contributed to the improved resistance to wear. Specifically, the erosion wear rate of C1 composite is measured at  $14.576 \times 10^{-5}$  g/g. Comparative analysis reveals a 28.76% decrease in erosive wear rate for C2 compared to C1, attributed to the improved interfacial adhesion induced by the wrinkled, rough surface of GO [239, 240]. Similarly, C3 demonstrates a significant 32.24% decrease in erosive wear rate compared to C1, owing to the reinforcing effect of CNTs on the matrix, which improves erosion wear resistance by distributing stress and absorbing impact energy [254]. Furthermore, C4 exhibits the lowest erosion wear rate, 44.56% less than C1, attributed to the synergistic effect of CNTs/GO hybrid coating on carbon fiber reinforced polymer composite. These results correlate with previous studies [255-257], that emphasize the role of nanoparticles in reinforcing fiber-matrix interfaces, thereby improving mechanical stability and reducing material degradation under erosive conditions. The hybrid coating promotes the formation of a 3D structure of hybrid carbon nanomaterials, increasing surface area and enhancing

contact and interlocking at the interface between the matrix and carbon fibers. Additionally, the uniform dispersion of stress throughout the matrix further enhances wear resistance [242]. The findings showed great enhancement in erosion wear properties due to the surface modification of carbon fiber with CNTs and GO.
