Chapter 8

Microstructure Analysis

8.1 Introduction

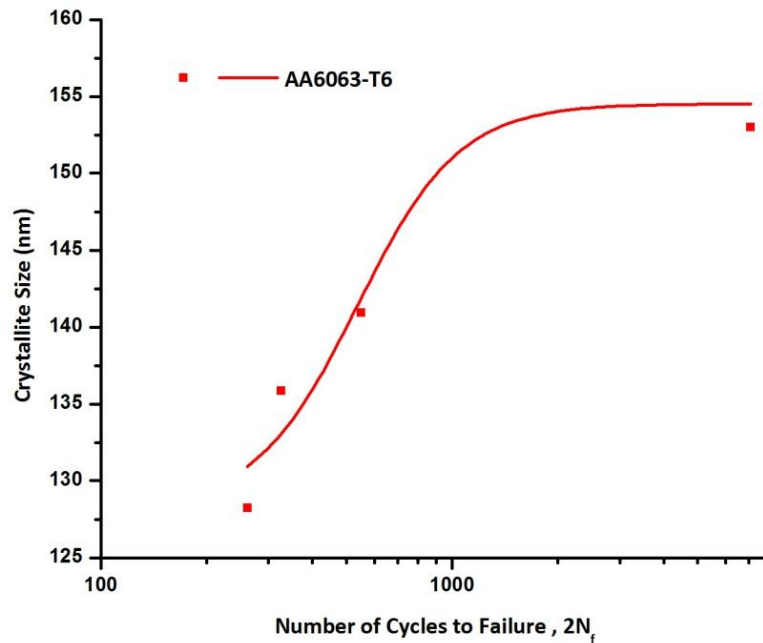
Fig. 8.3 Variation of crystallite size with the number of cycles to failure

Figure 8.2 shows that crystallite size increase with increase in load as applied during LCF test. The crystallite size increases with increase in number of cycles of failure as illustrate in Fig. 8.3. Figure 8.4 demonstrates the variation of diameter of sample at fracture with number of cycles to failure. It is observed that the diameter of sample at fracture has a decreasing tendency with number of cycles to failure.

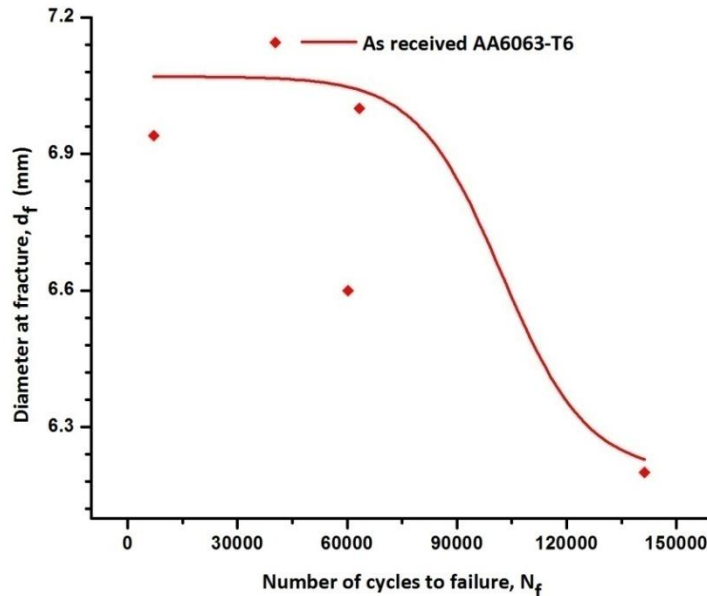
Fig. 8.4 Variation of diameter of sample at fracture with the number of cycles to failure

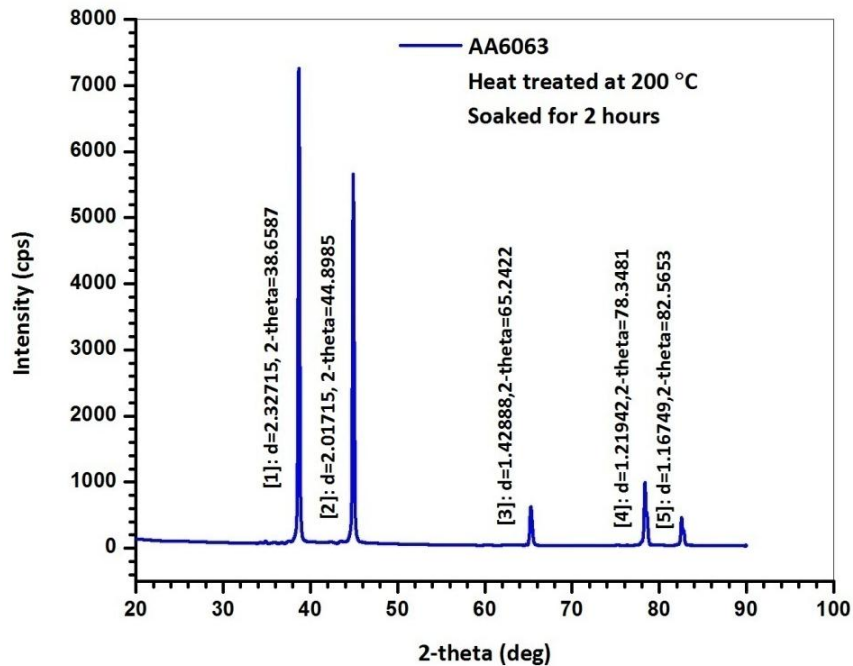
Fig. 8.5 X-RD pattern for AA6063 heat treated at 200°C and soaked for 2 hours

Figures 8.5 and 8.6 show XRD patterns for AA6063 samples heat treated at 200°C and 350°C, respectively and soaked for same time of 2 hours.

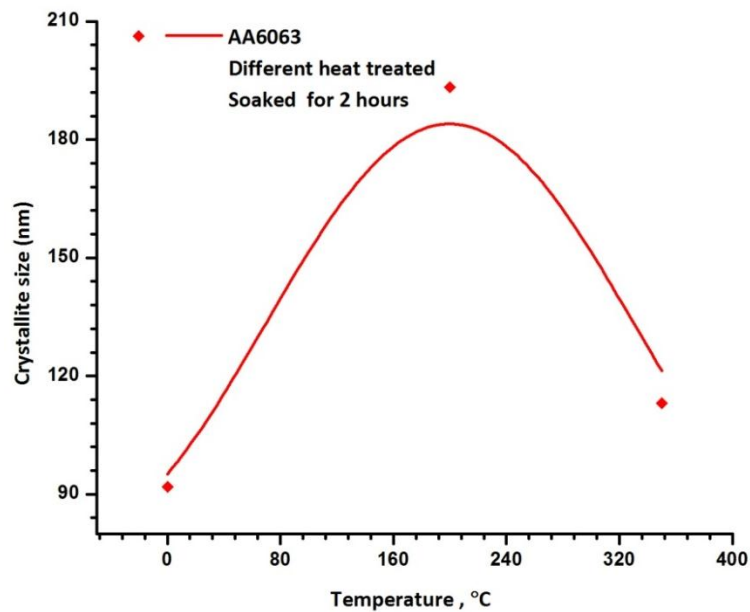
Fig. 8.7 Variation of crystallite size with different heat treatment temperature for same soaking time of 2 hours

Figure 8.7 demonstrates variation of crystallite size with heat treatment temperature for same soaking time of 2 hours. Variation of diameter of sample at fracture with the different heat treatment temperature at same soaking time of 2 hours show in Fig. 8.8 . The variation of diameter of sample at fracture with heat treatment temperature is demonstrated in Fig. 8.9. It is observed that the diameter of sample at fracture increases with increase in number of cycles to failure.

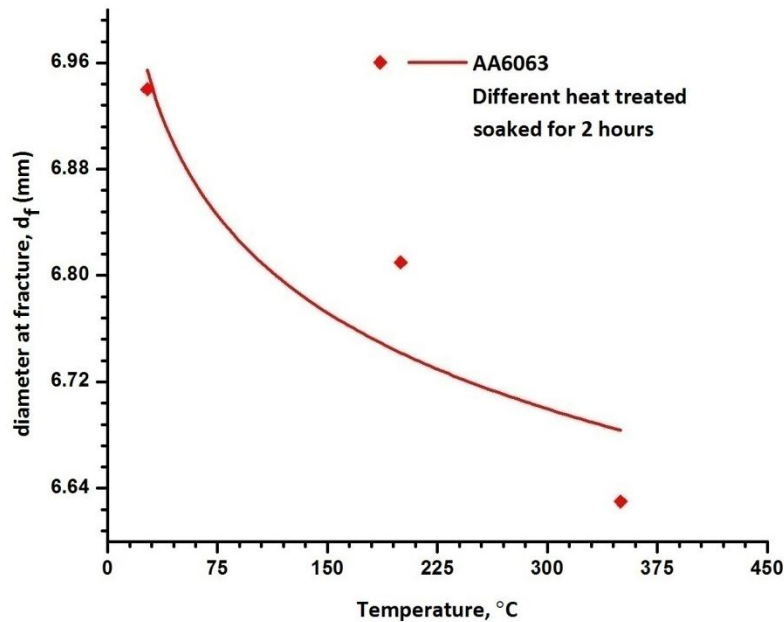
Fig. 8.8 Variation of diameter of sample at fracture with the different treat temperature and same soaking time of 2 hours

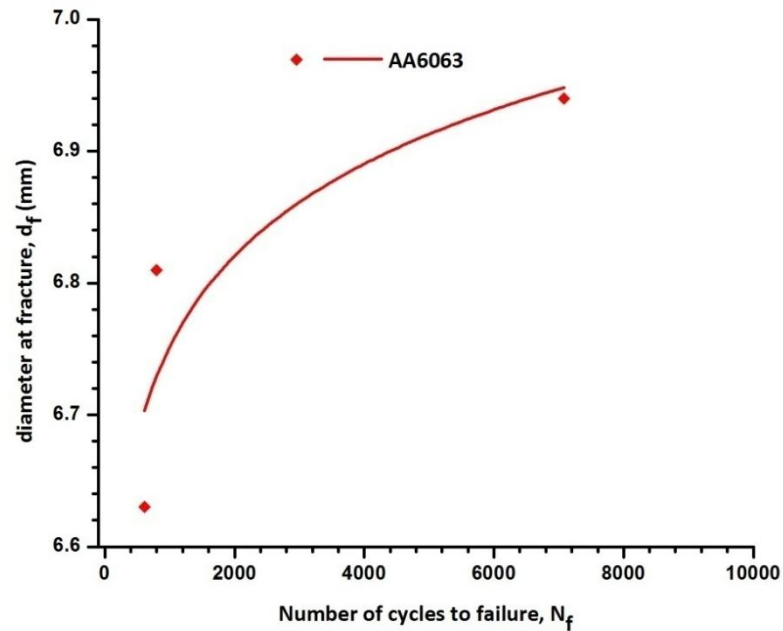
Fig. 8.9 Variation of diameter of sample at fracture with the number of cycles to failure for same soaking time of 2 hours

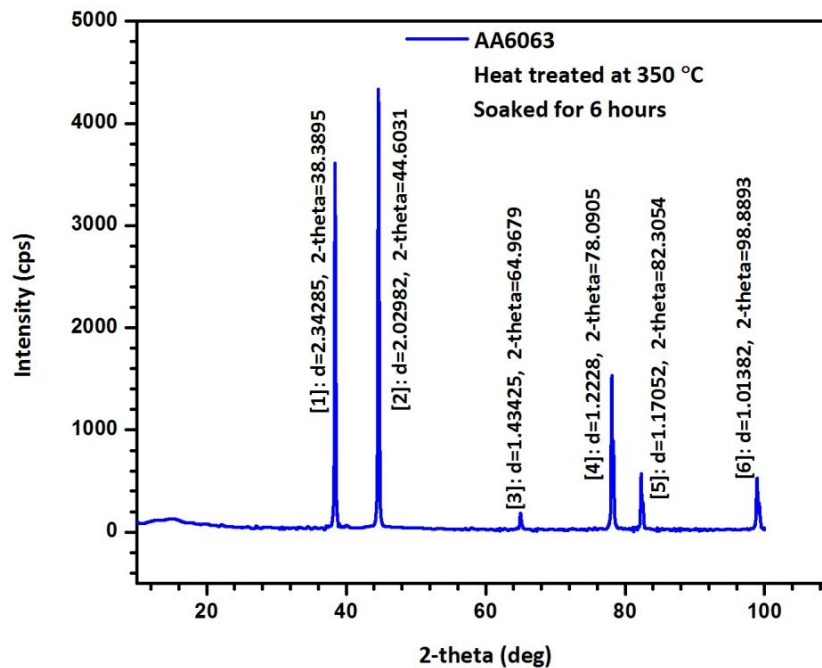
Fig. 8.11 X-RD Pattern for AA6063 heat treated at 350°C and soaked for 6 hours

Figure 8.10 to 8.12 show patterns for AA6063 samples heat treated at 350°C and soaked for 4 hours, 6 hours and 8 hours, respectively. Table 8.4 shows data of crystallite size, diameter of sample at fracture and numbers of cycles of failure for as received AA6063 and four heat treatment cases where heat treatment temperature is 350°C and soaking times are 2 hours, 4 hours, 6 hours and 8 hours. The variation of diameter at fracture of the sample with different soaking time of heat treatment at same heat treatment temperature of 350°C illustrated in Fig. 8.13. Figure 8.14 demonstrates the variation of crystallite size with soaking time of heat treatment at same heat treatment temperature of 350°C. Variation of diameter of sample at fracture with soaking time of heat treatment at same heat treatment temperature of 350°C is illustrated in Fig. 8.15. It is

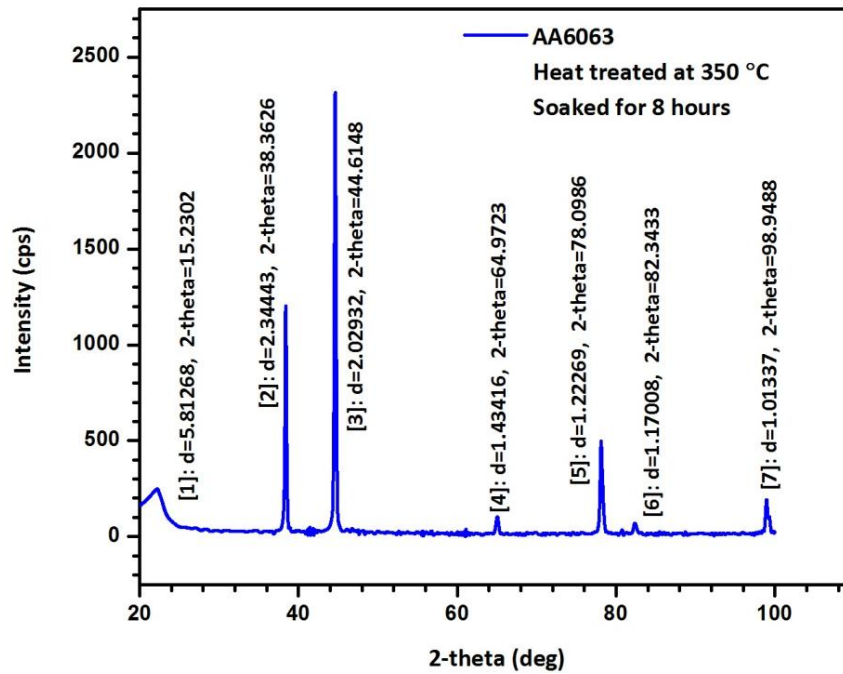
Fig. 8.12 X-RD Pattern for AA6063 heat treated at 350°C and soaked for 8 hours

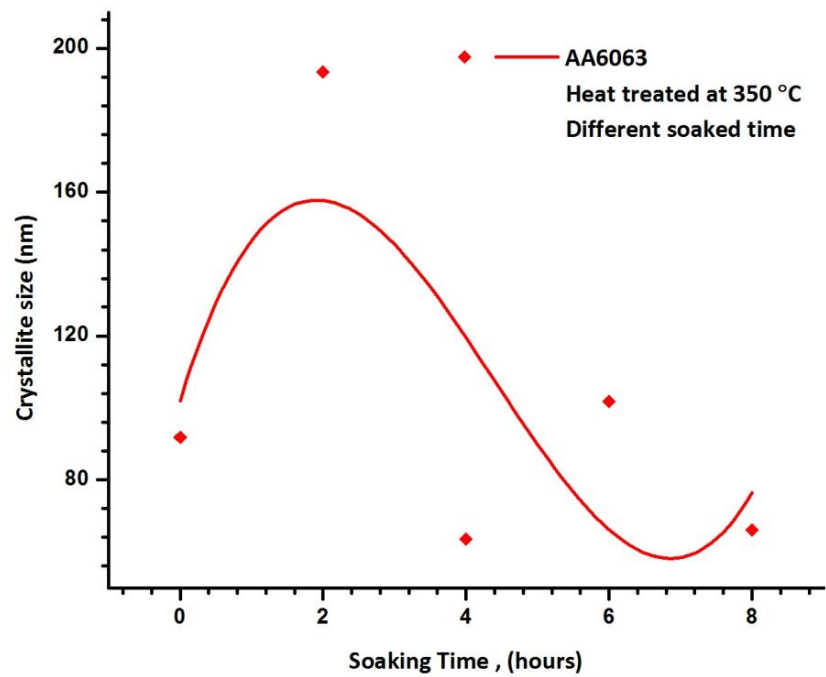
Fig. 8.13 Variation of crystallite size with different soaking time for same heat treatment temperature of 350°C

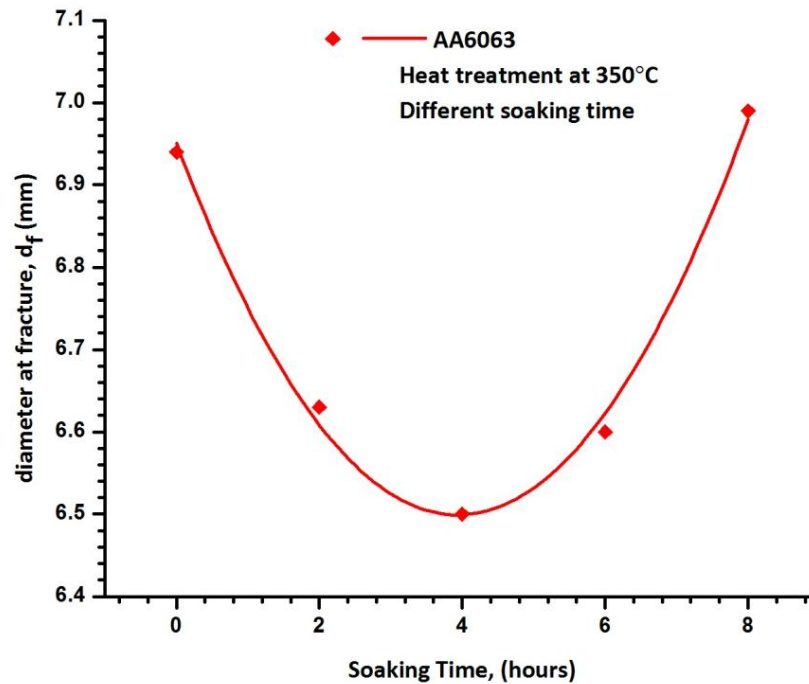
Fig. 8.14 Variation of diameter of sample at fracture with different soaking time for same heat treatment temperature of 350°C

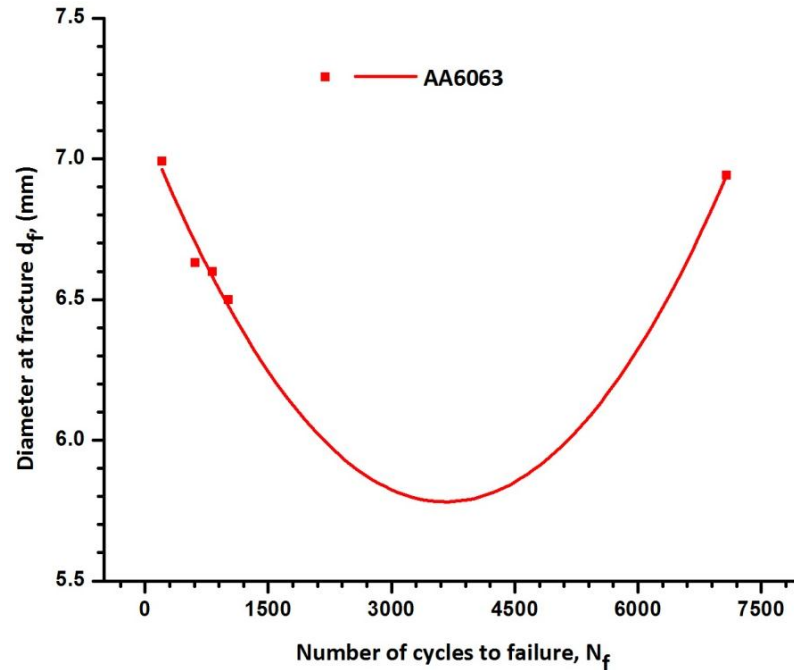
Fig. 8.15 Variation of diameter of sample at fracture with the number of cycles to failure for same heat treatment temperature of 350°C

observed that the diameter of sample at fracture has a decreasing till certain number of cycles after that increases with number of cycles to failure.

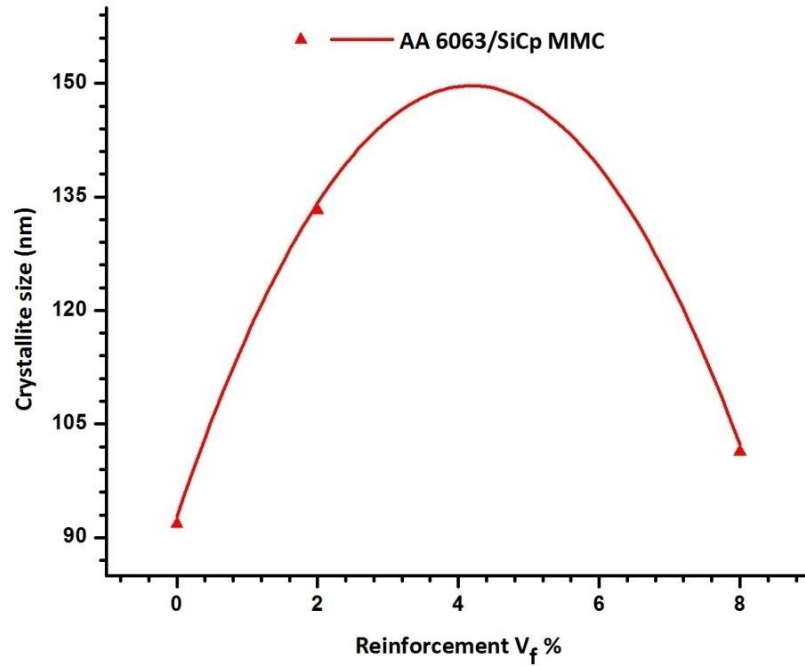
Fig. 8.18 Variation of crystallite size with different volume fraction of reinforcement particle of MMC

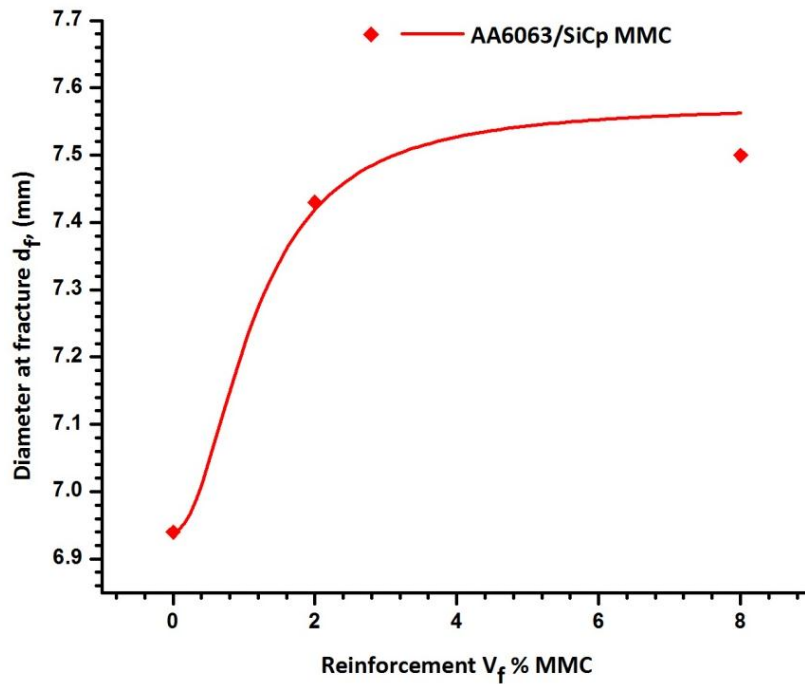
Fig. 8.19 Variation of diameter of sample at fracture with reinforcement particle of AA6063/SiCp V_f MMC

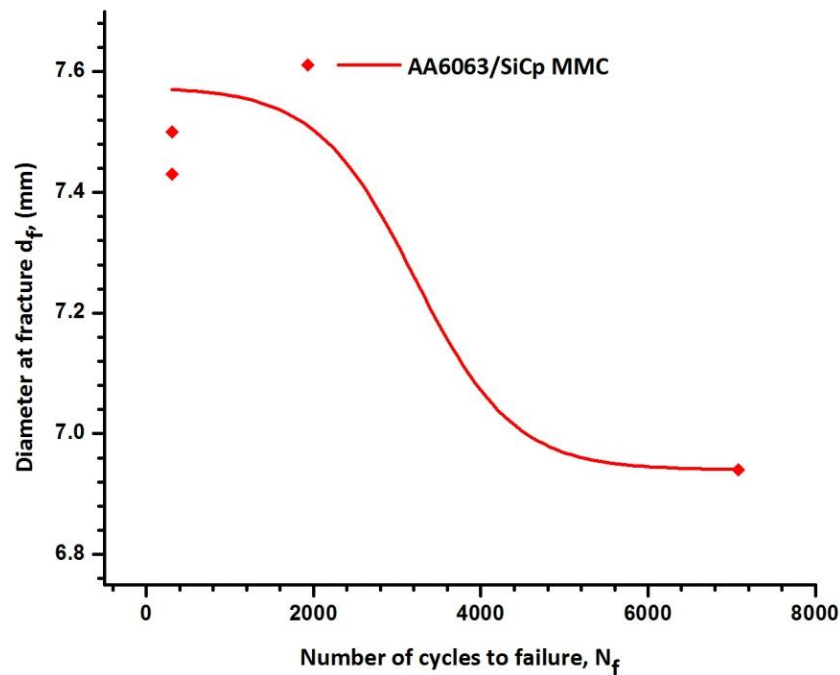
Fig. 8.20 Variation of diameter of sample at fracture with the number of cycles to failure of reinforcement particle of MMC

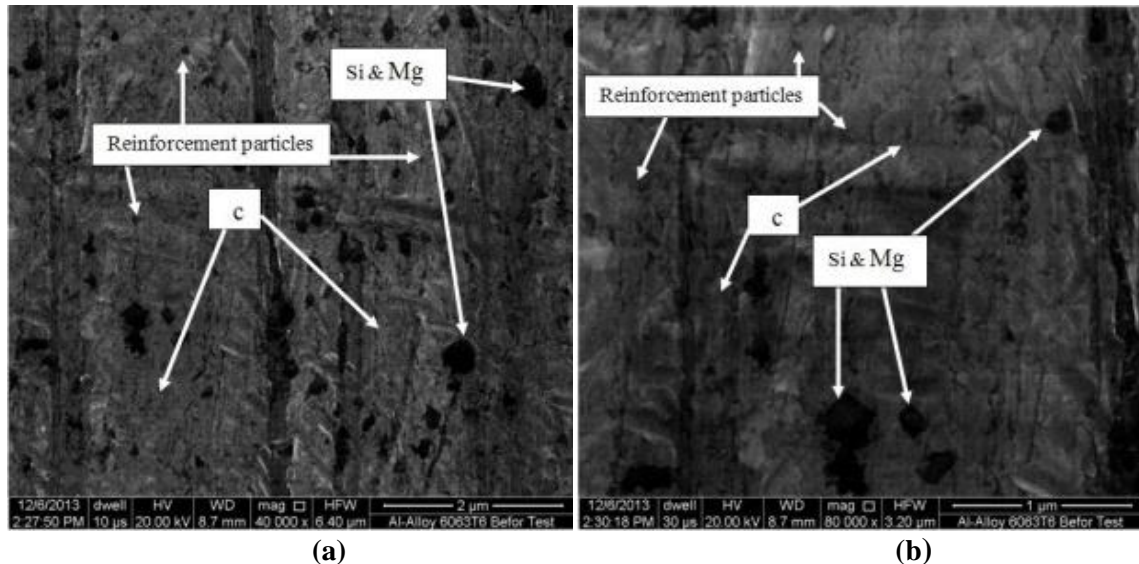
Fig. 8.23 SEM picture before the test at:

(a) 40000x magnification, (b) 80000x magnification

Figure 8.23 illustrates SEM images at high magnification before the test. The location c has a relatively coarse grain structure.

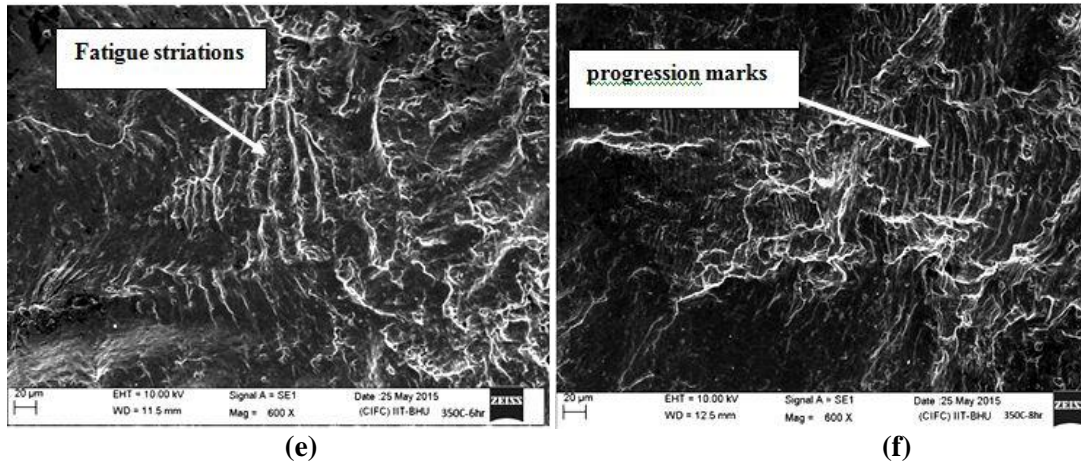
Fig. 8.29 SEM Fractograph (Segment) fracture surface of the Fatigue tested AA 6063 at different heat treatment conditions:

- (a) 100°C_2hours, (b) 200°C_2hours, (c) 350°C_2hours, (d) 350°C_4hours
(e) 350°C_6hours, (f) 350°C_8hours

Figure 8.29 shows SEM pictures for AA6063 samples heat treated at different temperatures and at different soaking time. These pictures clearly show the direction of progression of fatigue crack which resemble to river on physical map.

In same time at high magnification we can see the Progression Marks (beach marks) , and these marks tell us exactly how the crack face has progressed across the test piece and are only present in fractures where there have been substantial variations in the component stress as the crack grew across the piece . Appearance of regular fatigue striations due to regular loading, still one striation per cycle can be observed in Fig. 8.29, and it is called ductile striations with large, regular size and spacing.

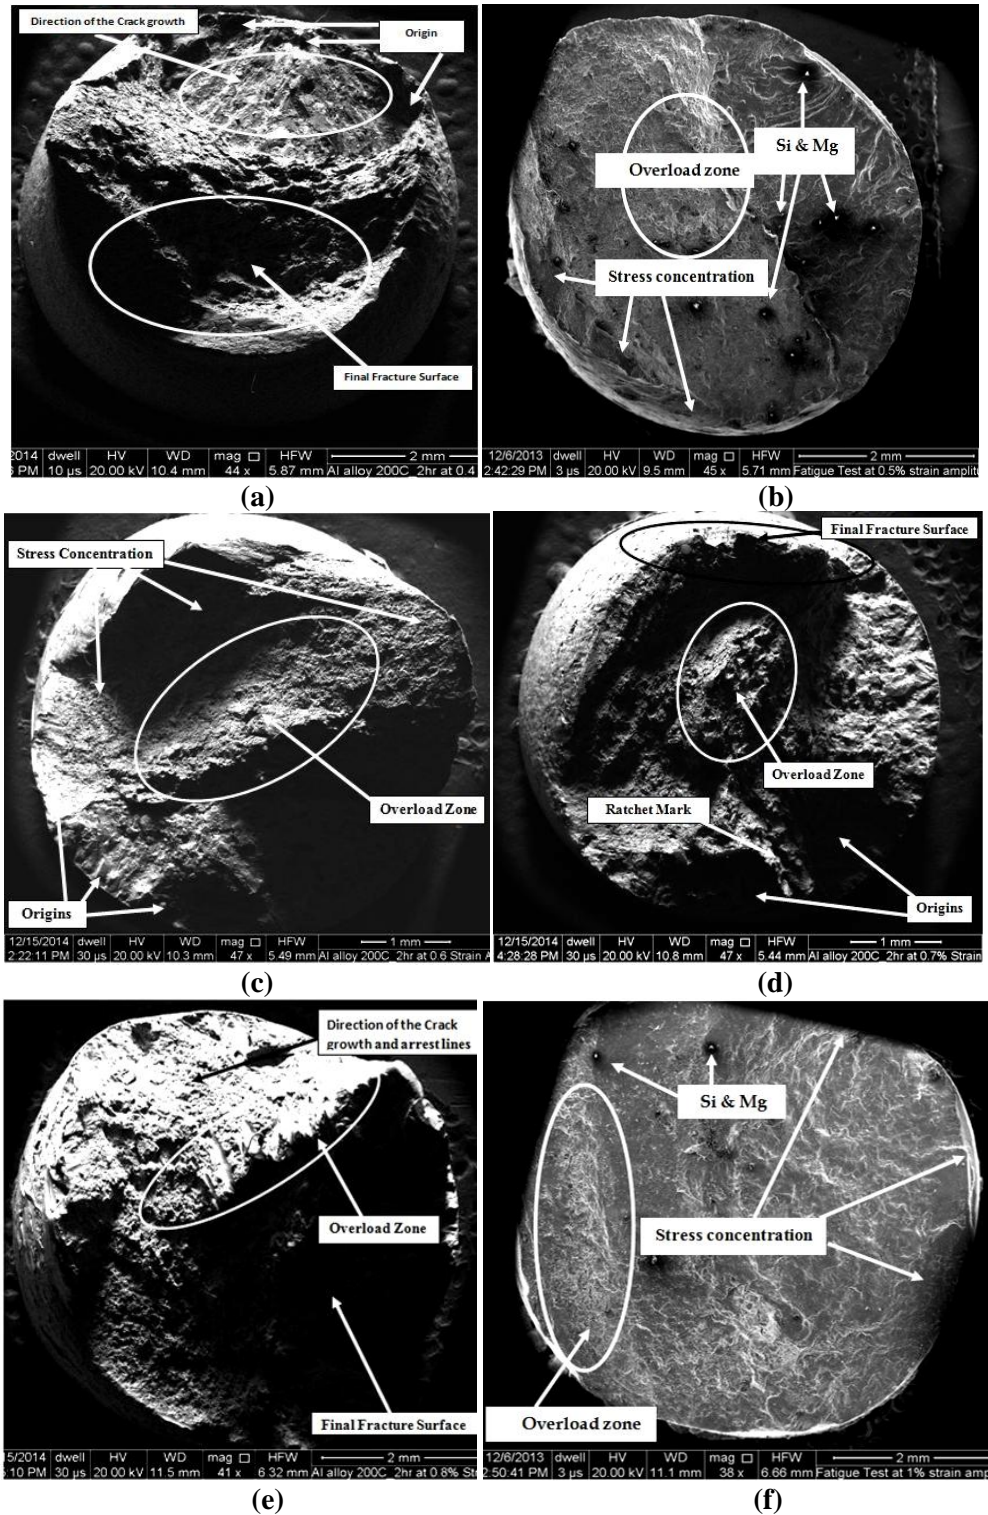
Fig. 8.32 SEM over view pictures for LCF simply supported samples at:

- (a) 0.4% strain amplitude
- (b) 0.5% strain amplitude
- (c) 0.6% strain amplitude
- (d) 0.7% strain amplitude
- (e) 0.8% strain amplitude
- (f) 1% strain amplitude

A cross-sectional view of this fatigue failure shows that the piece is domed with the smallest radius near the outer edge. Also of interest is the shape of the overload zone. The fact that it is elongated indicates some plane bending loads were present, as demonstrated in Fig. 8.32. Micro cracks (initiating fracture) began almost simultaneously on parts of the circumference of the specimen. Here we can see the overload zone, or fast fracture zone, where the final catastrophic failure occurs.
