### 5.1 INTRODUCTION

### 5.2 Wear and Erosion Behaviour

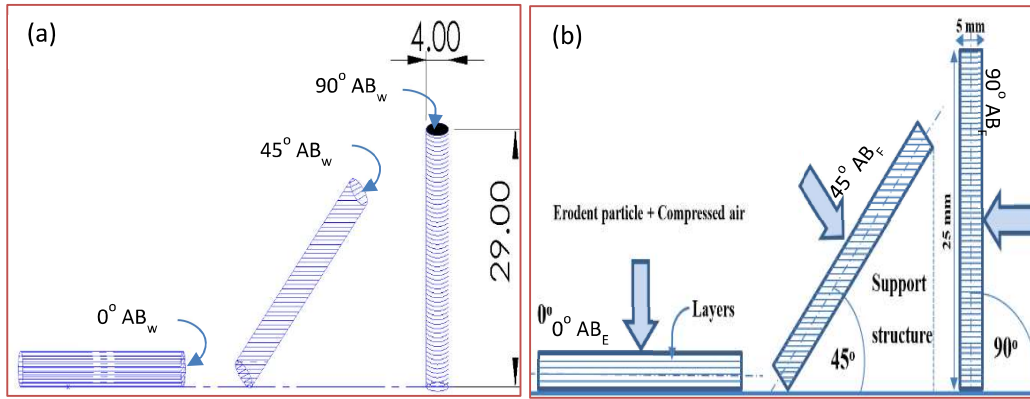
The faces, of the samples subjected to rubbing action against rotating disc in the wear test, are denoted as  $0^\circ AB_w$ ,  $45^\circ AB_w$  and  $90^\circ AB_w$  in Fig. 5.1(a). The faces on which the

high velocity erosion particles fall in erosion test are denoted as  $0^\circ AB_E$ ,  $45^\circ AB_E$  and  $90^\circ AB_E$  in Fig. 5.1 (b).

**Fig. 5.1** Schematic presentation of  $0^\circ$ ,  $45^\circ$  and  $90^\circ$  built samples used for: (a) wear test sample,  $0^\circ AB_w$ ,  $45^\circ AB_w$  and  $90^\circ AB_w$  are mating surfaces with rotating disc and (b) erosion test samples,  $0^\circ AB_w$ ,  $45^\circ AB_w$  and  $90^\circ AB_w$  are exposed surfaces in erosion.

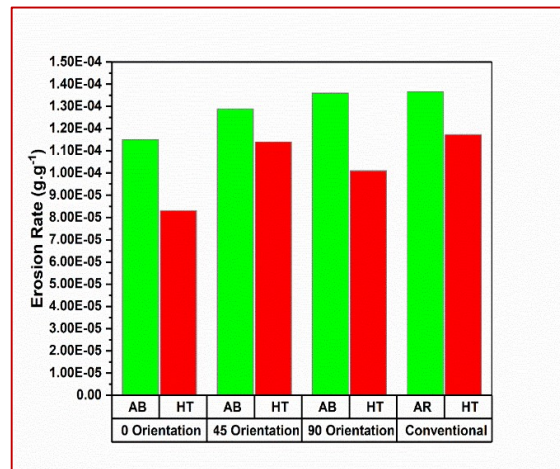
Mass loss of material, up to 4 decimal points, was noted and erosion rate was calculated using Eq. 2.8 given in Chapter 2. Fig. 5.8 shows comparison of erosion rate of the as-built and heat-treated samples in 0°, 45° and 90° orientations with the rates observed in conventional sample in the as received and heat-treated conditions. The conventional sample, in as received condition, exhibited more erosion rate than the rates in as-built additive samples. The erosion rate before heat treatment follows the trend: CM ( $1.37 \times 10^{-4} \text{ gg}^{-1}$ ) > 90° AB ( $1.36 \times 10^{-4}$ ) > 45° AB ( $1.28 \times 10^{-4}$ ) > 0° AB ( $1.15 \times 10^{-4}$ ). After the heat treatment, the erosion resistance was improved and minimum erosion rate was observed for the 0° HT ( $8.3 \times 10^{-5}$ ) sample and was followed by 90° HT ( $1.01 \times 10^{-4}$ ), 45° HT ( $1.14 \times 10^{-4}$ ) and CM-HT ( $1.17 \times 10^{-4}$ ) samples respectively.

Fig. 5.8 Erosion rate of additive and conventional samples in as built/as-received and heat-treated conditions.

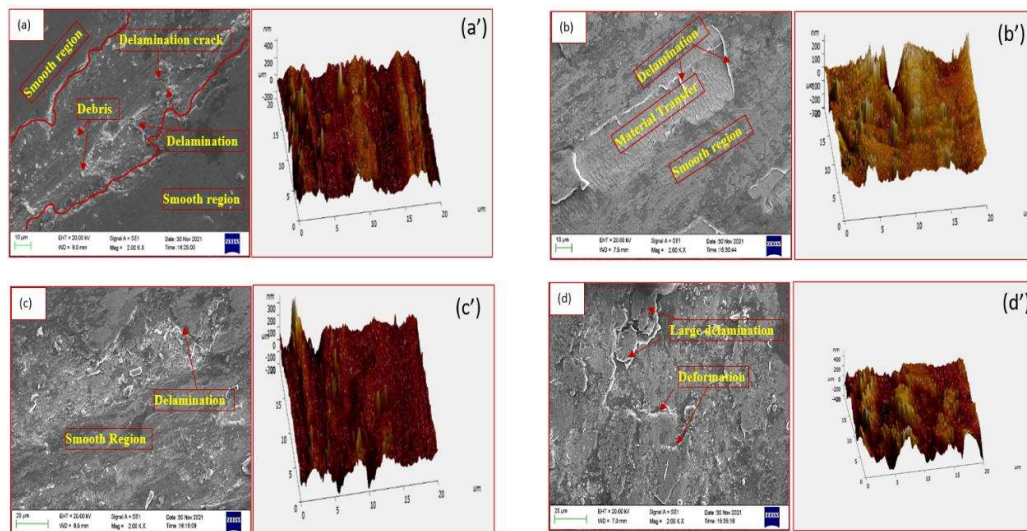
Surface morphology of the as-built/as-received additive and conventional samples, wear-tested at the highest load of 80 N is shown in Fig. 5.10. Fig. 5.10(a) shows the worn

surface of the CM samples; it depicts wear tracks as well as delamination. Similarly, worn surfaces of the as-built additive samples in Figs. 5.10(b, c, and d) show mainly materials transfer, delamination and plastic deformation on the surface. Smoother surface was observed for the  $0^\circ$  orientation, followed by  $45^\circ$  and  $90^\circ$  AB samples and the results are consistent with the COF results of the respective samples. The 3D profiles of the samples tested at 80N, (Figs. 5.10 a', b', c' and d') reflect that only the conventional as received samples showed mixed wear characteristics, like wear tracks and delamination with a track width of about  $\sim 10 \mu\text{m}$  and peak and valley depth of  $\pm 300 \text{ nm}$ . The  $0^\circ$ ,  $45^\circ$  and  $90^\circ$  AB samples showed only delamination and materials transfer, due to which there were no clear tracks and track width observed was  $\sim 200 \text{ nm}$  as unevenness was created by materials transfer and delamination (Figs. 5.10 b', c' and d').

**Fig. 5.10** Worn surfaces of as received conventional sample (CM) and as-built additive samples (AB) in different orientations at 80 N load: (a) CM (b)  $0^\circ$  AB (c)  $45^\circ$  AB and (d)  $90^\circ$  AB and their corresponding 3D profile images (a', b', c' and d').

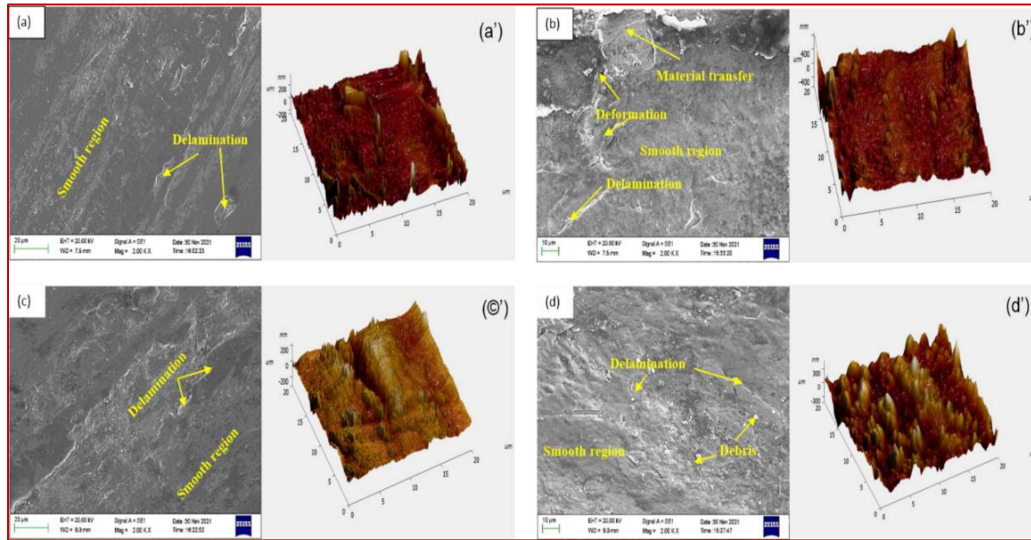
The wear surface morphology of heat-treated samples at highest applied load of 80 N displayed in Fig. 5.11(a, b, c and d).

**Fig. 5.11** Worn surfaces of heat-treated conventional and additive samples in different orientations: (a) CM-HT (b) 0° HT (c) 45° HT (d) 90° HT and their corresponding 3D profile images (a', b', c' and d').

Delamination and deformation were observed on worn surfaces of the conventional, 0°, 45° and 90° heat-treated samples. Smoother region was observed as compared to the surfaces of AB/CM wear tested samples at 80N applied load. The SEM observations of worn surfaces for the heat-treated samples were found to be matching with the COF and wear rate results of the respective samples.
