5. Study on galling behaviour of HiPIMS deposited Mo/DLC multilayer coatings at room and elevated temperature.

**Work published in Wear [250]*

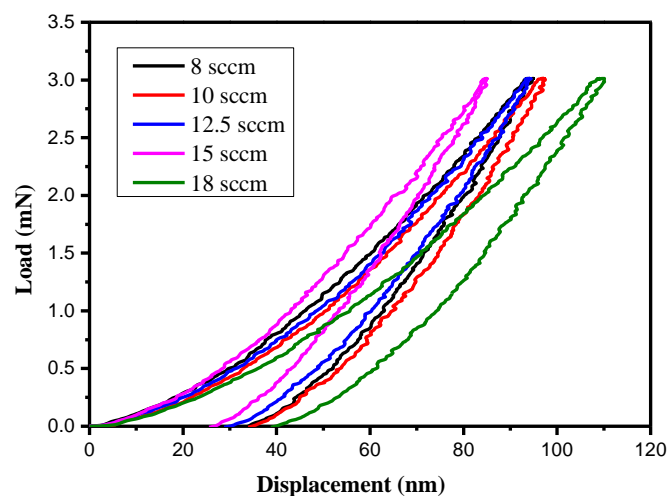
Figure 5.8. Load vs displacement curves of Mo/DLC multilayer coatings at different flow rates.

The effect of the argon flow rate on the hardness of the Mo/DLC multilayer coating is demonstrated by the load-displacement curve in **Figure 5.8**. The coating deposited at a 15 sccm flow rate shows the least displacement, leading to the coating with the highest hardness of 21 GPa. The hardness increased when the flow rate was increased from 10 to 15 sccm but decreased significantly to 8 GPa when the flow rate increased to 18 sccm. An increase in hardness was observed when the coating was deposited at flow rates lower than 10 sccm, which was in agreement with the results obtained by Takumi et al. [177]. However, the coating deposited at low pressure caused heavy arcing in the system, was uneven, and a gradual color change was also observed on the coating surface. Moreover, the coating also peeled off completely when it was left idle for two days after tribotesting. Therefore, the high hardness value can be attributed to the high internal stress in the coating deposited at lower flow rates, which leads to peeling off later.

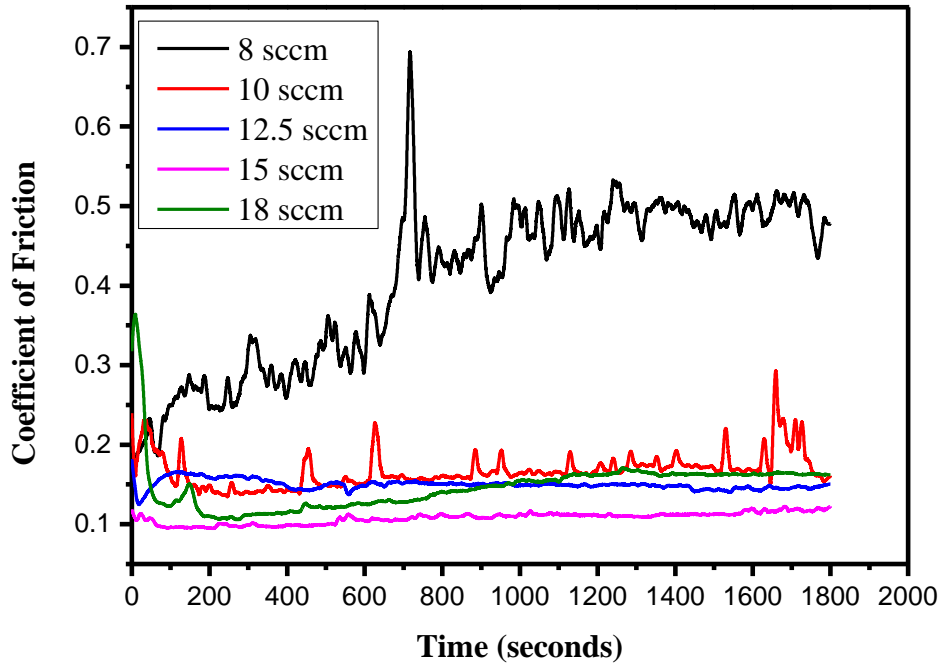
Figure 5.9. Coefficient of friction of Mo/DLC multilayer coating deposited at various argon gas flow rates.

Figure 5.9 shows the variation of CoF in the coatings deposited at various flow rates obtained from nanotribometer. The coating deposited at a flow rate of 8 sccm failed at the initial stages of the wear testing. The CoF seemed to be stabilized for higher flow rates. The CoF of the coating deposited at 10 sccm flow rate seemed to be partially stabilized but with several spikes in CoF during the tribo-testing. The CoF of coatings deposited at 12.5, 15, and 18 sccm of Ar flow rates did not show any peaks. Many investigations have already been reported on the tribological behaviour of the DLC type of coatings [39,174,176,263]. The formation of the DLC transfer layer on the counter surface has been the main reason for low friction and wear. The wear profiles of coatings deposited at different flow rates are shown in **Figure 5.10**. Coating deposited at 10 sccm Ar flow rate showed the highest wear, which can be attributed to the continuous disruption of the transfer layer. This can also be observed from the presence of peaks in the graph of CoF (**Figure 5.9**). It has been reported that the higher values of H/E (resistance to elastic deformation) and H^3/E^2 (resistance to plastic deformation) result in lower wear rates [114]. The material with high H/E and H^3/E^2 values distribute the load over a larger area, and they respond to an external force due to elastic recovery rather than plastic deformation [288]. The coating deposited at 15 sccm flow rate had the highest H/E and H^3/E^2 values (**Figure 5.11**) and showed the lowest CoF and wear. Coating deposited at 18 sccm flow rate exhibited lower H/E and H^3/E^2 values than the coating deposited at 10 sccm flow rate, but the wear observed in the coating deposited at 10 sccm is much more than the one deposited at 18 sccm. Therefore, the antiwear characteristics of the coating not only depend on the H , E , H/E , and H^3/E^2 values, but also on the formation and disruption of the transfer layer in a DLC coating. Hence, the optimum value of friction and wear were observed at the coating deposited at 15 sccm of the argon flow rate. This optimized coating was then studied for galling experiments at RT and 300 °C.

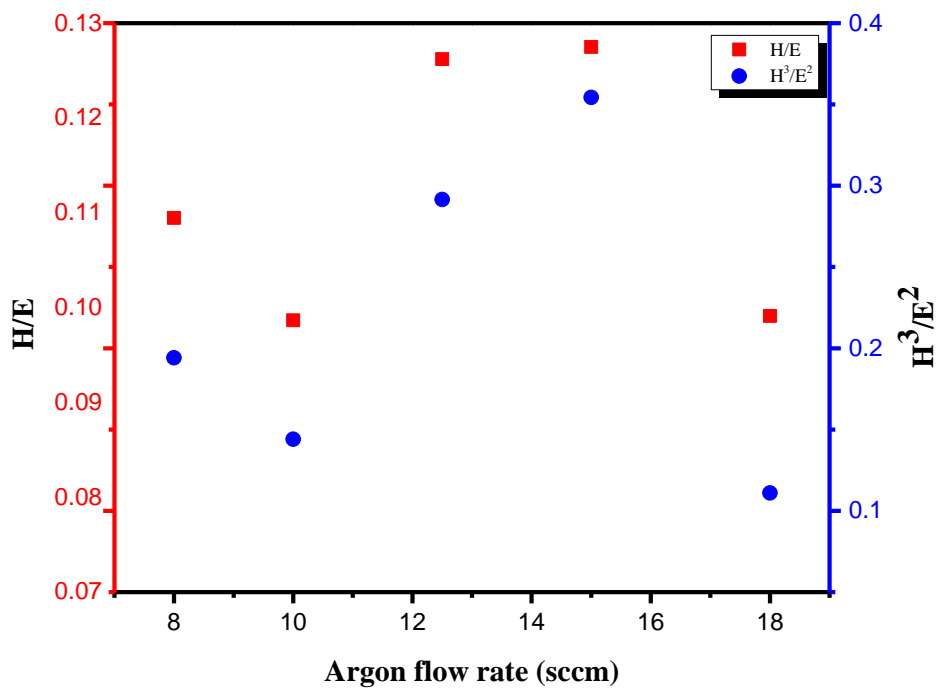
Figure 5.11. H/E and H^3/E^2 values of Mo/DLC coating deposited at different argon flow rates.
